Watercare Services Limited

ŌRĀKEI MAIN SEWER FAILURE ANALYSIS REPORT

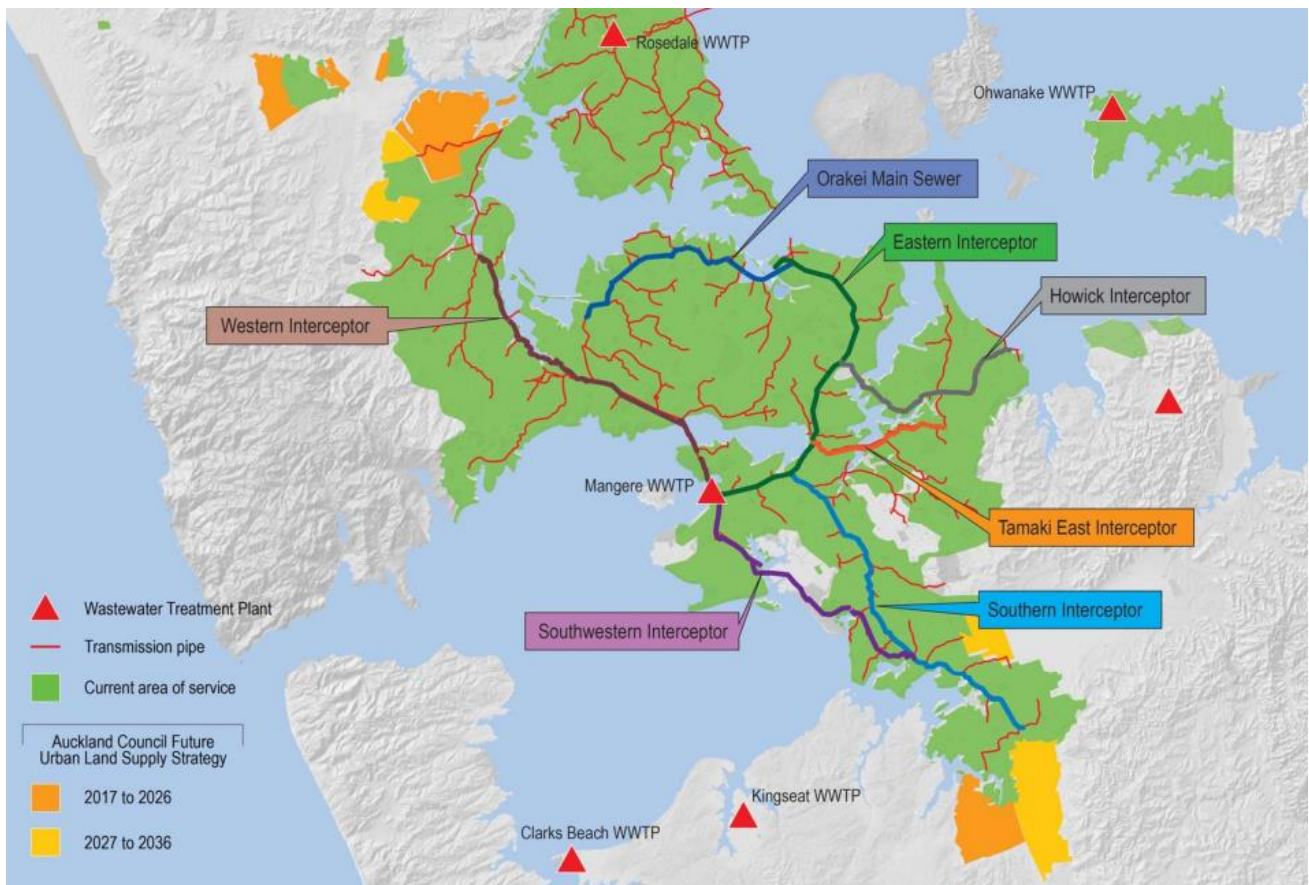
Figure 2:1 Map of wastewater transmission pipes in Auckland (Auckland Council, 2021)

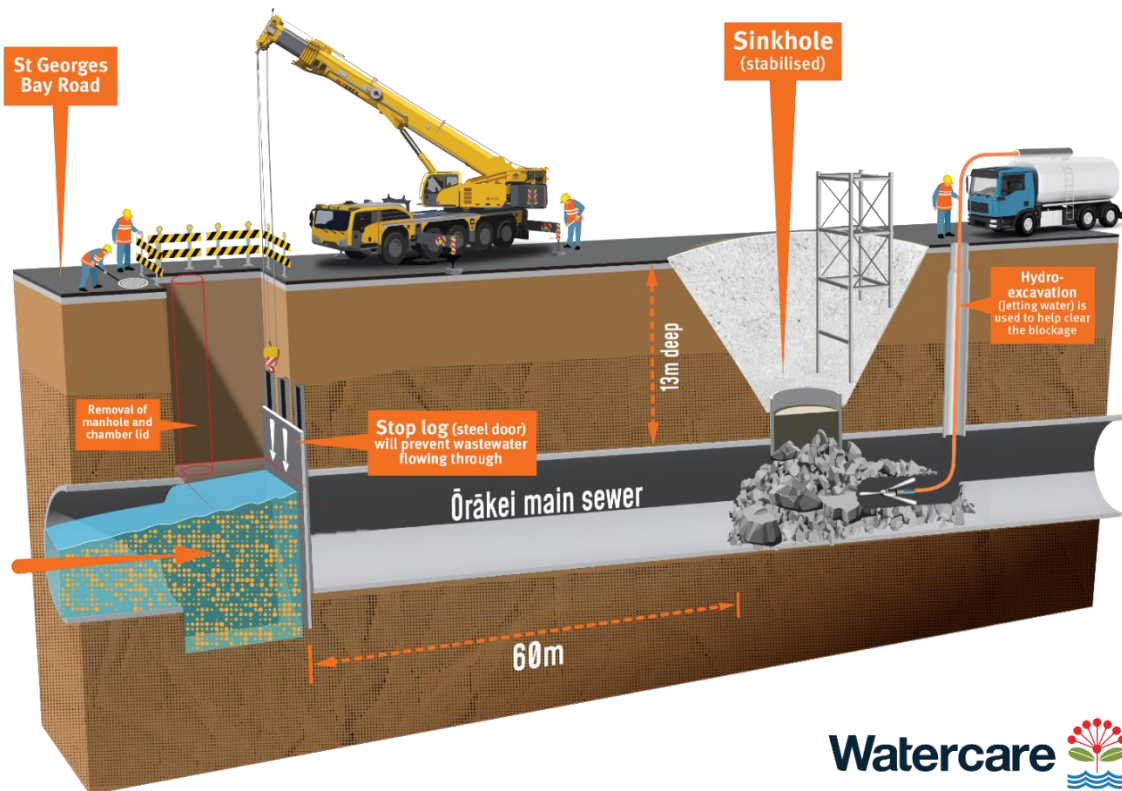
Figure 2:4 Graphic of OMS failure and initial repairs (supplied by WSL)

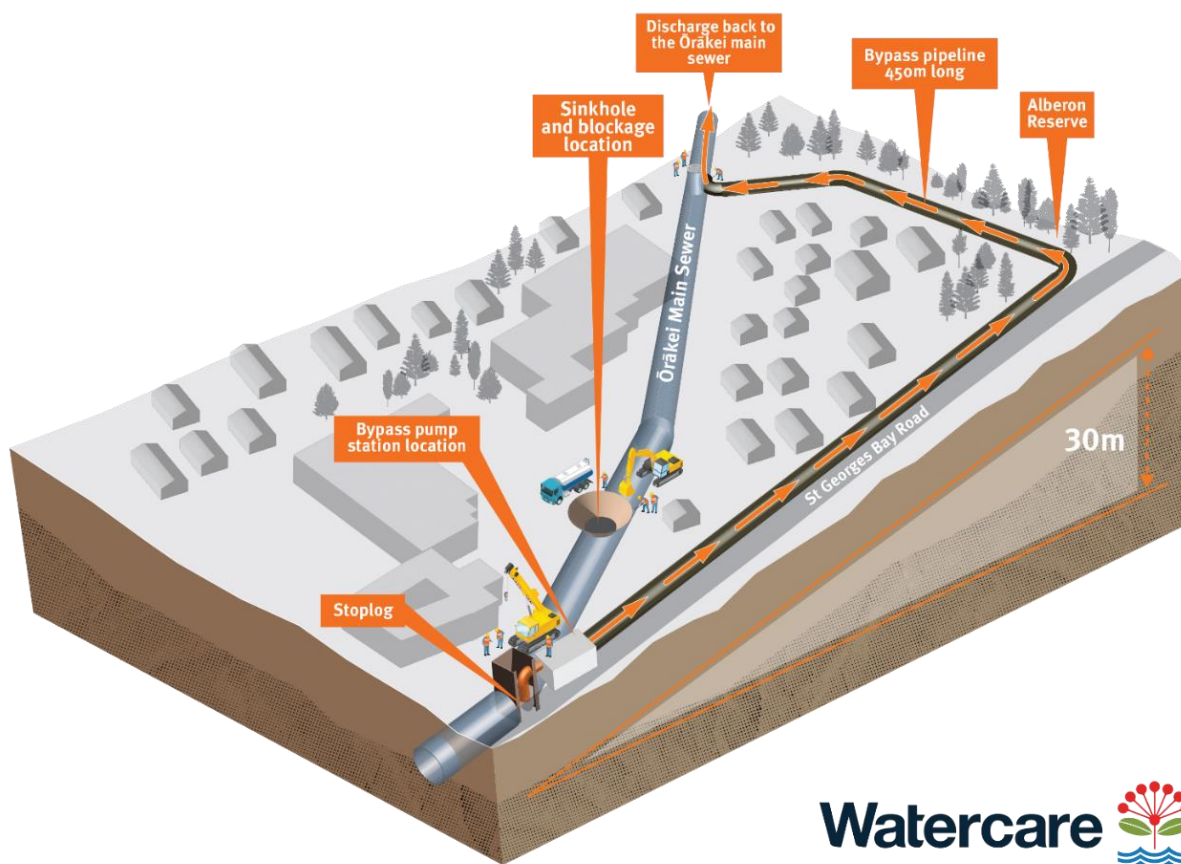
Figure 2:5 Graphic showing sinkhole location and temporary bypass pipeline (supplied by WSL)

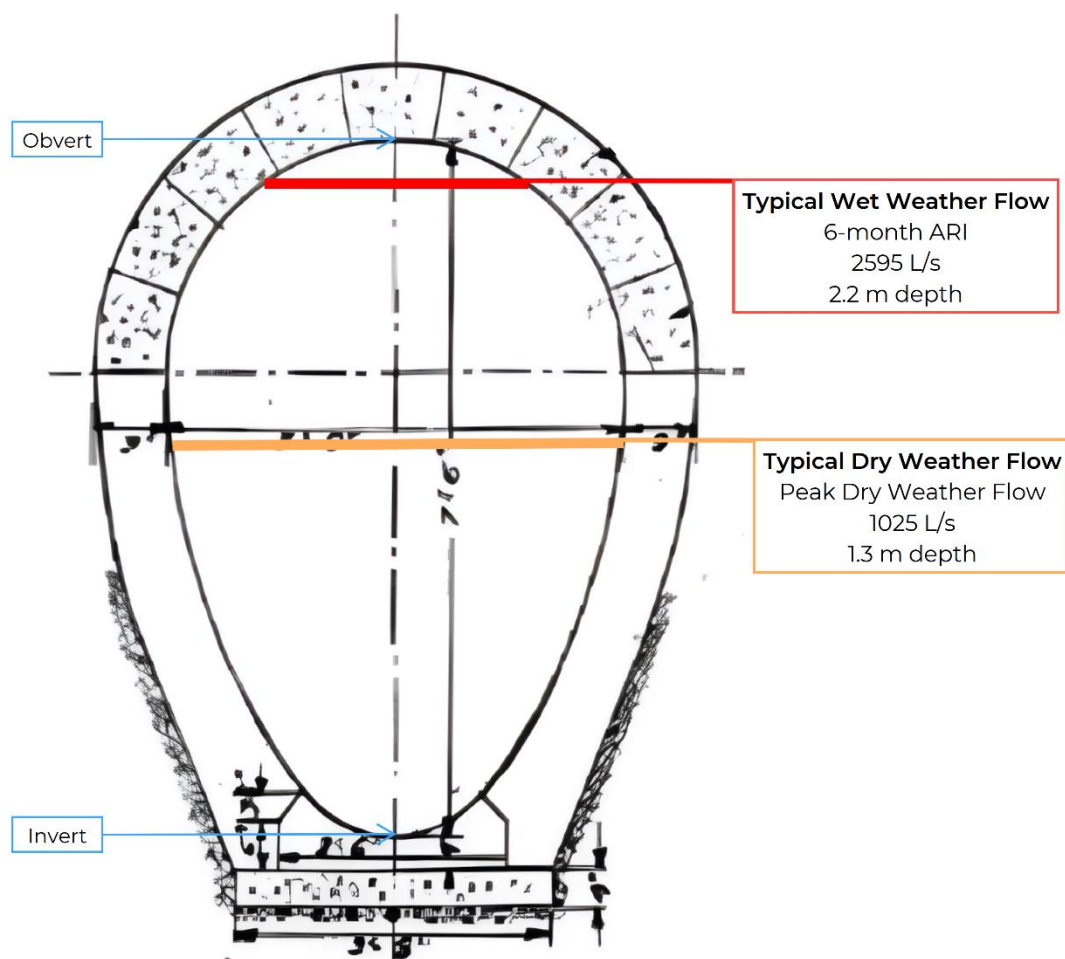
Figure 3:1 Depth of typical flow rates relative to the OMS cross-section (supplied by WSL)

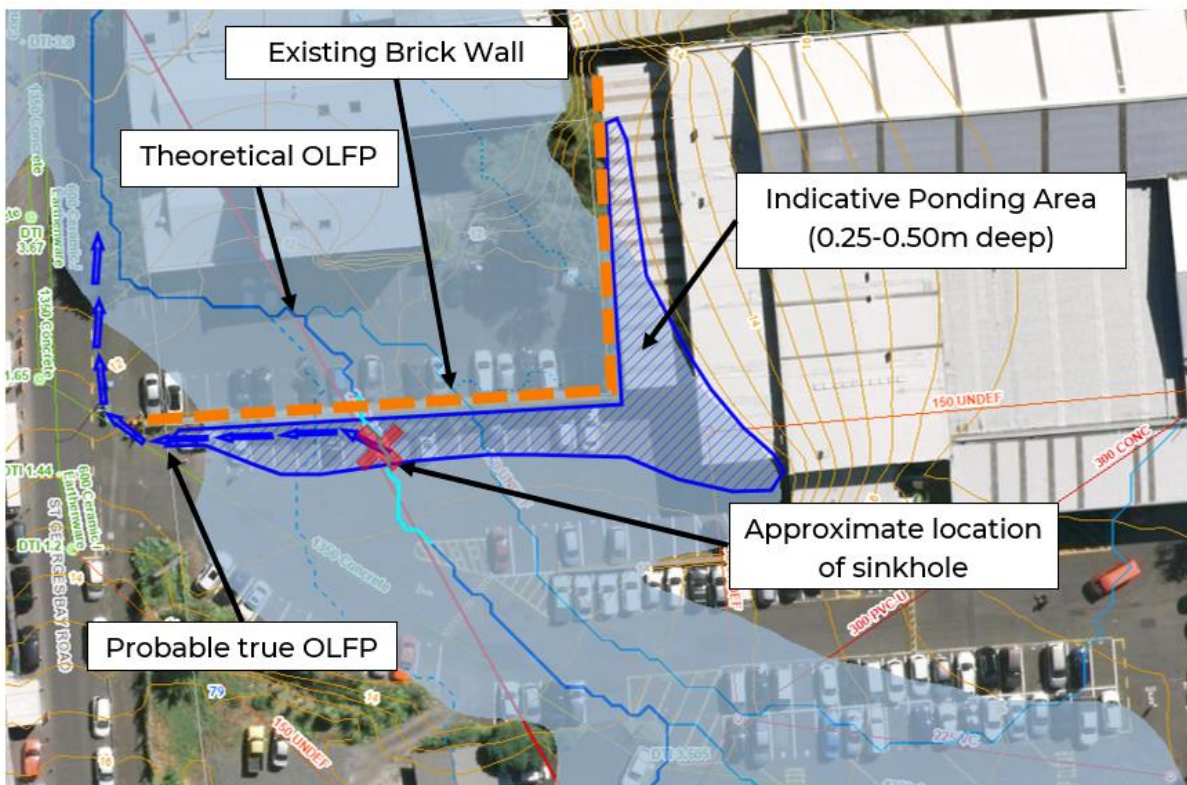
Figure 3.3 Overland flow paths near the sinkhole location

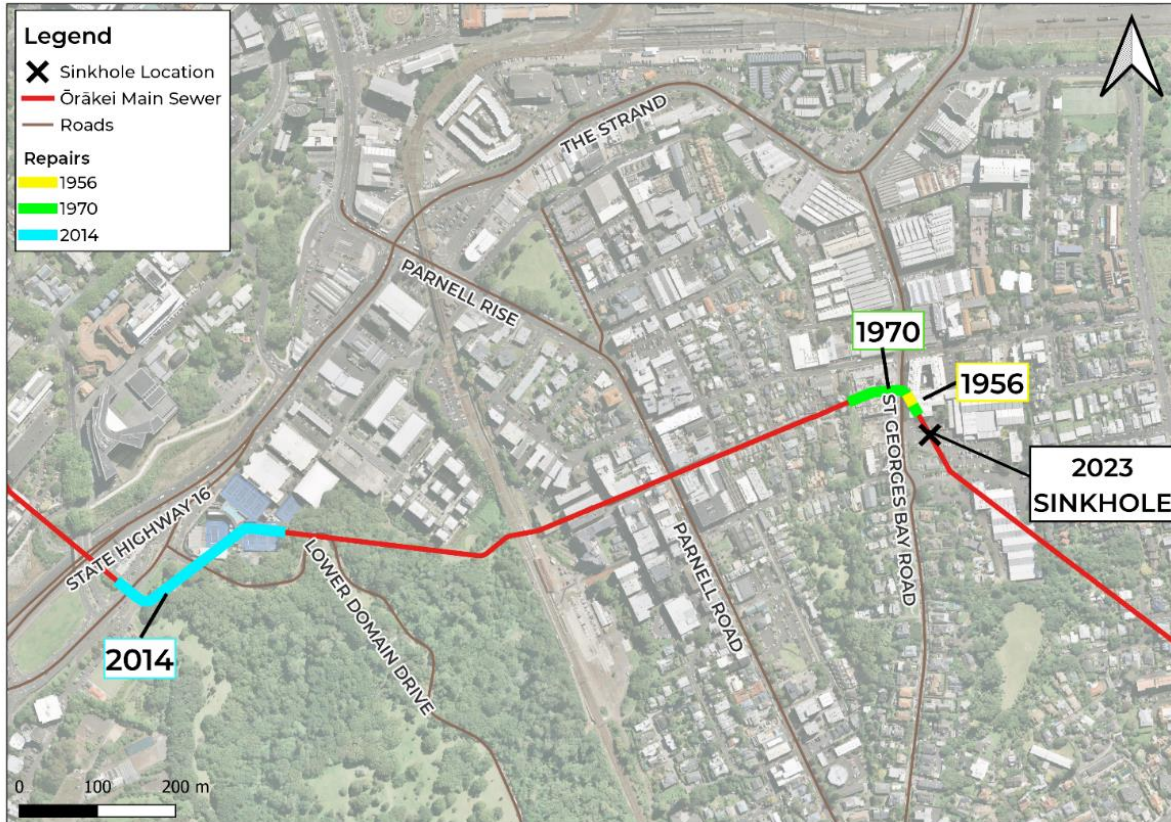
Figure 3:4 Locations of previous OMS repairs in relation to the 2023 failure

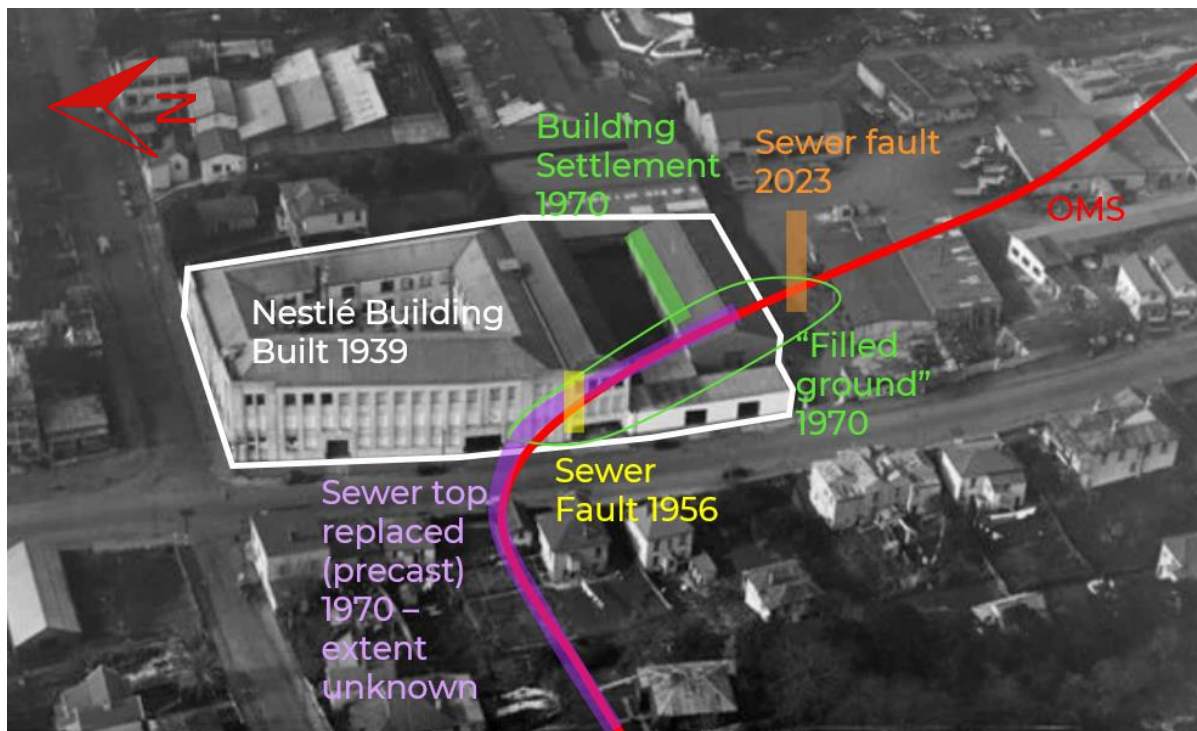
Figure 3:5 Annotated 1949 aerial image (supplied by WSL)

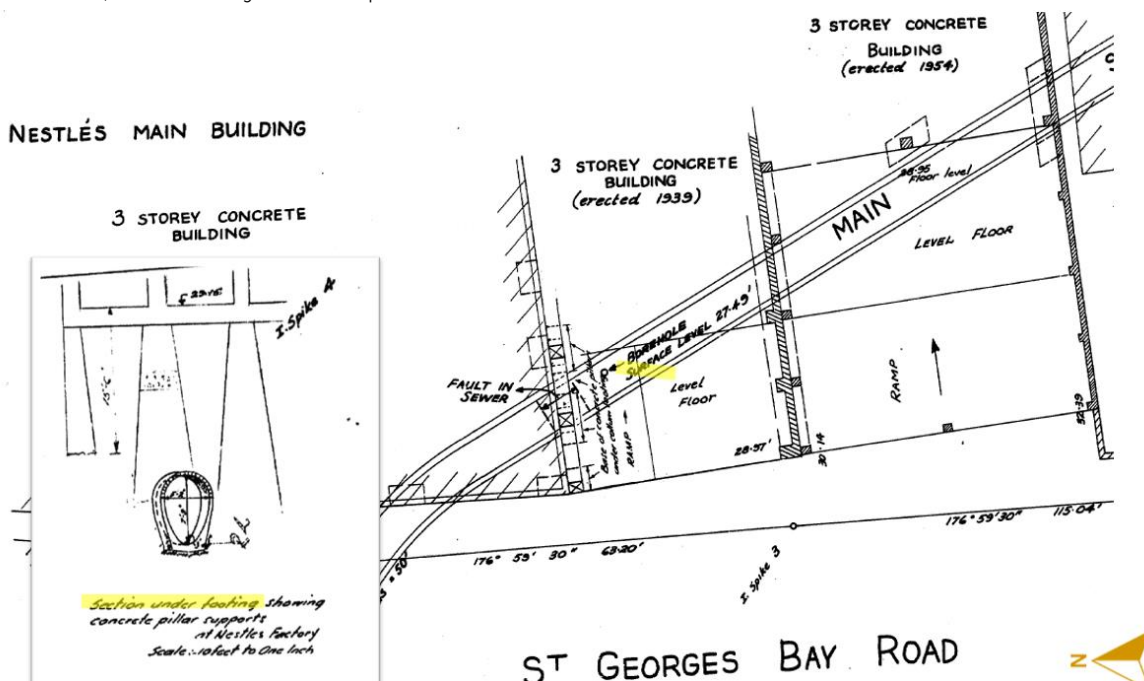
Figure 3:6 Fault Under Nestlé Building circa 1956

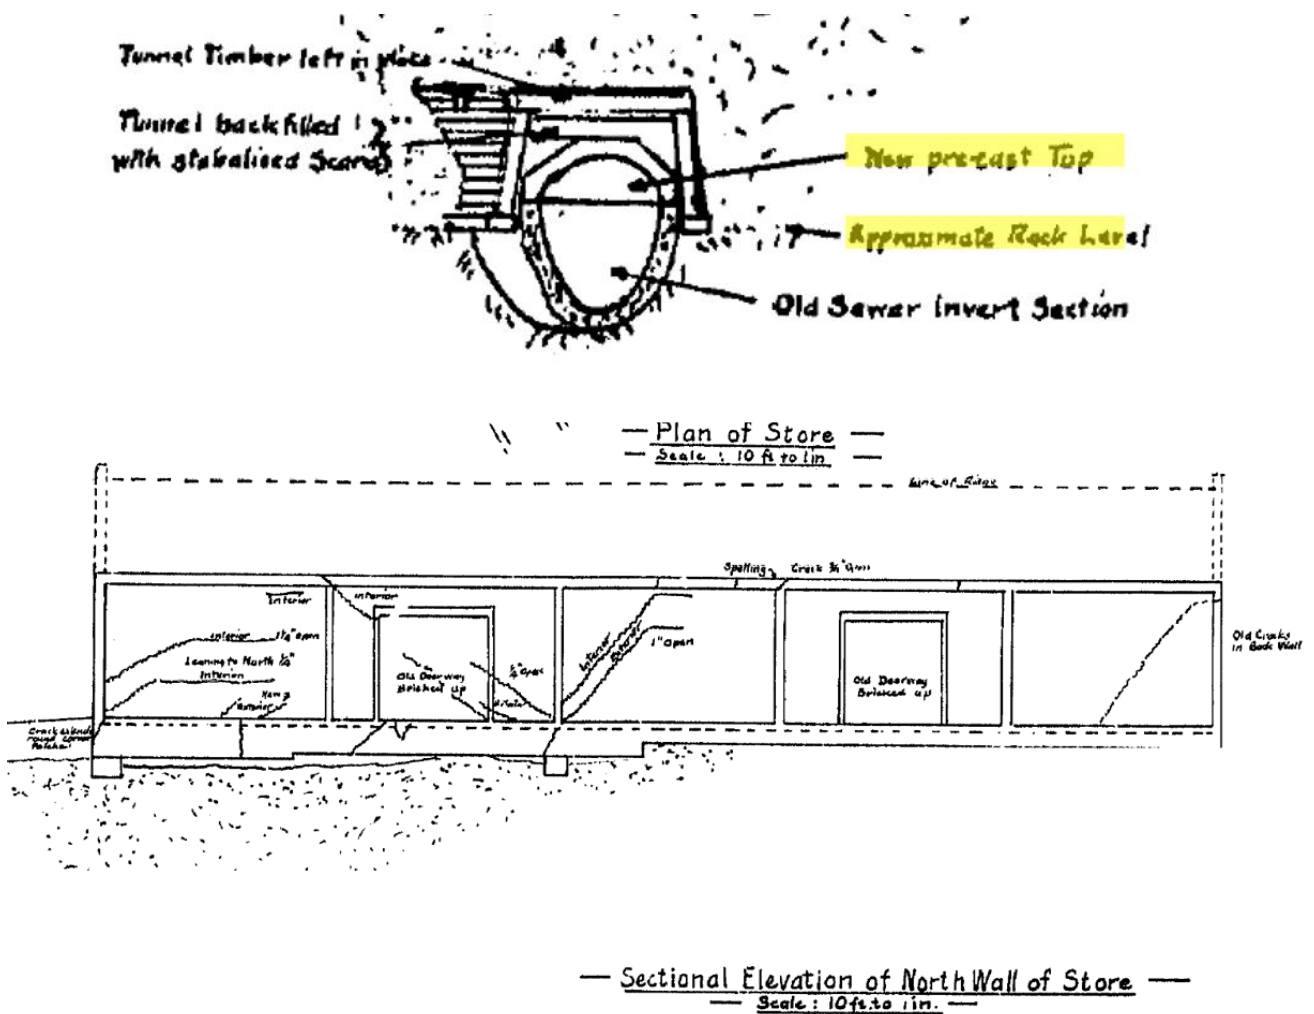
Figure 3:7 Nestlé's subsidence/ cracks in 1970

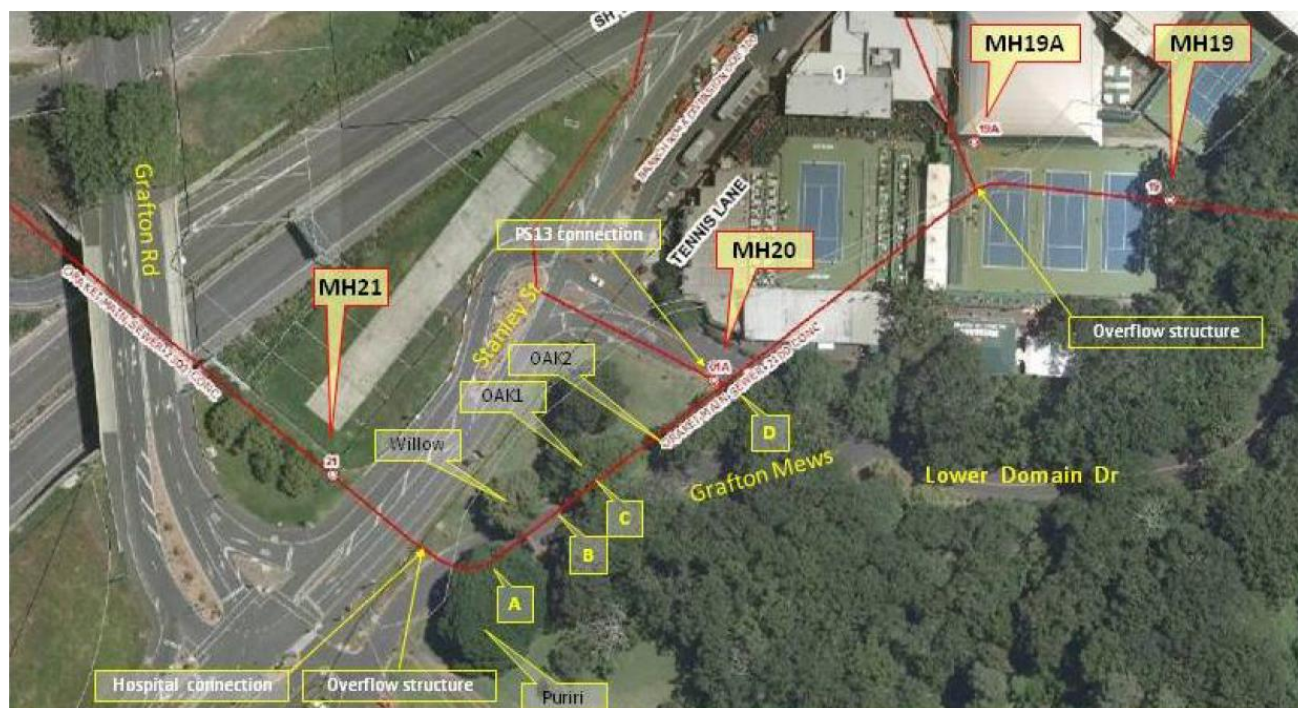
Figure 3:8 Location of Stanley St rehabilitation in 2014

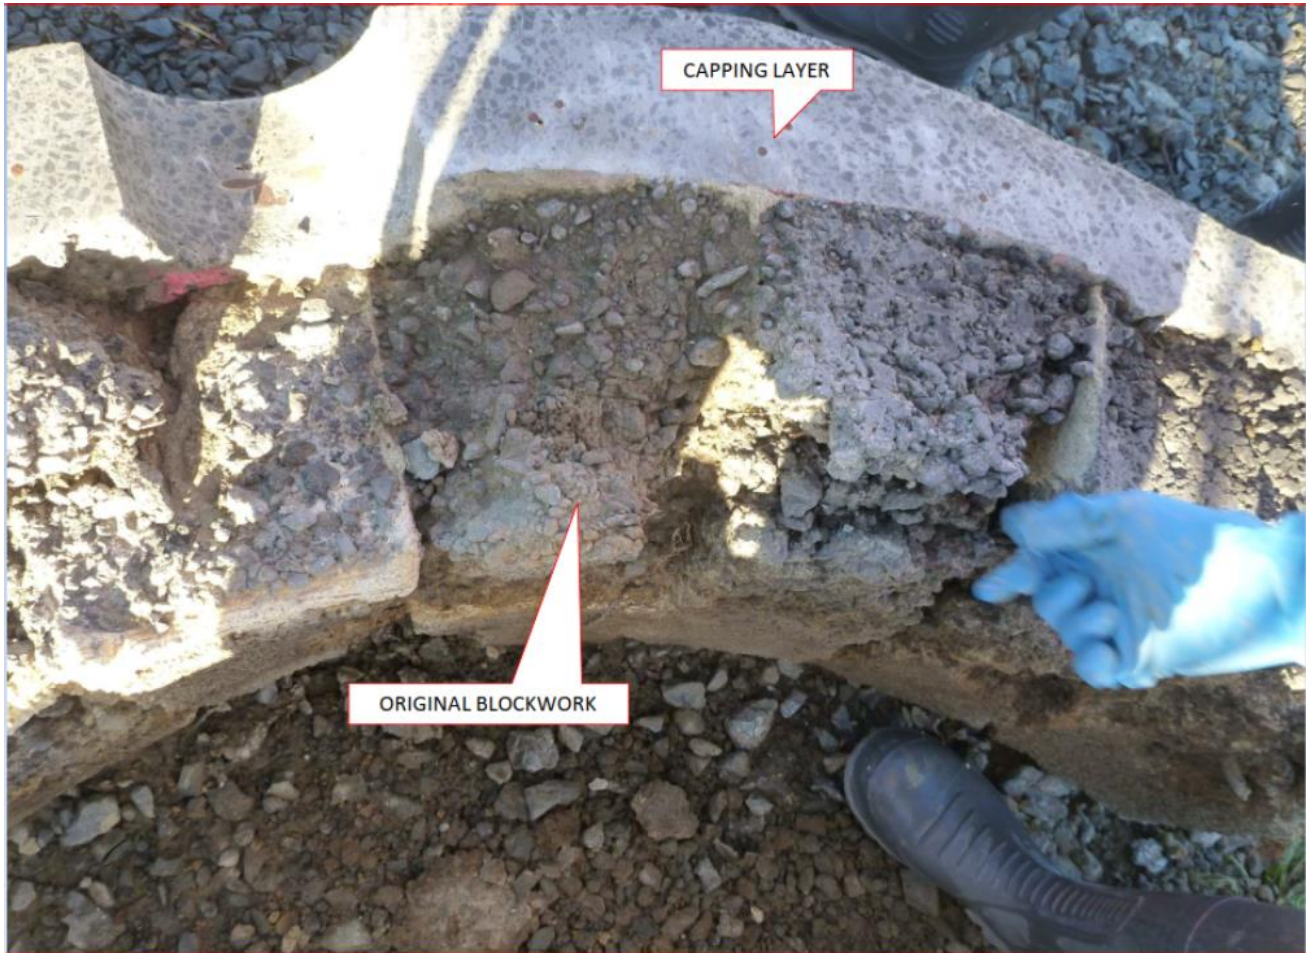
Figure 3:9 Photo of capping layer and original blockwork

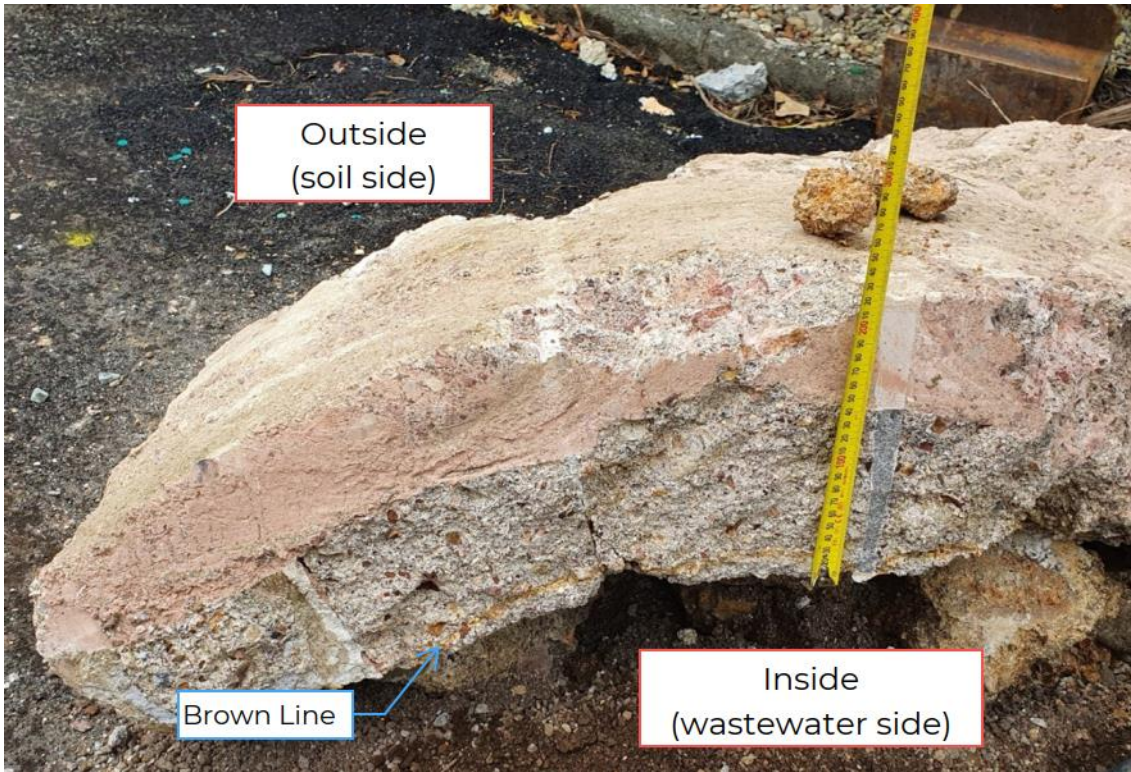
Figure 4:1 Typical block arch section after removal. Note the brown line indicating the extent of corrosion on the inside face

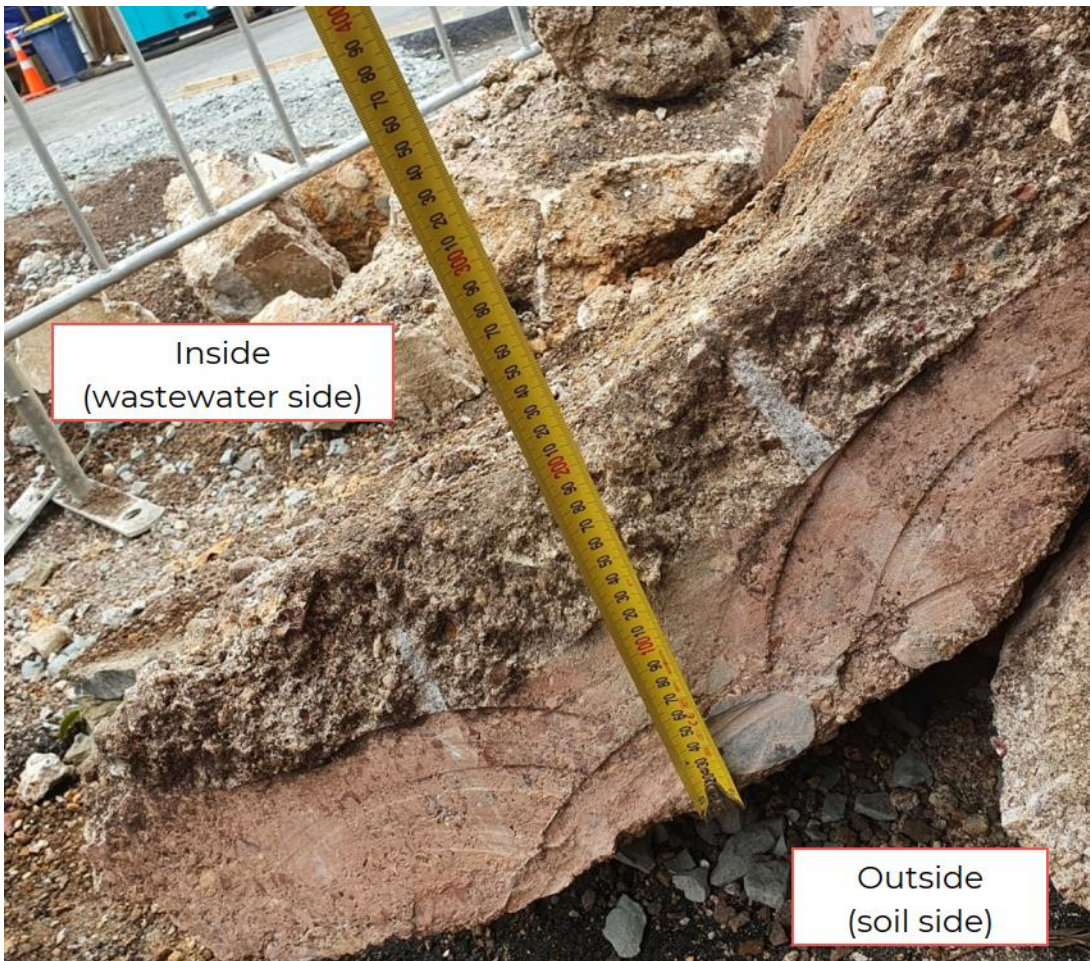
Figure 4:2 Weak blockwork after removal

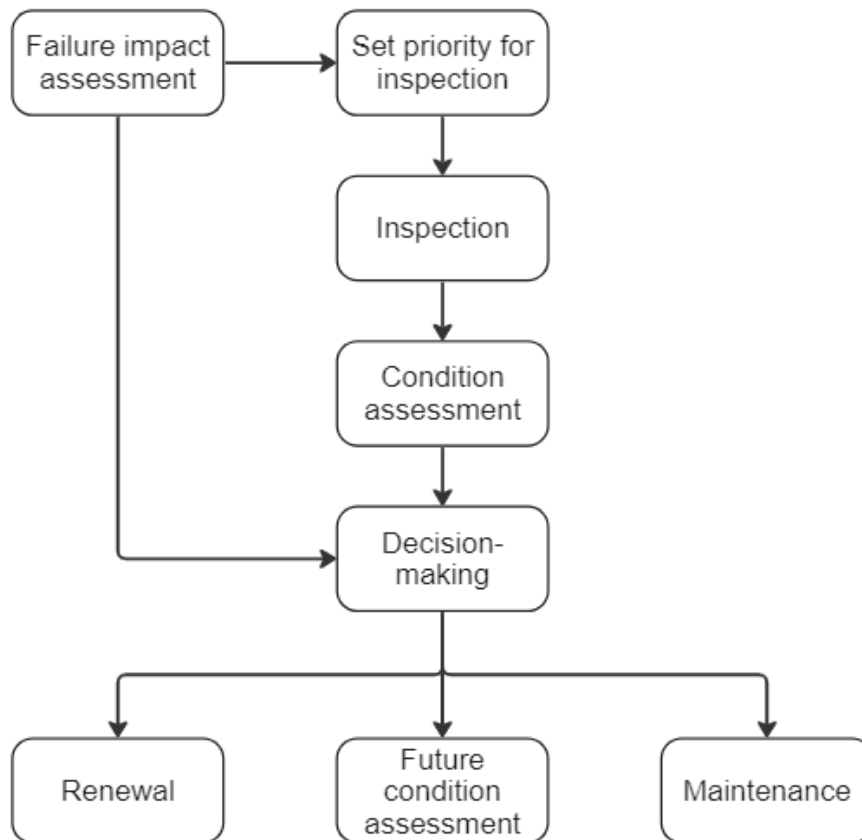
Figure 7:1 Steps for managing sewer assets (Zhao, McDonald, & Kleiner, 2001)

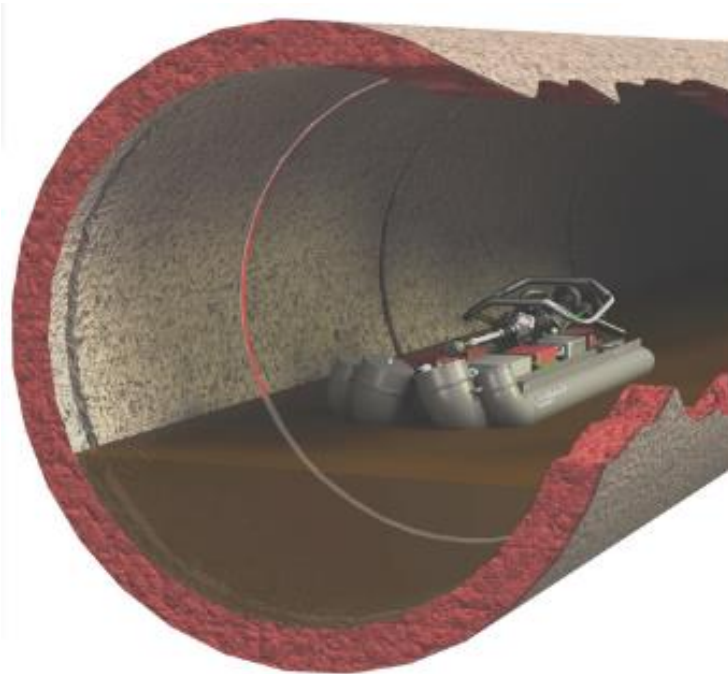
Figure 7:2 Pipe inspection unit (Kawasmi & Brown, 2019)

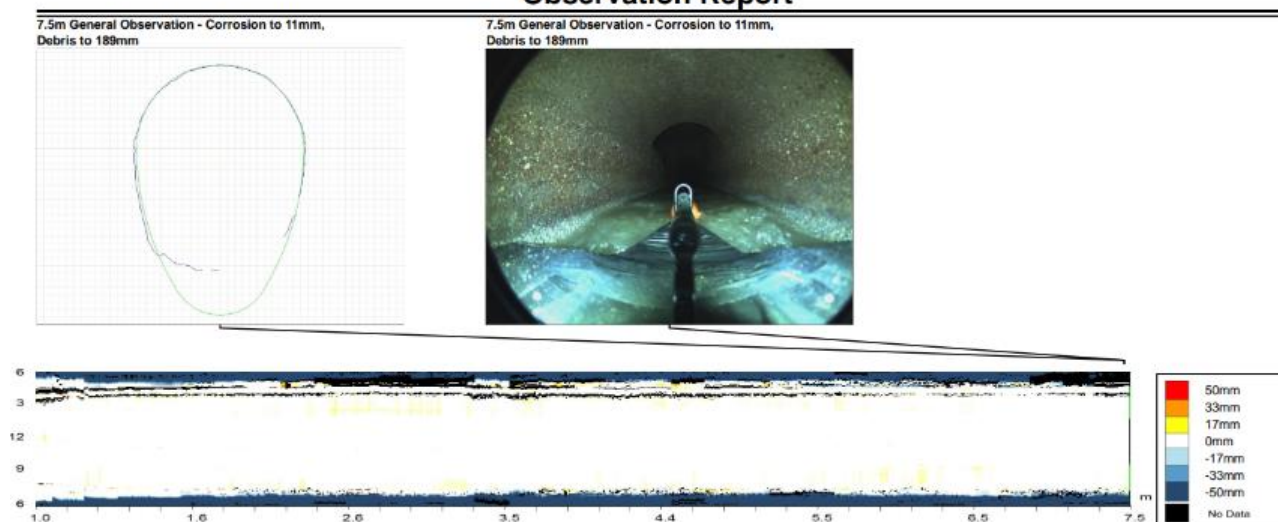
Figure 7:3 Pipe inspection observation report example (from the 2012 inspection of the OMS, supplied by WSL)

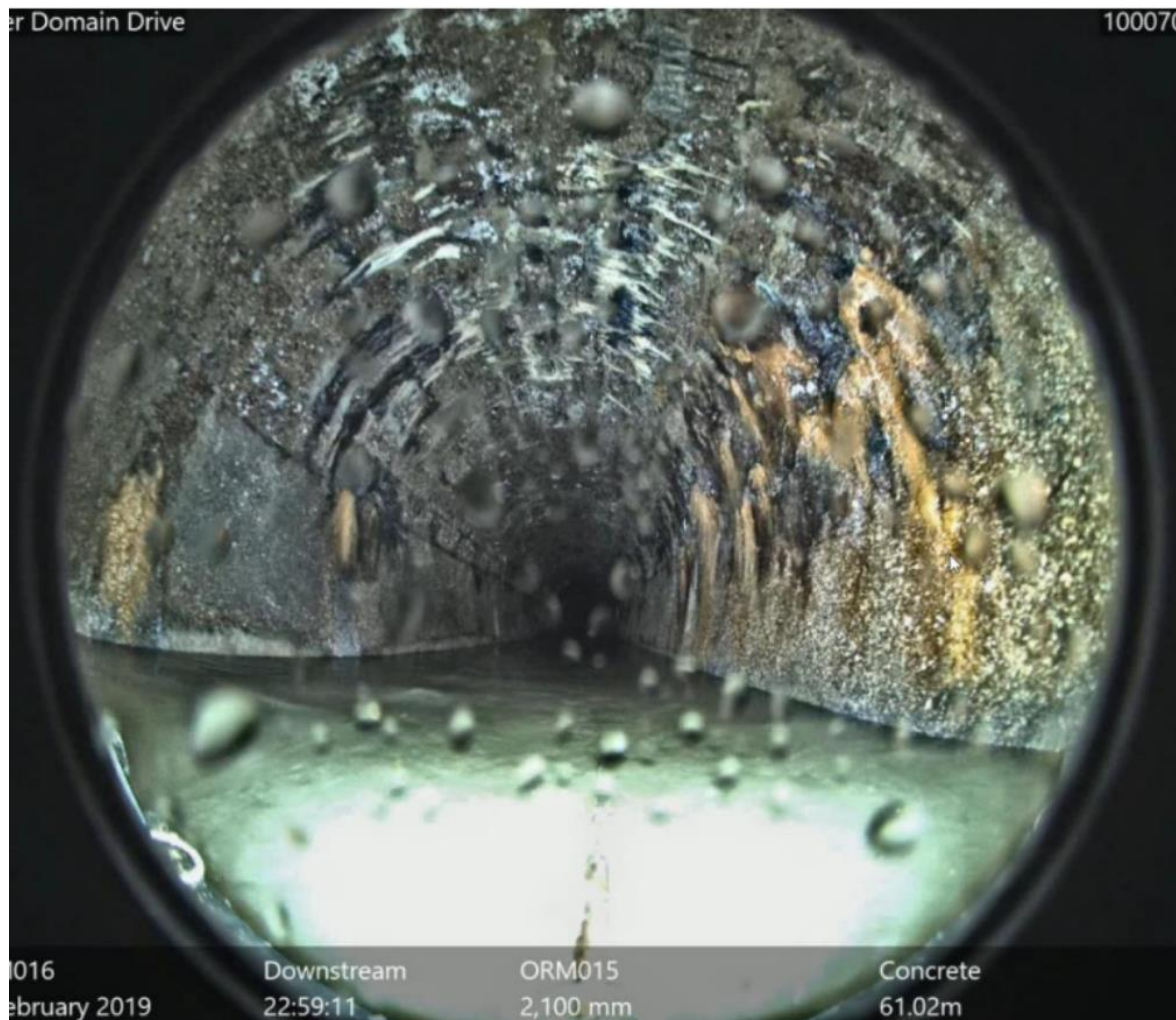
Figure 7.4 Sample CCTV output from OMS in 2019, shows the location near the collapse (supplied by WSL)

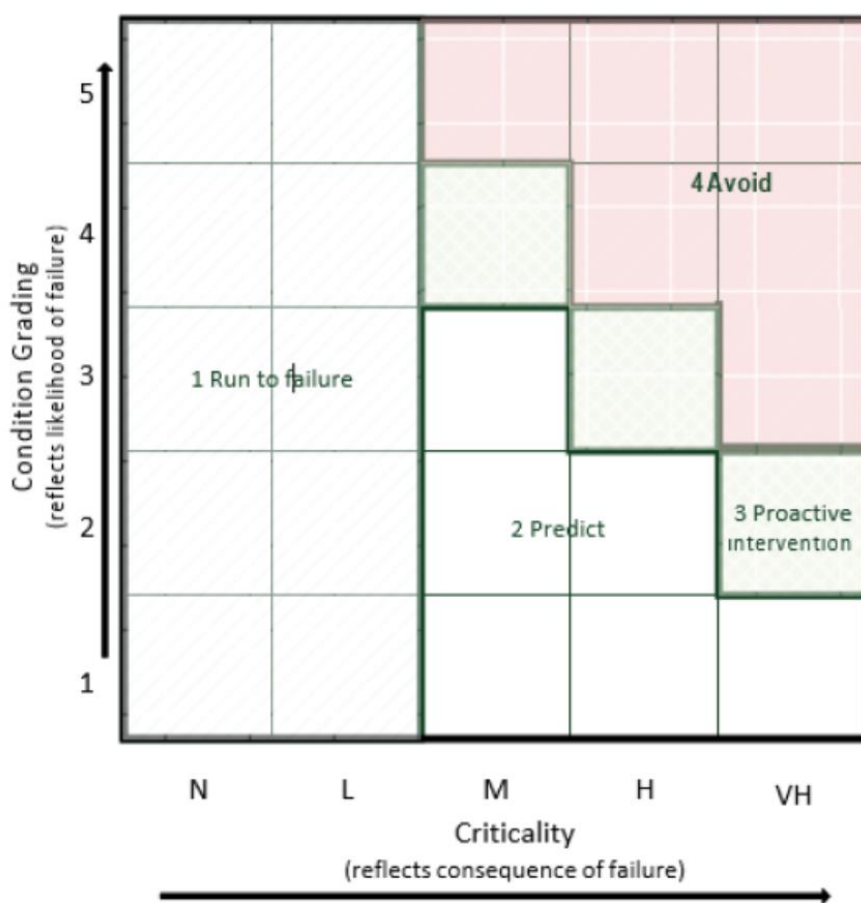
Figure 7:5 Example risk-based renewal matrix (WSP for Quake Centre, 2018)

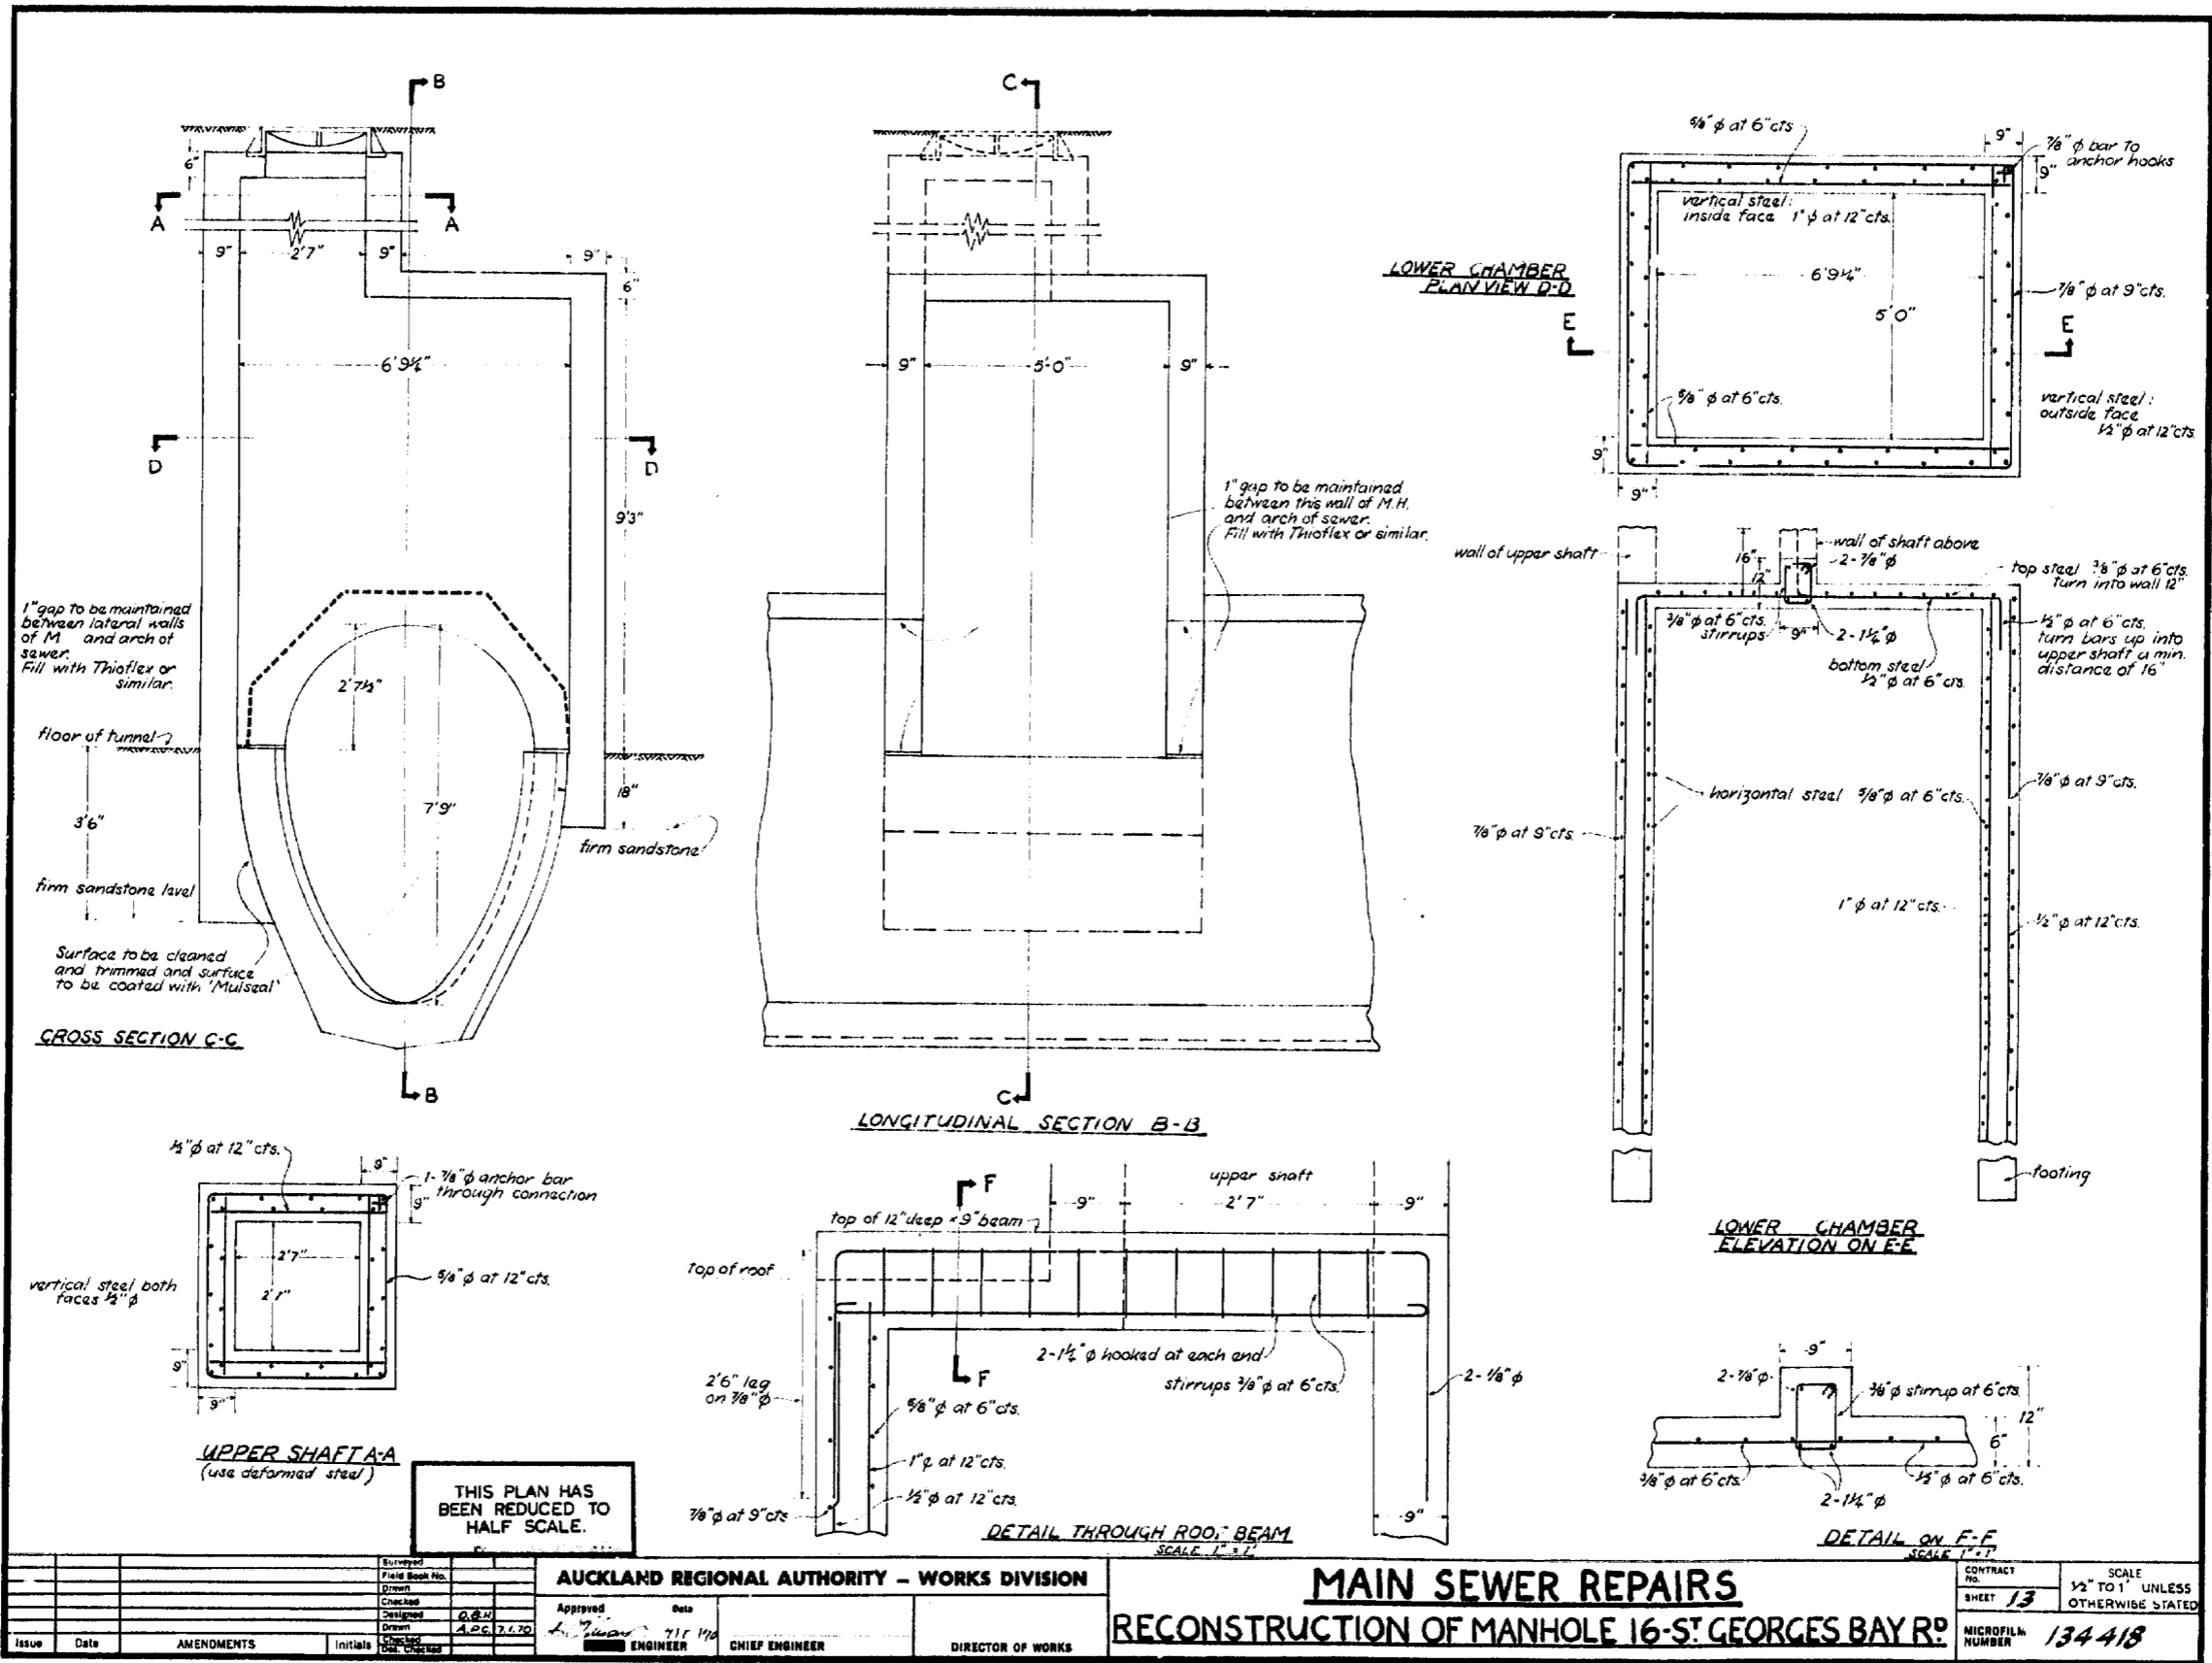
Auckland Regional Authority - Works Division Approved: [Signature] Date: 7/17/1990 Chief Engineer: [Signature] Director of Works: [Signature]				MAIN SEWER REPAIRS RECONSTRUCTION OF MANHOLE 16-S. GEORGES BAY R.P.		CONTRACT No. 13 SHEET 13	SCALE 1/2" TO 1" UNLESS OTHERWISE STATED MICROFILM NUMBER 134418
Issue	Date	AMENDMENTS	Initials	Checked	Designed	Drawn	Checked

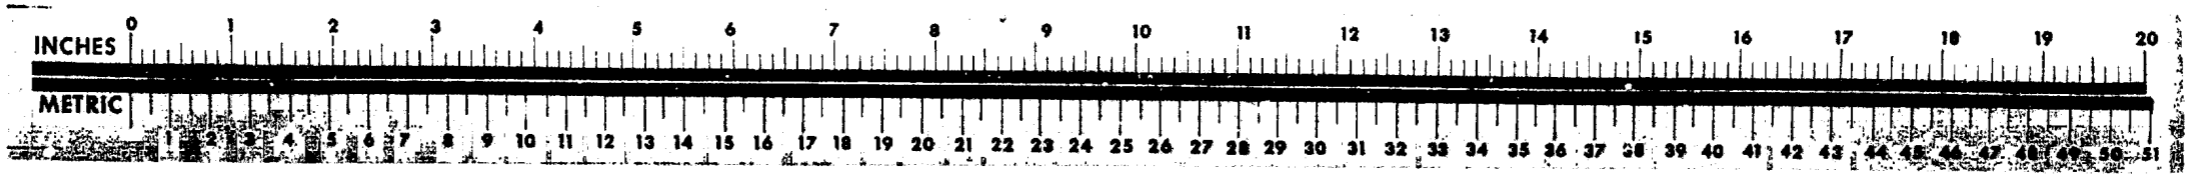
APPENDIX D: GEOTECHNICAL MEMO

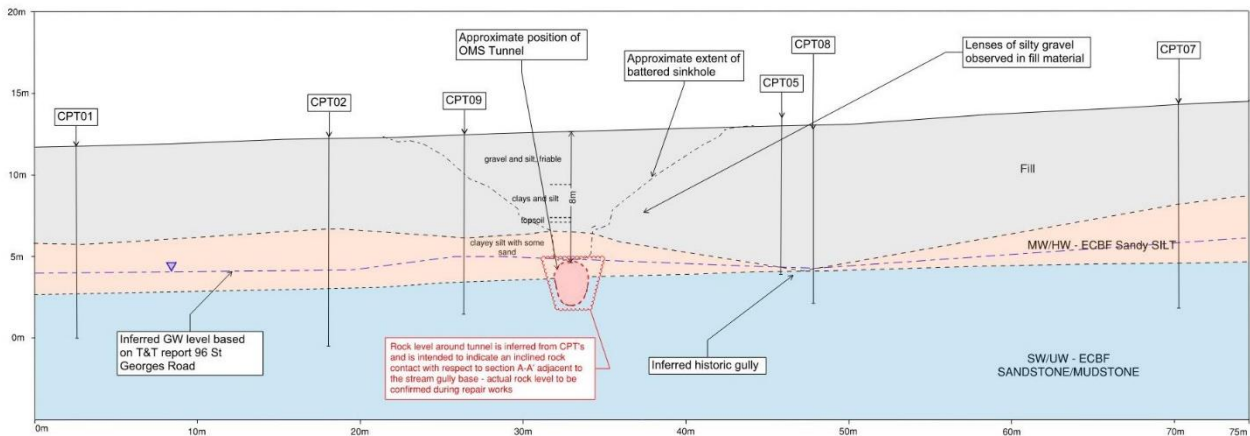
Figure 5: Cross-section showing the profile of the historic infilled gully in relation to the sinkhole and pipeline.

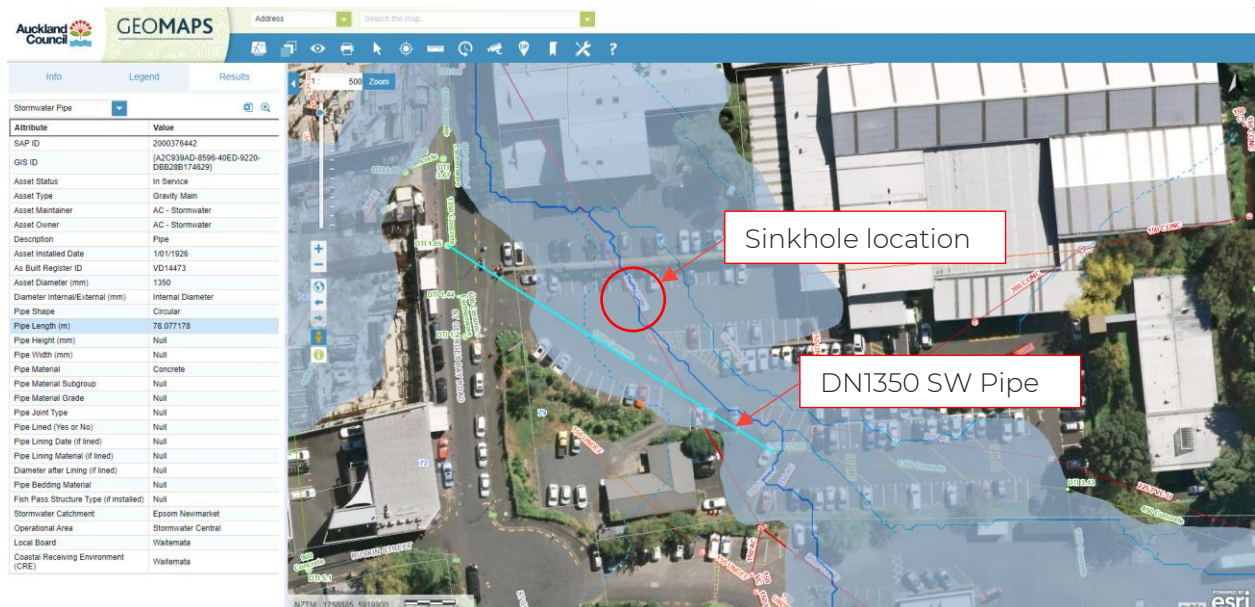
There is an existing DN1350 stormwater pipe which crosses the OMS immediately south of the location of the sinkhole/collapse. GIS records show that his pipe was installed in 1926 and is a
