Watercare Services Limited

ŌRĀKEI MAIN SEWER FAILURE ANALYSIS REPORT

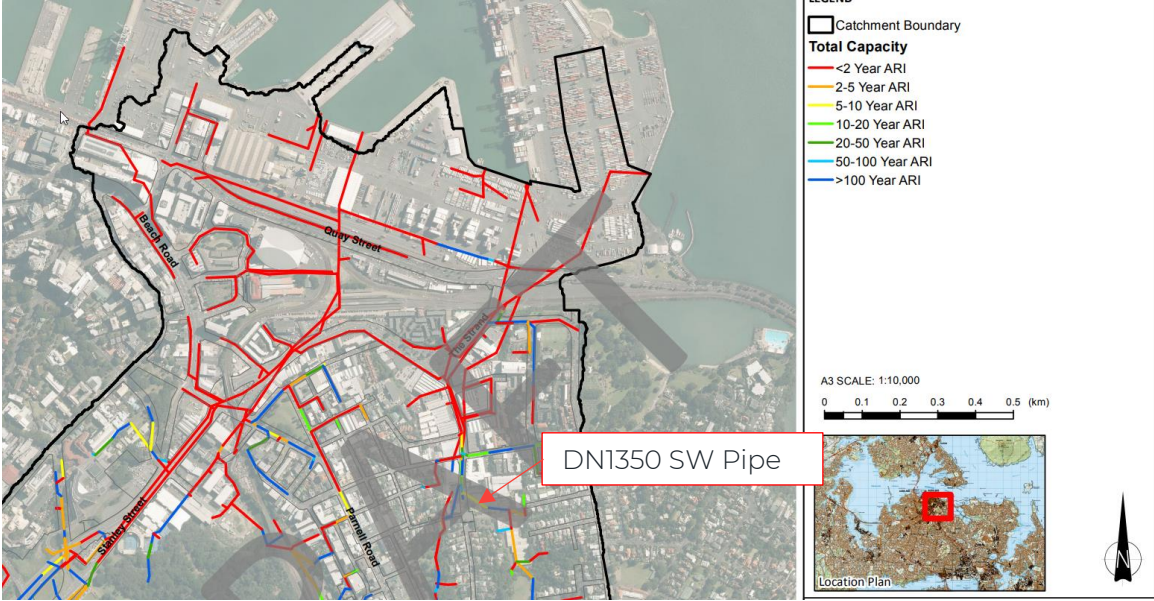
3 Overland Flow Paths

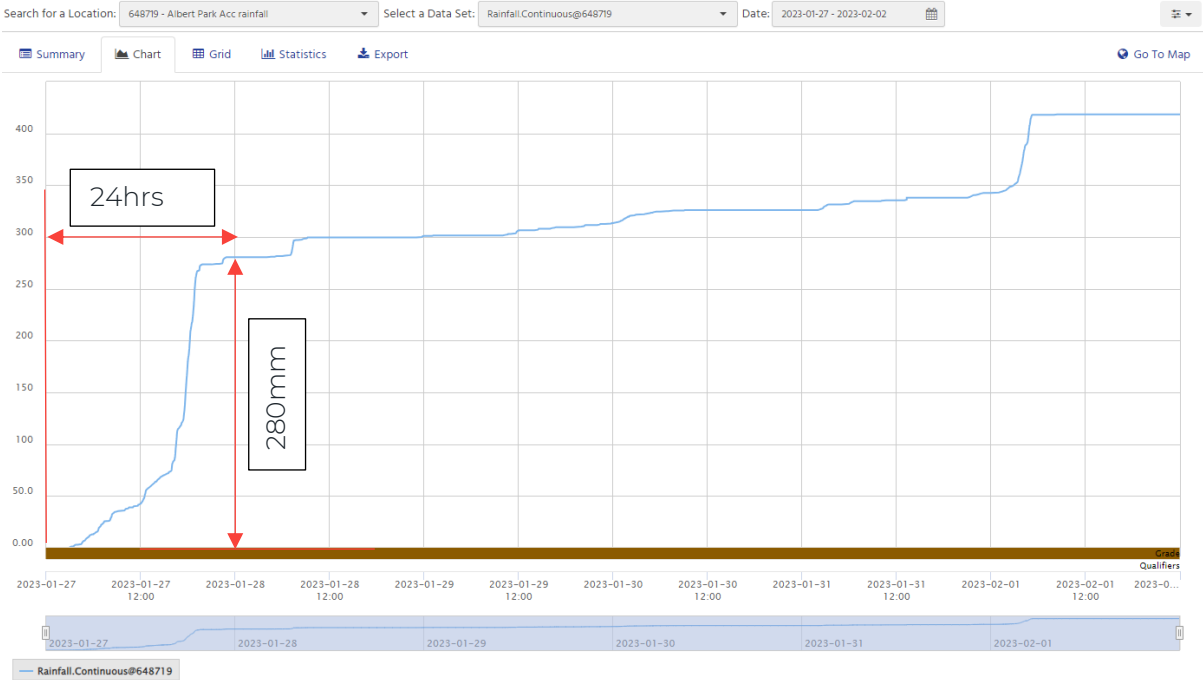
4.2 Cyclone Gabrielle (12-14 February 2023)

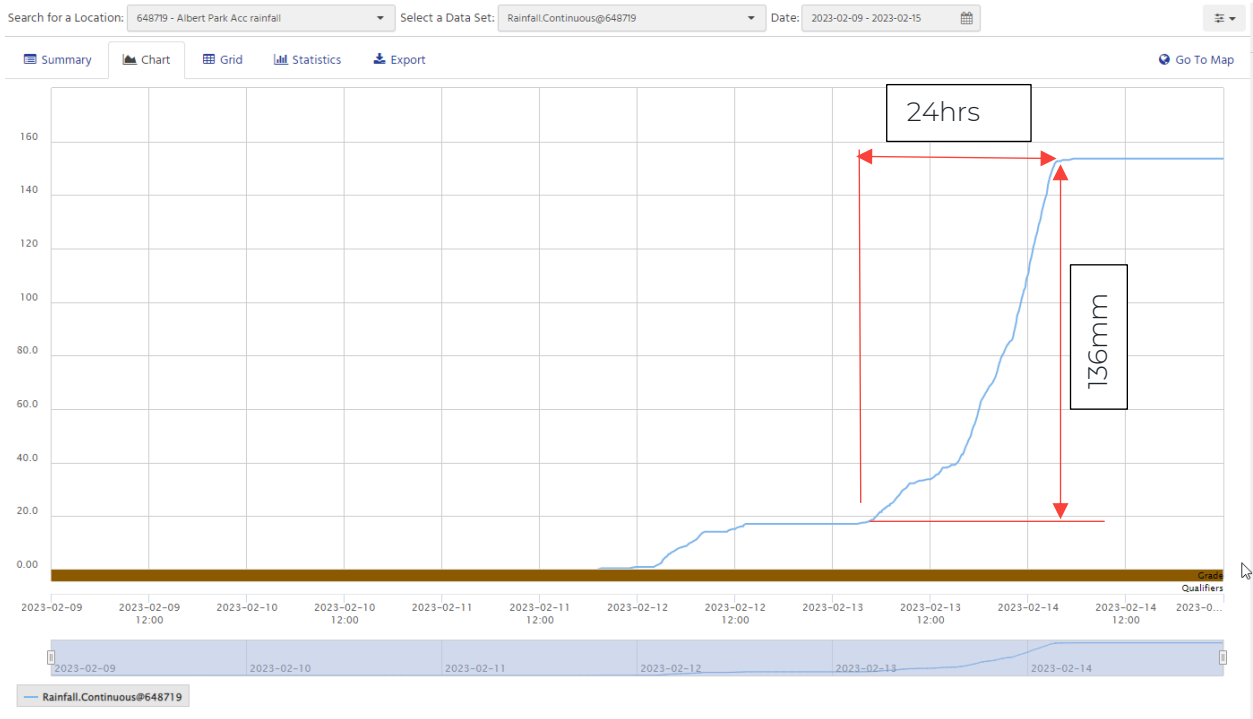
³ [Auckland ClimateWEB.pdf \(niwa.co.nz\)](https://niwa.co.nz)

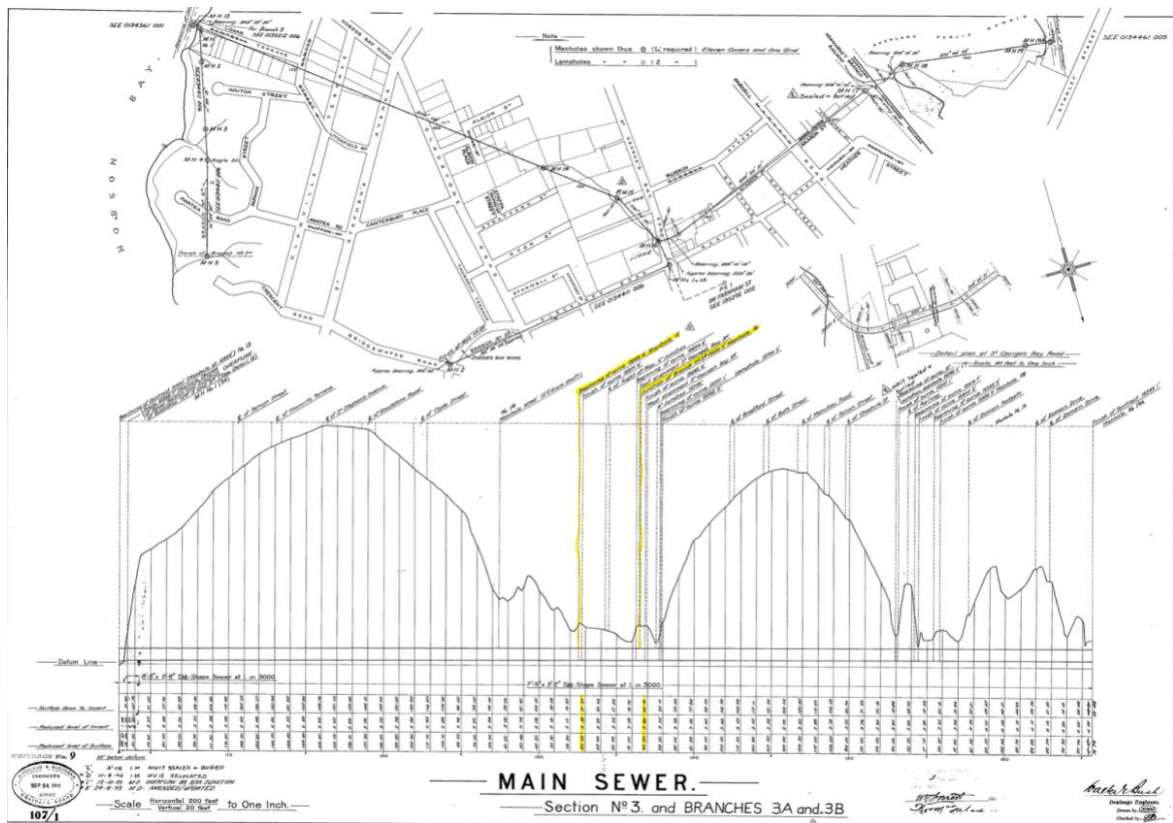
Figure 4-2 Longitudinal section of the sewer main, with failure section between the yellow highlights

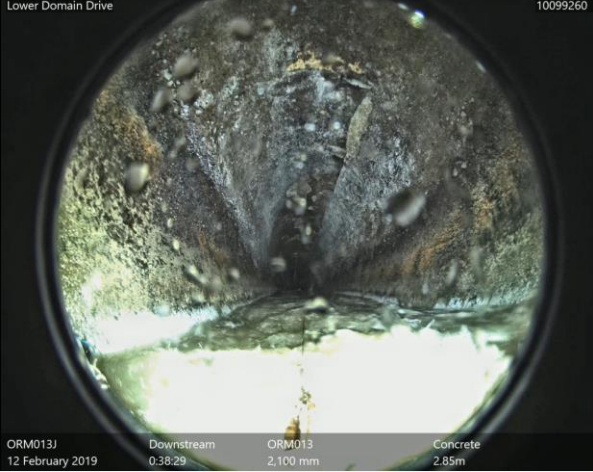
<p>Lower Domain Drive 10099260</p> <p>ORM013J Downstream ORM013 Concrete 12 February 2019 0:38:29 2,100 mm 2.85m</p>

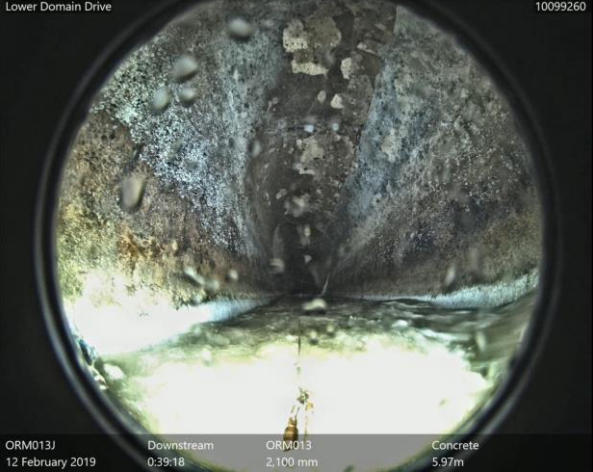
<p>Lower Domain Drive 10099260</p> <p>ORM013J Downstream ORM013 Concrete 12 February 2019 0:39:18 2,100 mm 5.97m</p>
<p>Surface damage, spalling (only at obvert) and aggregates visible, full circumference above sewage, for the full length of main, from CH:2.85m to 17.6m</p>	<p>Longitudinal joint at 2o'clock of CH: 5.97m</p>

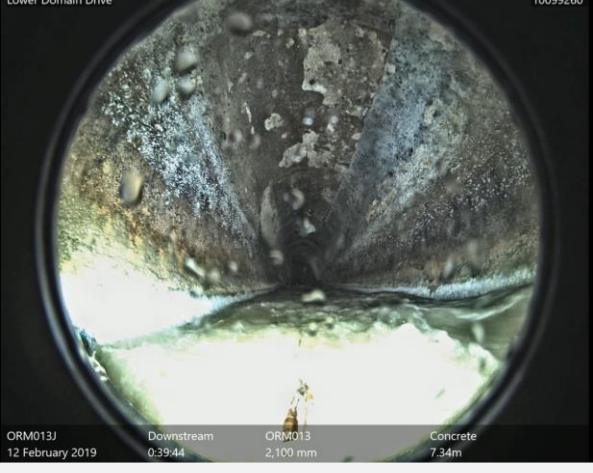
<p>Lower Domain Drive 10099260</p> <p>ORM013J Downstream ORM013 Concrete 12 February 2019 0:39:44 2,100 mm 7.34m</p>

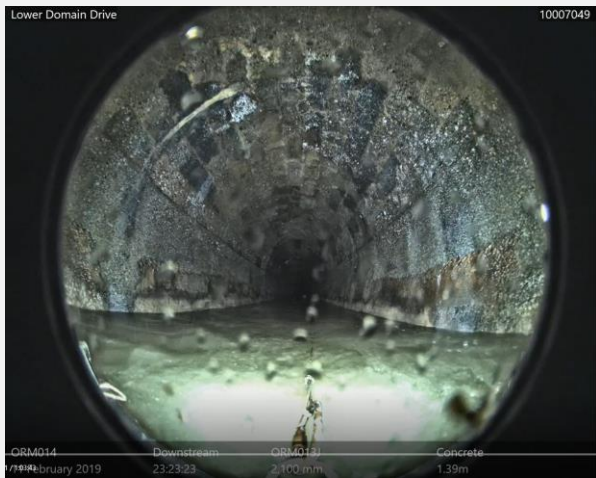
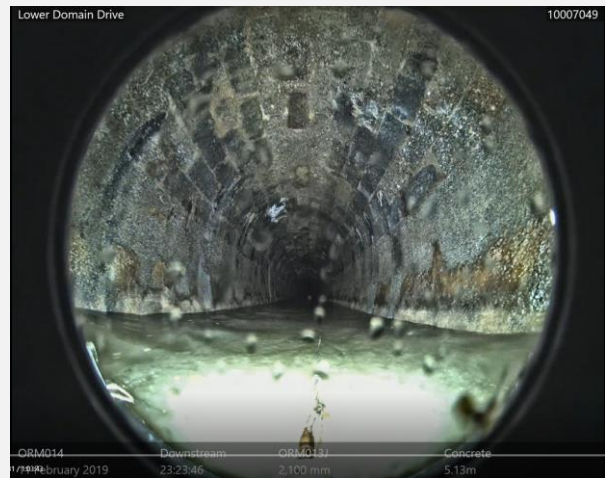
Infiltration seen at 11 o'clock of CH: 1.39m

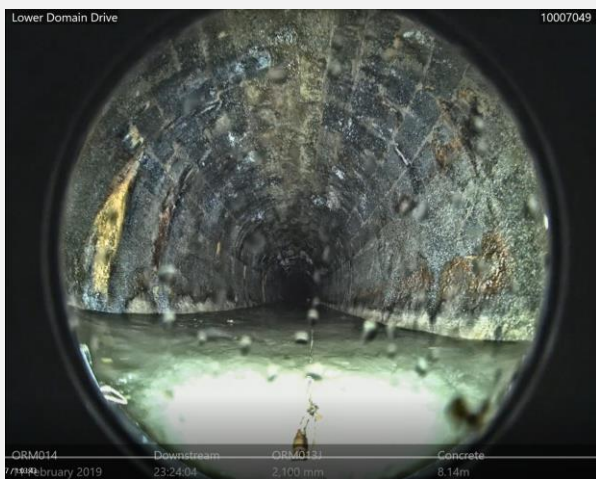
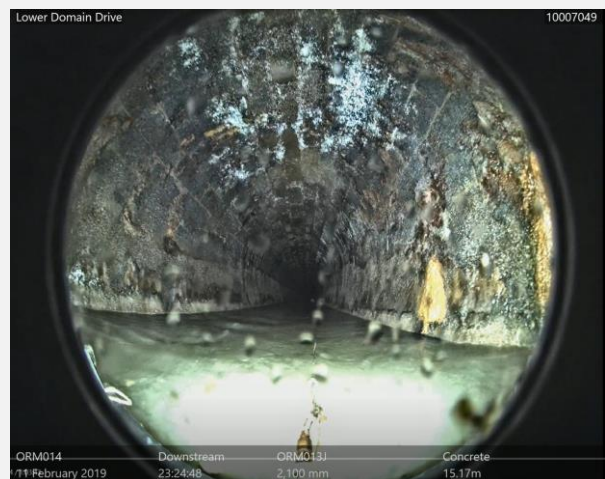
Infiltration staining at 9 o'clock of CH: 8.14m

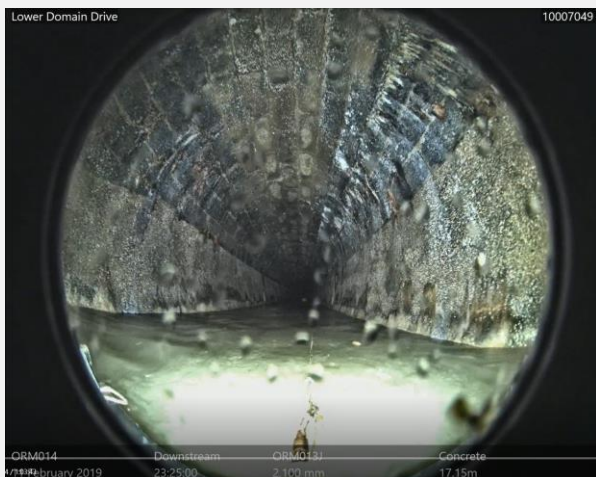
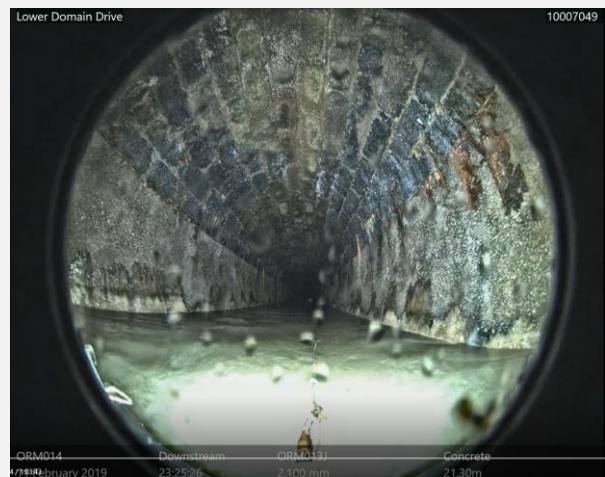
Longitudinal loss of mortar found at 1 o'clock from CH: 17.15m to 20.38m, allowing ingress

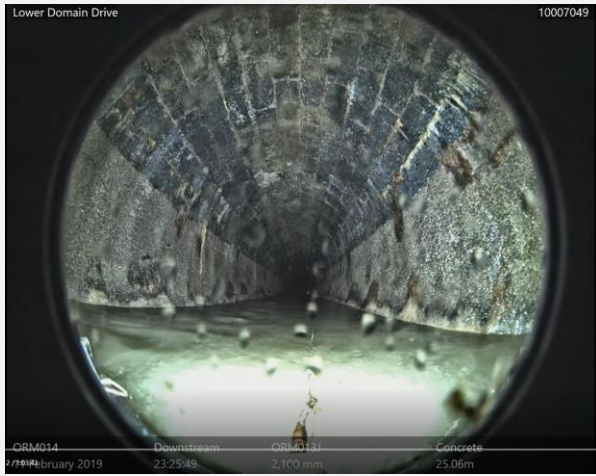
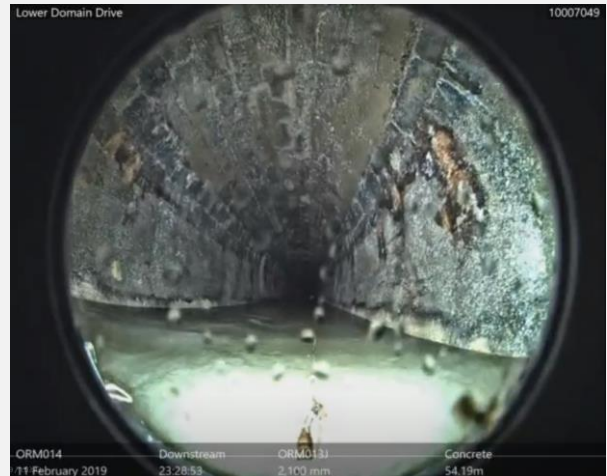
Longitudinal loss of mortar seen at 2 o'clock of CH: 25.06m, allowing ingress

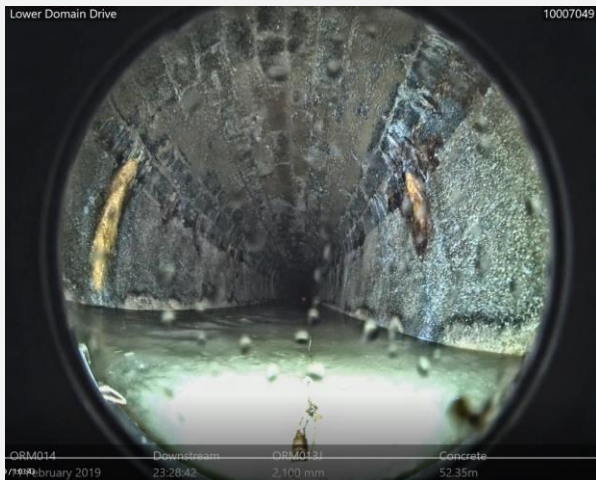
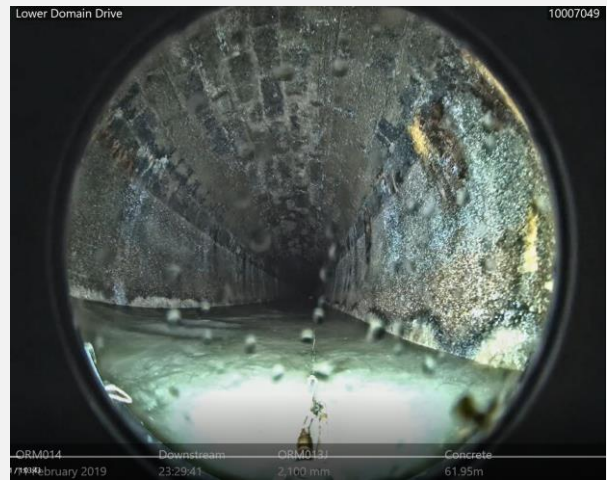
Hole/opening in blocks resulting in mass infiltration/ingress at 3 o'clock of CH: 52.35m

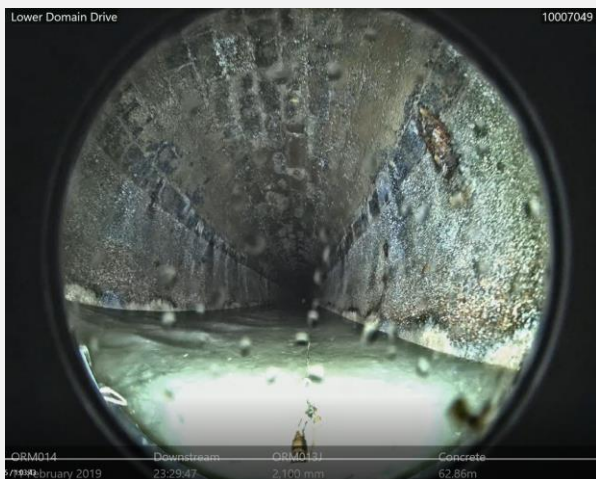
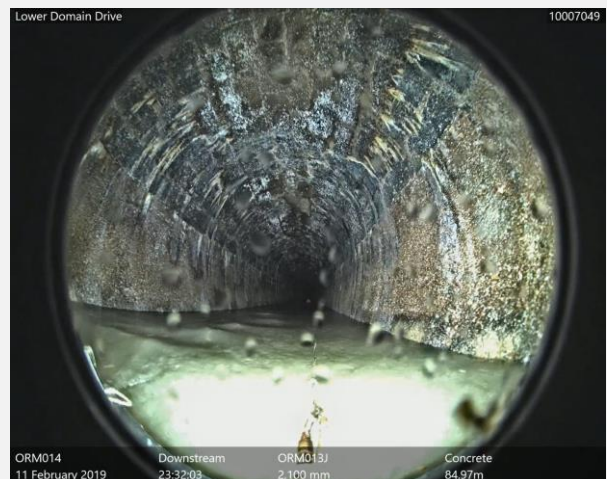
Hole/opening in blocks resulting in mass infiltration/ ingress at 3 o'clock of CH: 62.86m

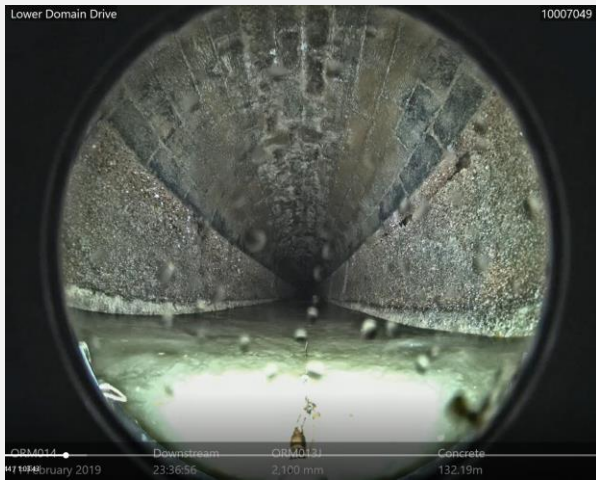
Calcification and infiltration staining is seen at the obvert of CH: 84.97m

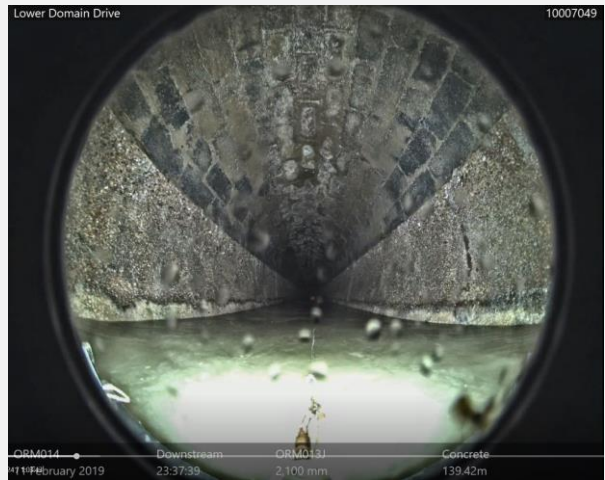
Mortar missing at 3 and 9 o'clock at CH:132.19m

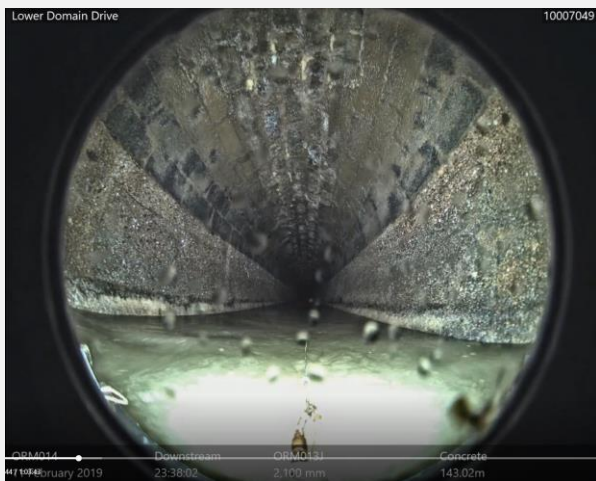
Possible reinforcement is visible at 4 o'clock at CH: 139.42m

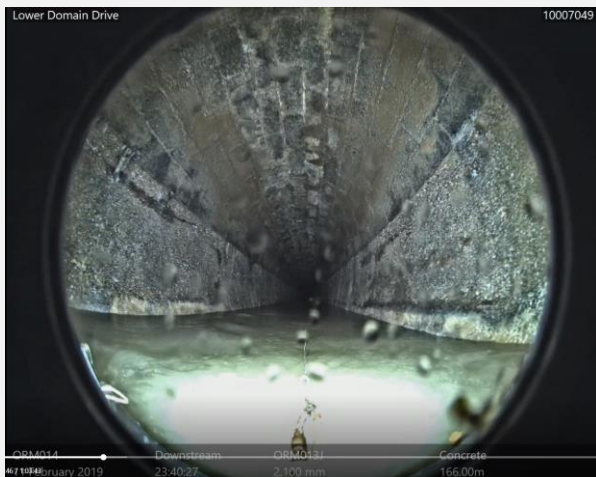
Mortar missing at 3 and 9 o'clock (interface between the concrete and blocks) at CH: 160.79m

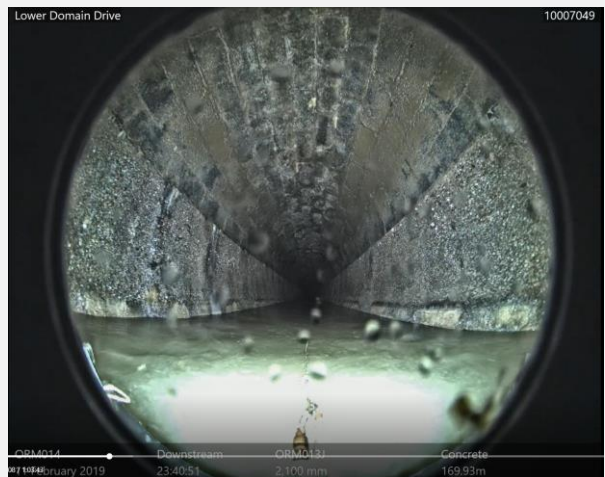
Mortar is missing at 3 and 9 o'clock of CH: 166m

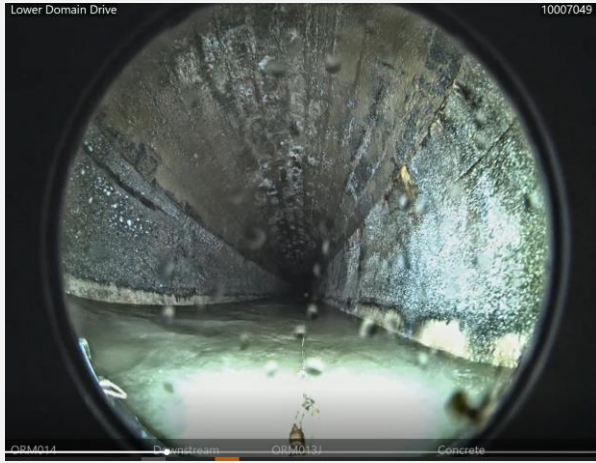
Mortar missing at 3 and 9 o'clock of CH: 222.94m

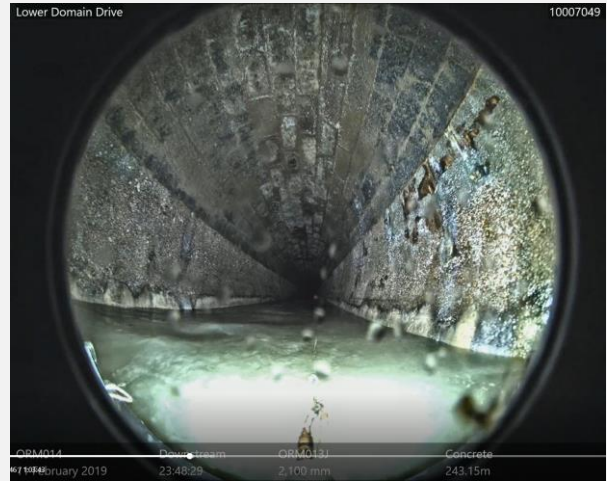
Mortar missing at 3 o'clock of CH: 243.15m

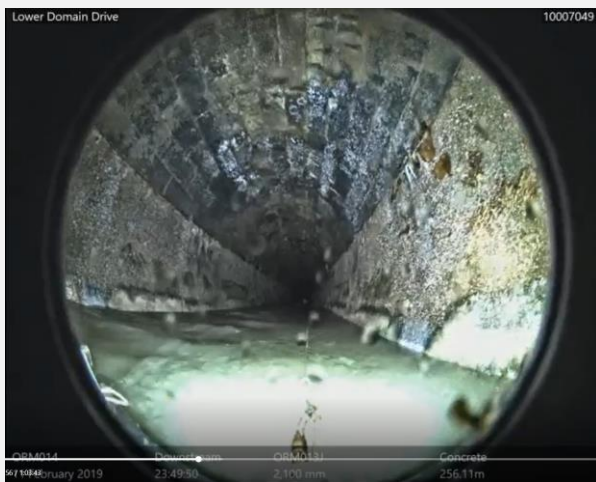
Mortar missing at 3 o'clock of CH: 256.11m

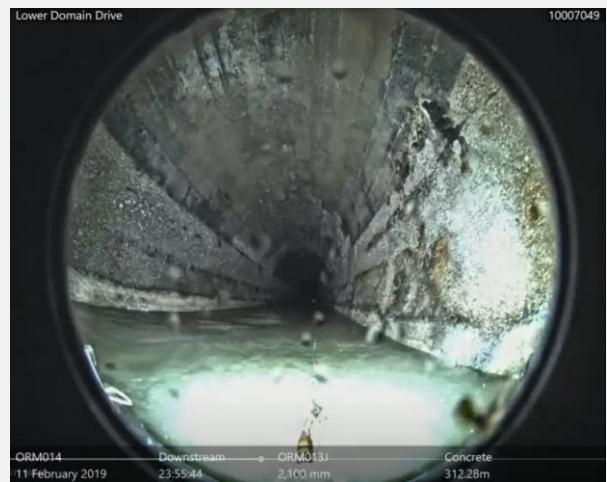
Mortar missing at 3 o'clock of CH: 312.28m

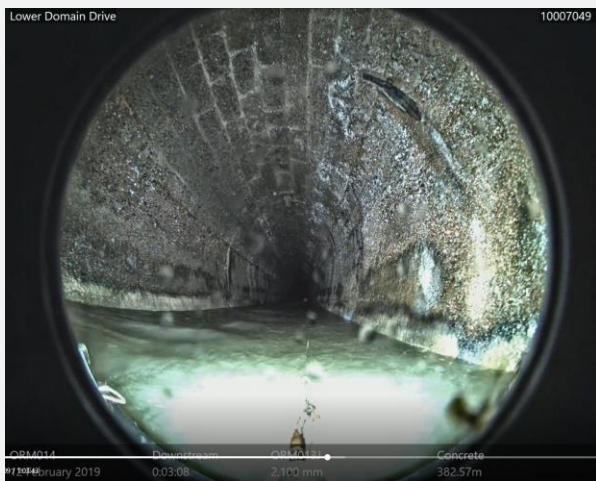
Hole/opening in blocks resulting in mass infiltration/ingress at 2 o'clock of CH: 382.57m

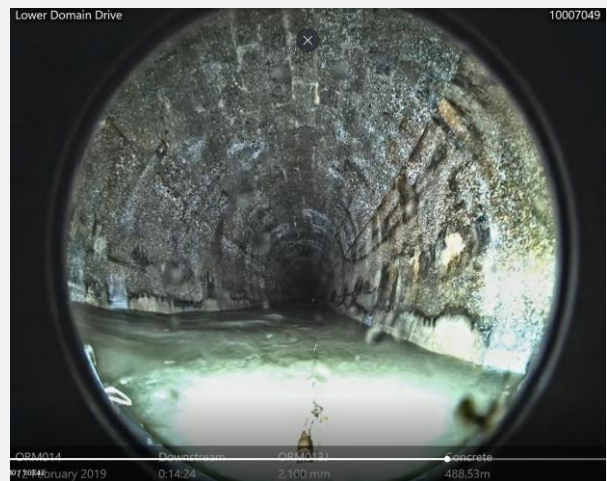
Mortar missing at 10 o'clock of CH: 488.53m

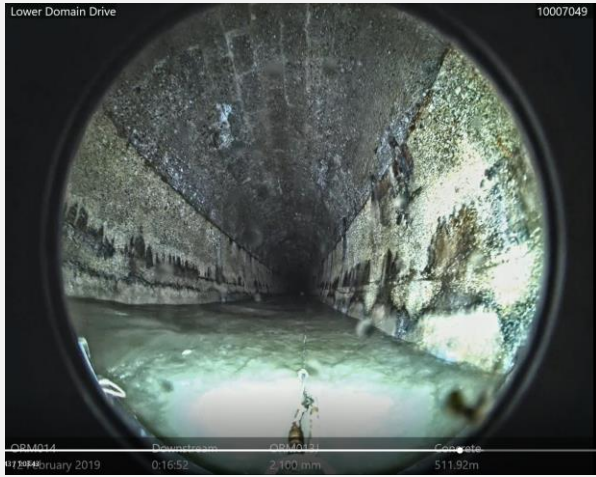
Mortar missing at at 4 o'clock of CH: 511.92m

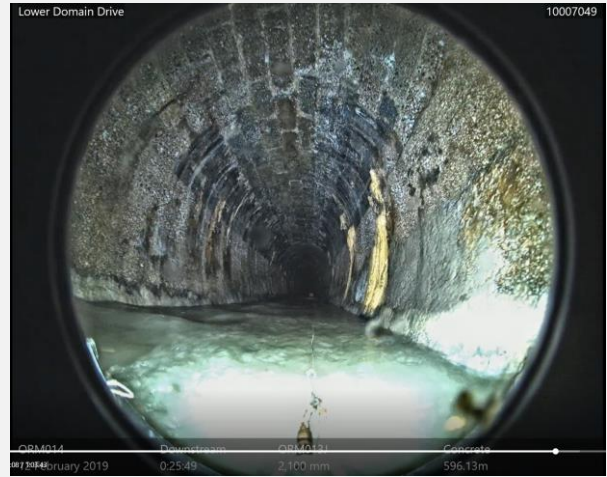
Dripping infiltration seen at the obvert of the pipe at CH: 596.13m and 598.23m

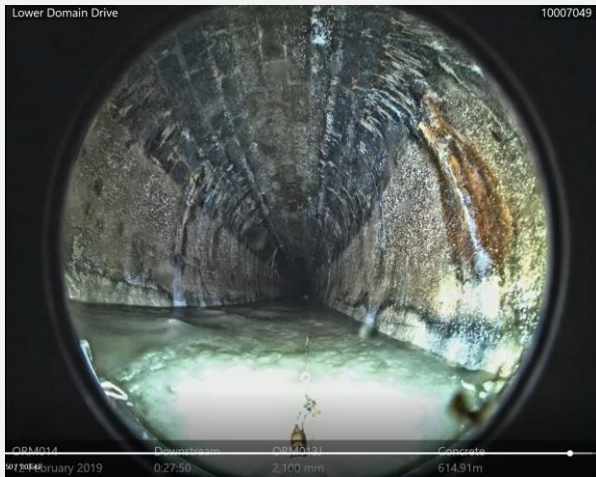
Hole/opening in blocks resulting in mass infiltration/ ingress at 3 o'clock of CH: 614.91m

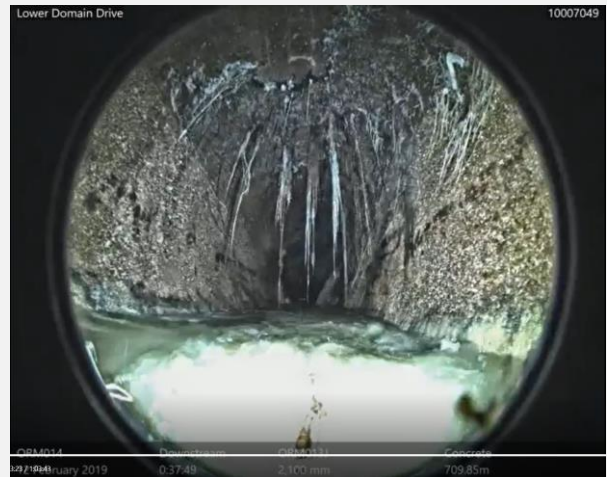
Tap root intrusion from 10 to 3 o'clock of CH: 709.85m

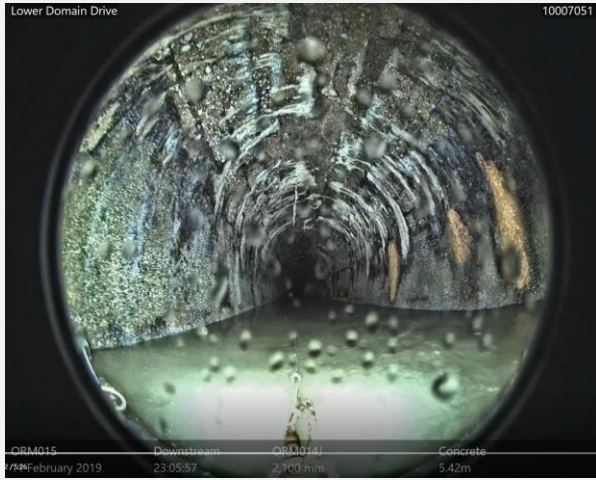
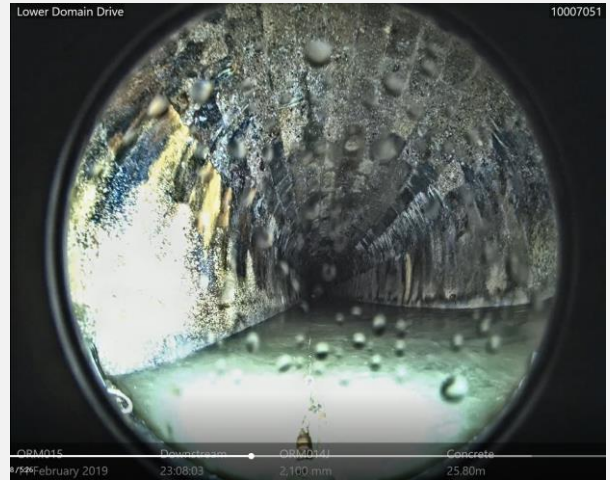
Fine root intrusion from 10 to 2 o'clock of CH: 5.42m

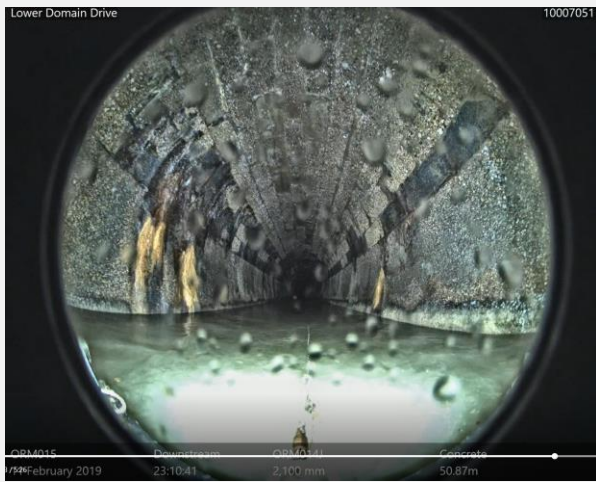
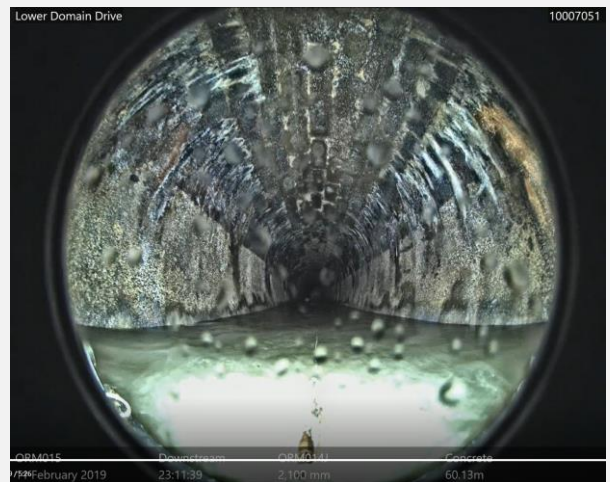
Infiltration/ingress, loss of mortar and staining at 9 o'clock of CH: 50.87m

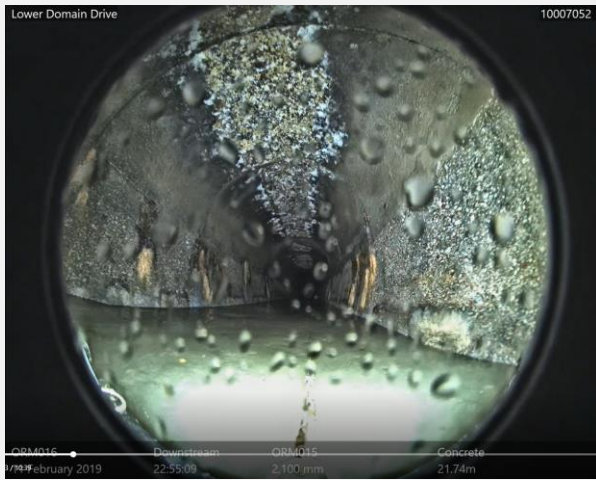
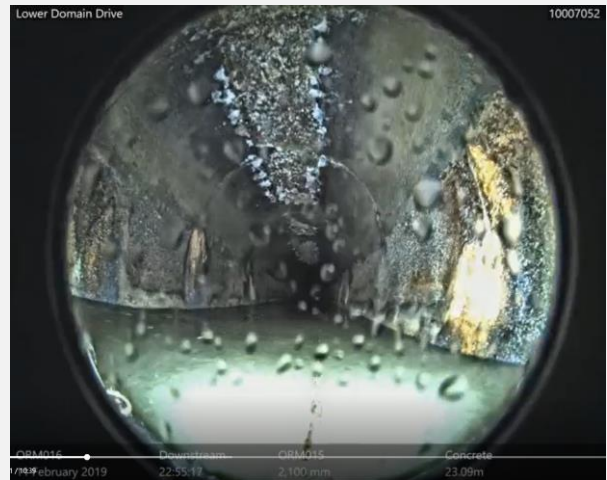
Aggregate visible throughout the length of the pipe with exposed aggregates and spalling at the concrete obvert

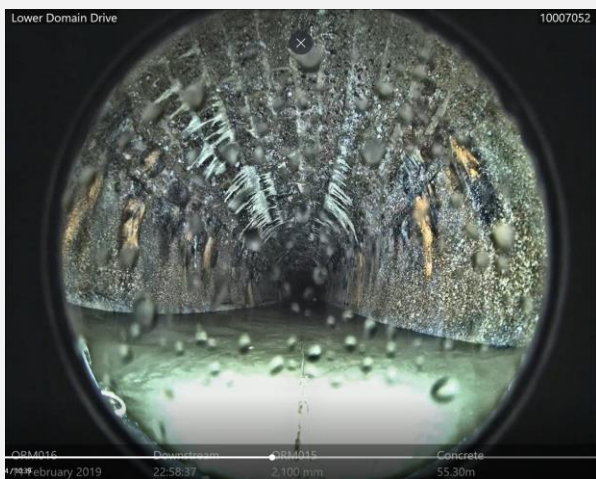
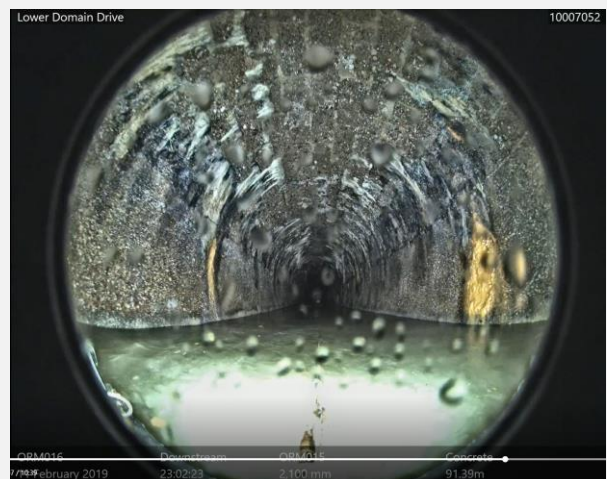
Fine root intrusion with loss of mortar at 11 and 1 o'clock, ingress at 3 and 9 o'clock at CH: 55.30m

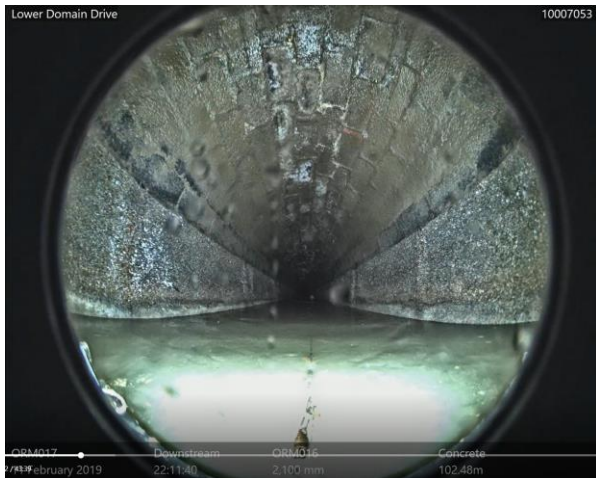
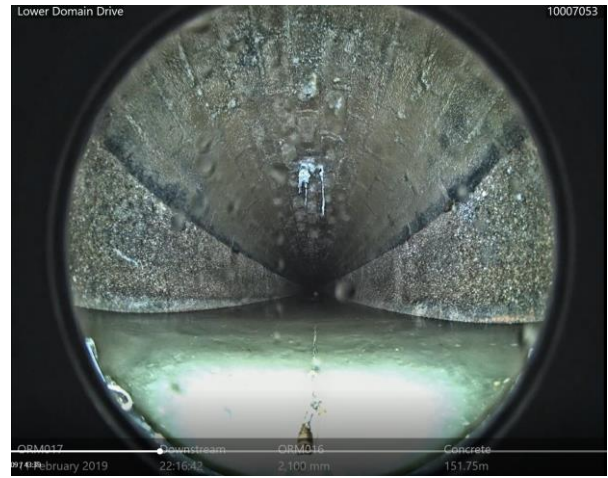
Infiltration and loss of mortar at the obvert at CH: 102.48m, visible aggregate across full length of concrete base

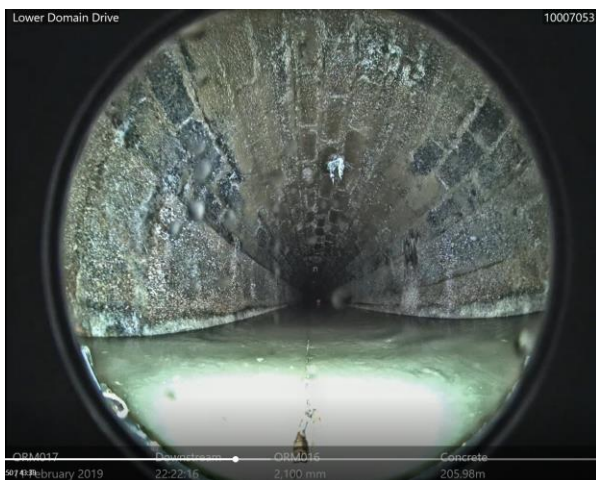
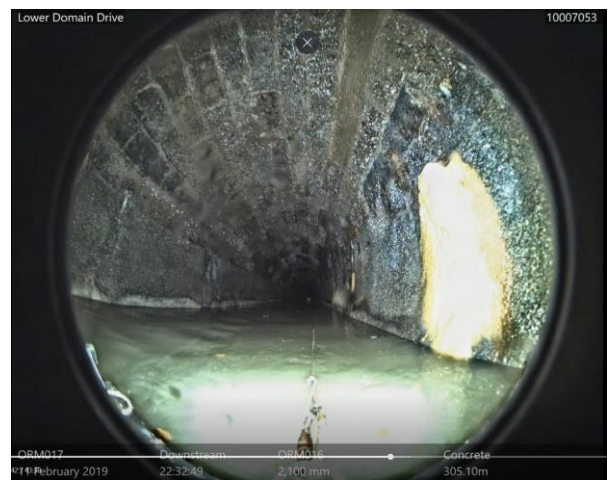
Root intrusion at the obvert of CH: 205.98m

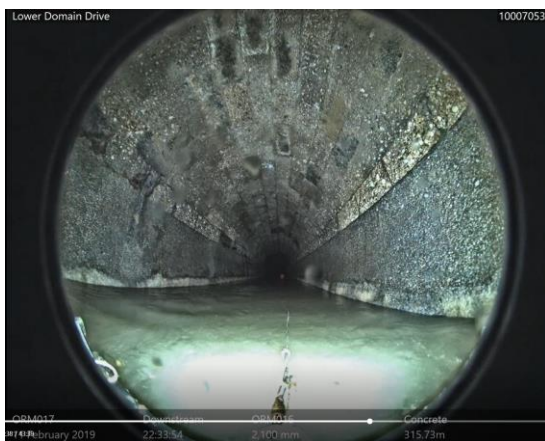
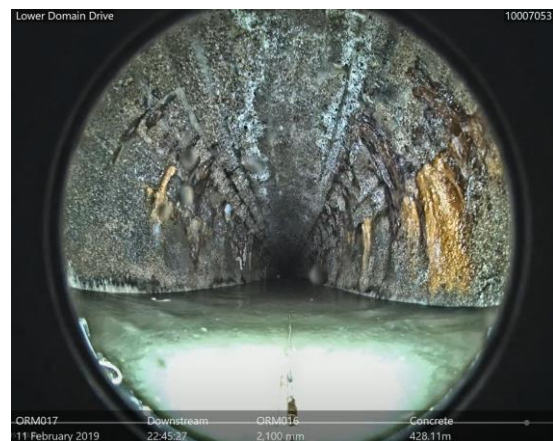
Mortar missing at 9 o'clock of CH:315.73m

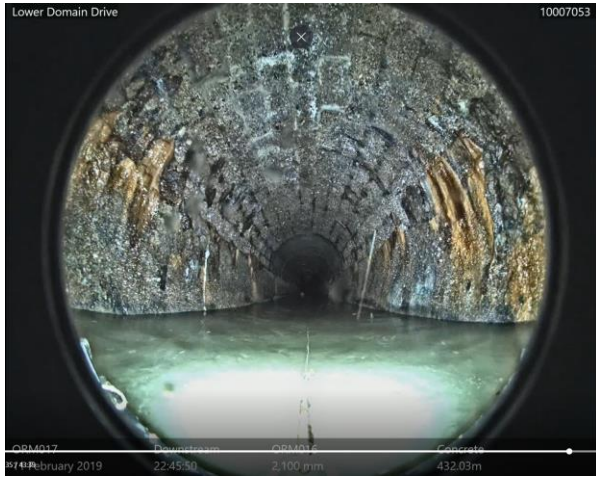
Dripping infiltration at 1 o'clock of CH: 432.03m

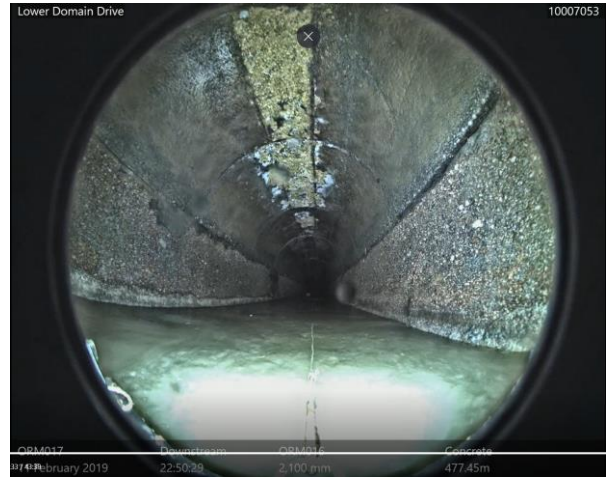
Spalling and rebar exposed at the obvert from CH:444.48m to 487.68m

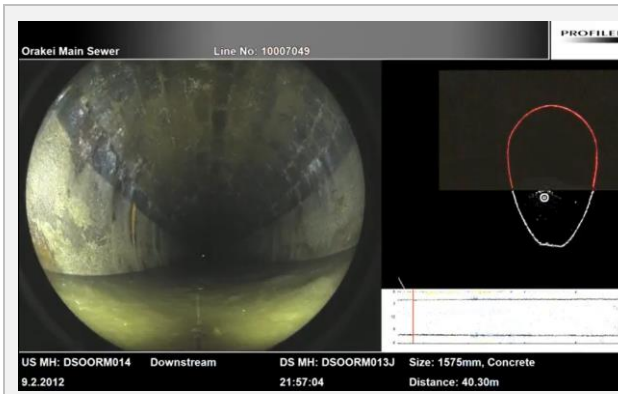
Encrustation seen at the obvert of the conduit, however no erosion of the block is seen

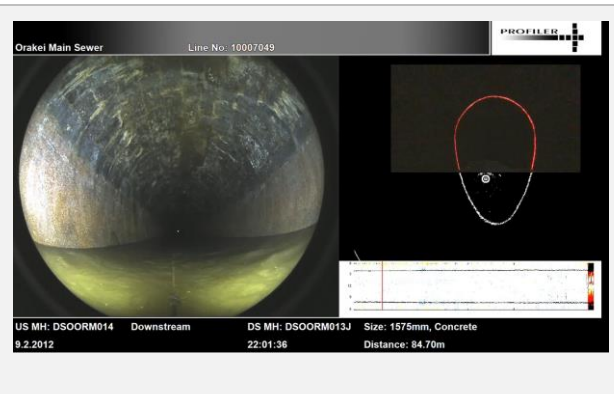
Infiltration and loss of mortar from 9 to 3 o'clock of CH: 84.7m.

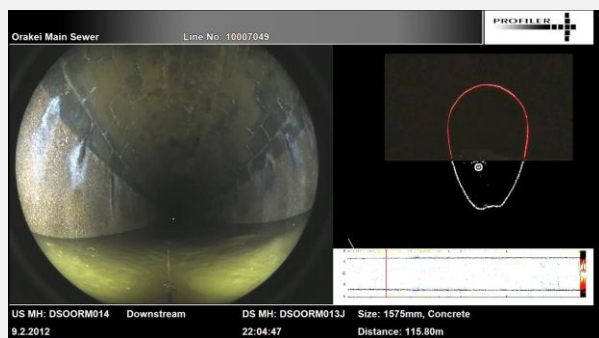
Roughening seen from visual spectrum of 3 to 9 o'clock, throughout the conduit, (evident lime leaching)

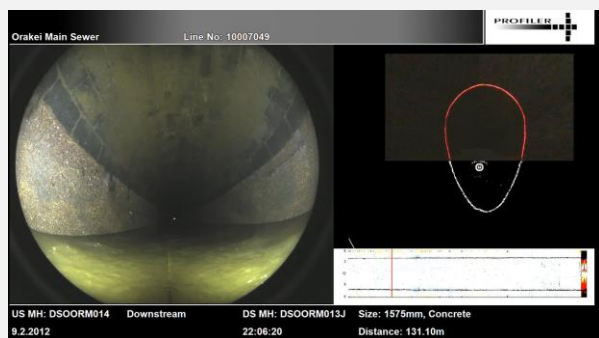
Minor spalling seen at 3 o'clock of CH: 131.10m

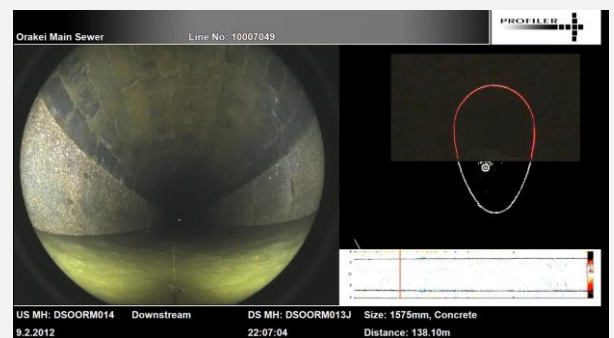
Spalling/reinforcing at 3 o'clock of CH:138.1m

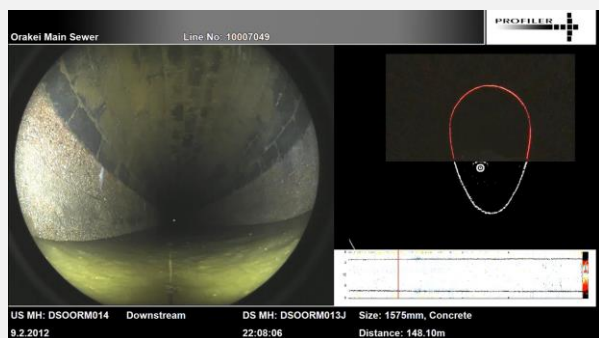
Spalling/reinforcing appears exposed through corroded concrete at 3 and 9 o'clock of CH:148.1m

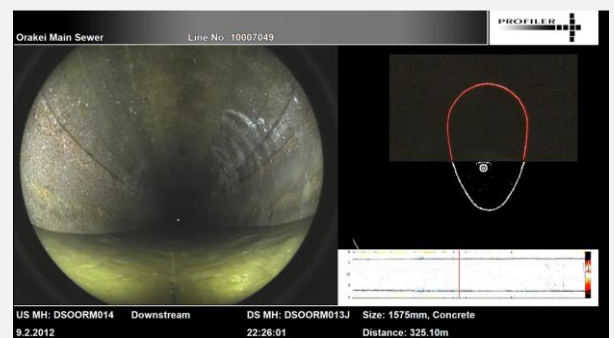
Lime leaching through the mortar is evident throughout the conduit at 3 o'clock

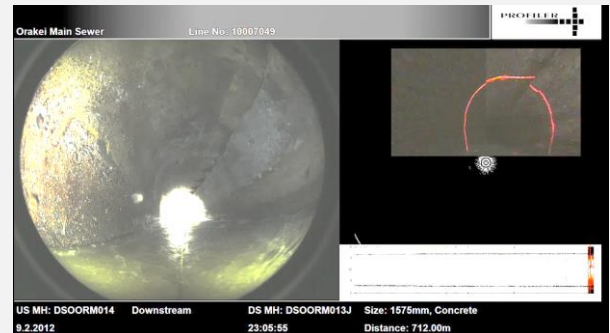
Longitudinal crack, assumed at mortar joint, observed at 1 o'clock from CH: 712m to 717.6m

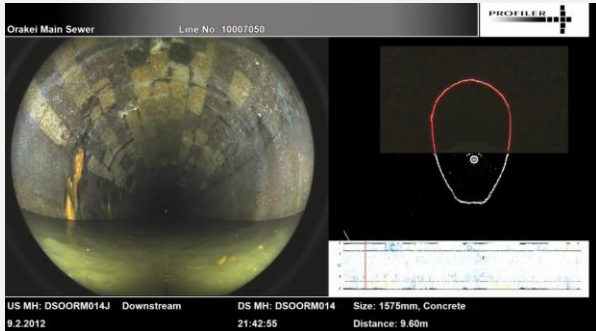
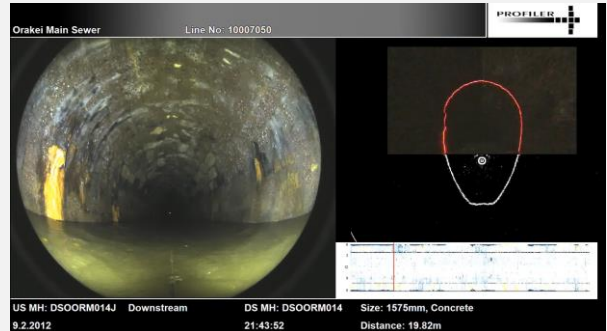
Infiltration and loss of mortar seen at 9 o'clock of CH:9.6m

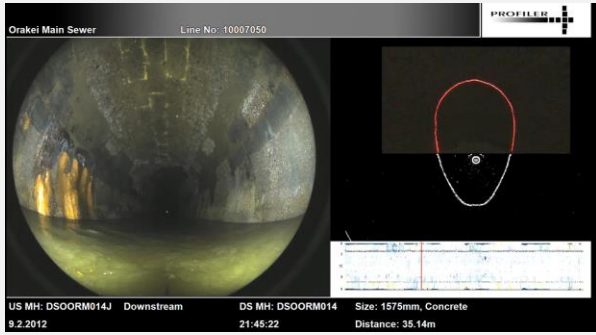
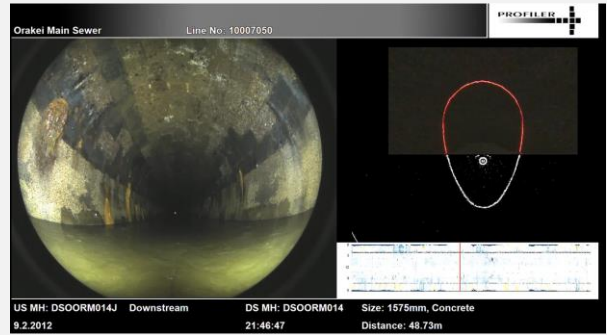
Infiltration and loss of mortar seen at 9 o'clock of CH:35.14m

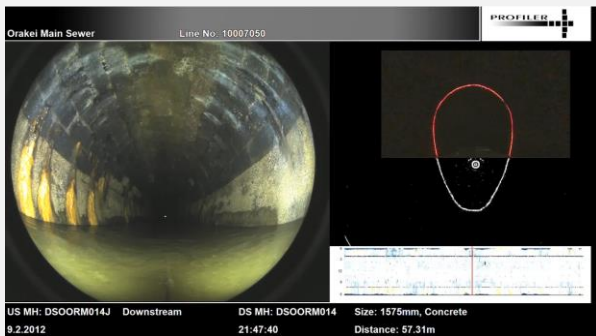
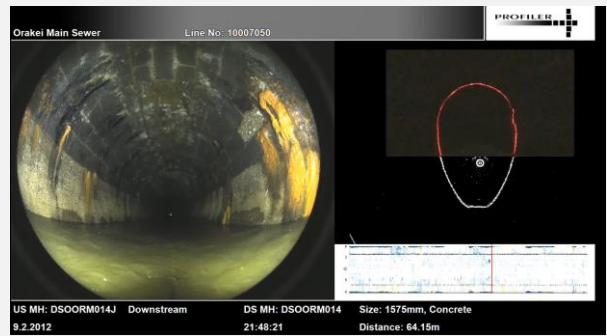
Infiltration and loss of mortar seen at 9 o'clock of CH:57.31m

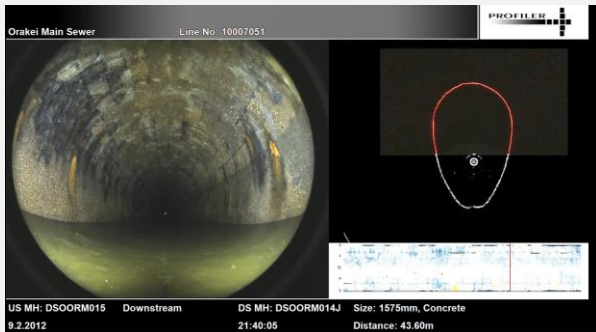
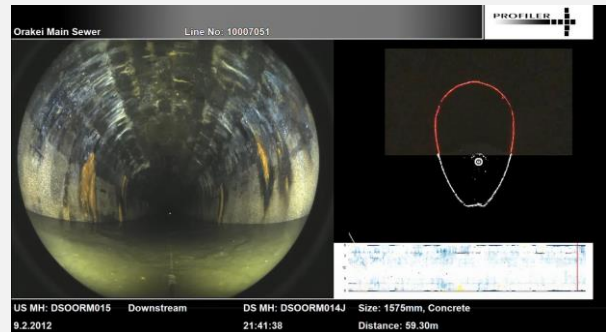
Efflorescence observed at 9 o'clock of CH: 43.60m

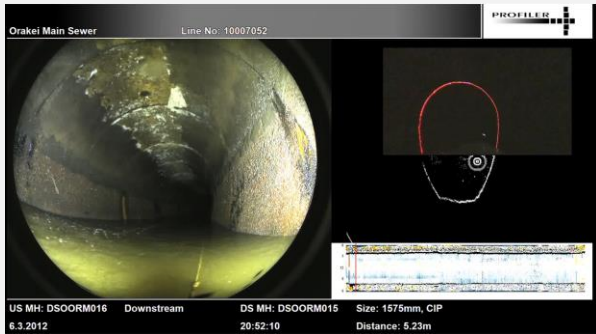
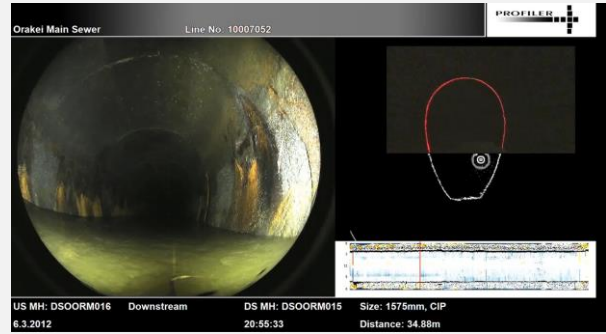
Surface damage at the obvert is seen throughout the precast section. However, the surface has not breached until the visibility of aggregates. Hence this defect can be considered as roughening (CH:0 to CH:46.34m)

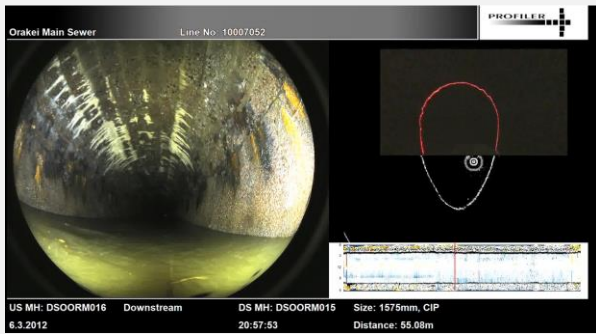
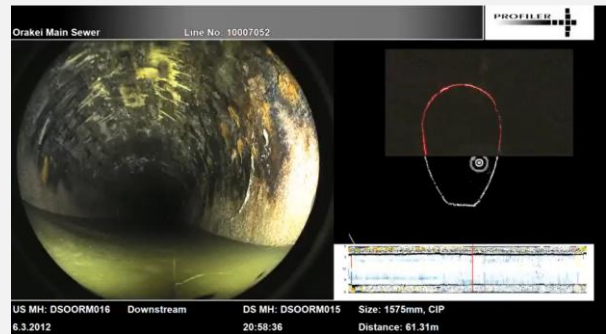
Lime leaching through the mortar is evident throughout the conduit from 9 to 1 o'clock

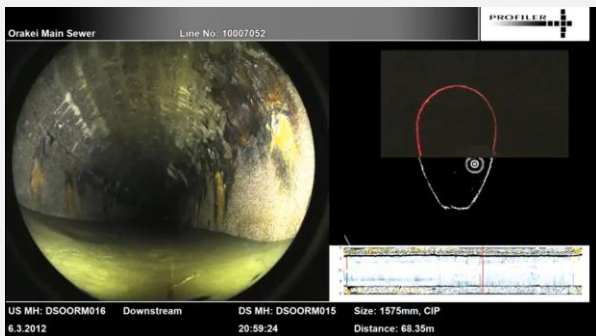
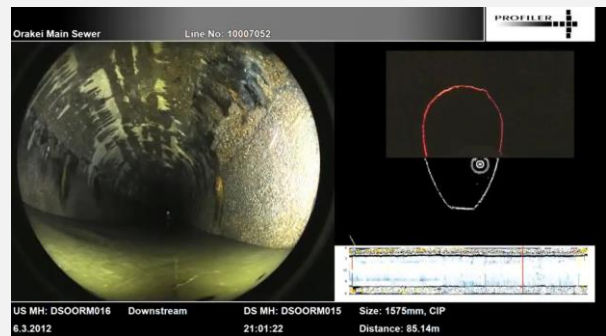
Mortar loss observed at 3 o'clock of CH: 68.35m

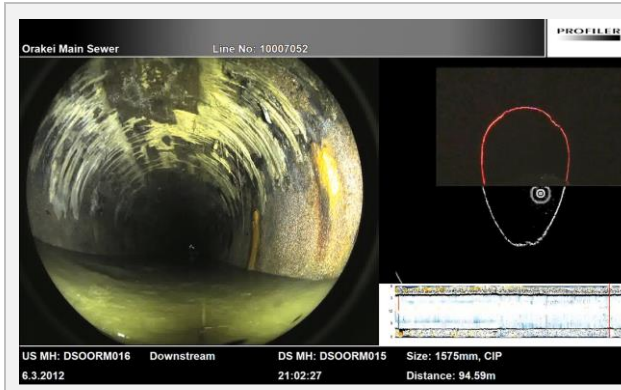
Lime leaching through the mortar is evident throughout the conduit from 9 to 3 o'clock

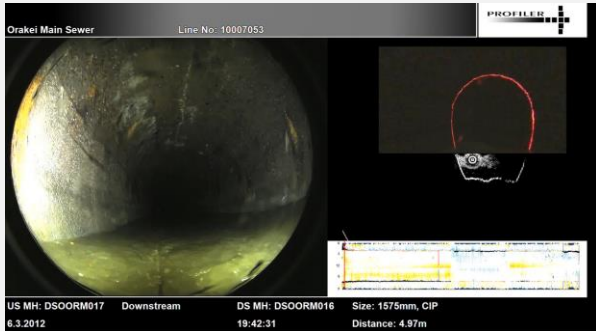
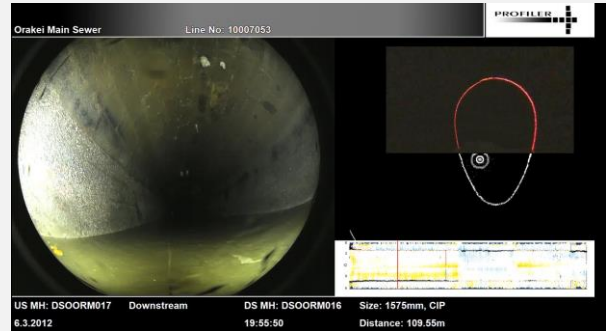
Longitudinal crack (between blocks) observed at the obvert from CH: 4.97m to CH:7.51m

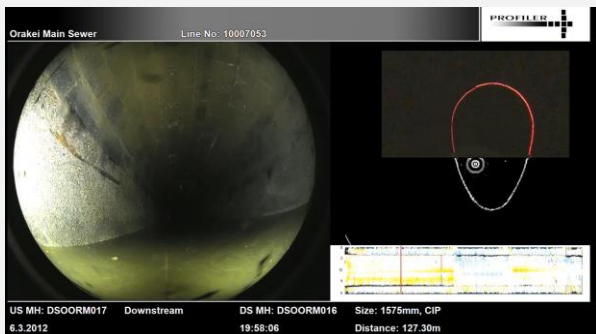
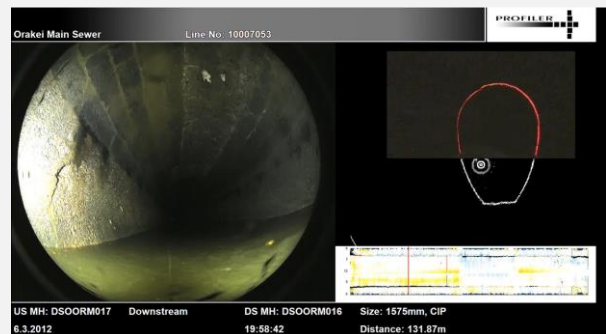
Minor spalling/reinforcing expsoure at 9 o'clock of CH: 127.3 m
