Watercare Services Limited

ŌRĀKEI MAIN SEWER FAILURE ANALYSIS REPORT

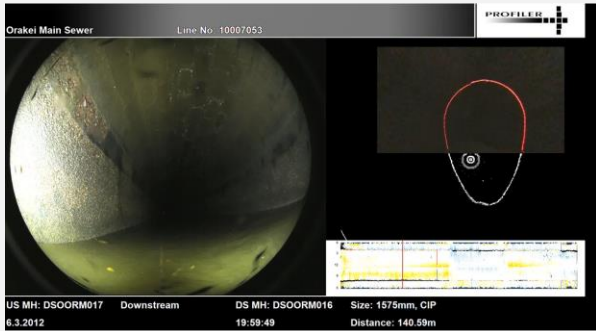
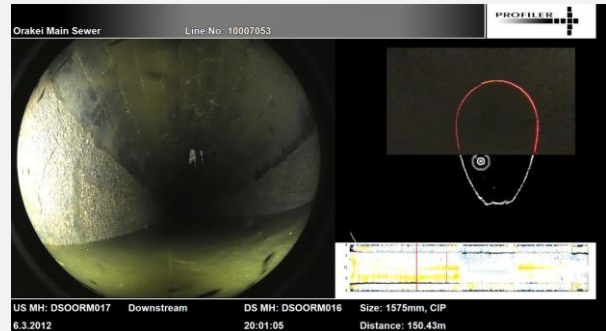
Blocks roughening at 9 o'clock of CH: 140.59m

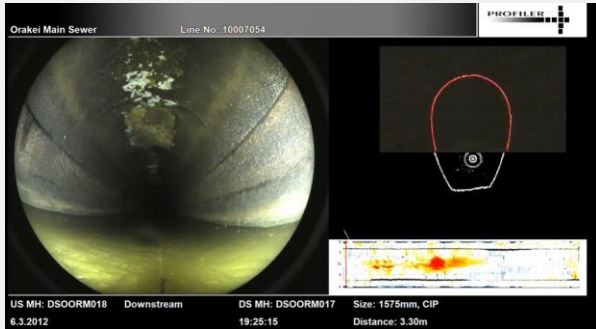
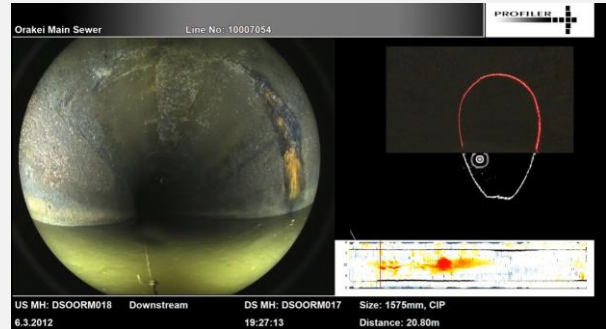
Surface damage at the obvert is seen throughout the precast section. However, the surface has not breached until the visibility of aggregates. Hence this defect can be considered as roughening (From CH:0m to CH:20m)

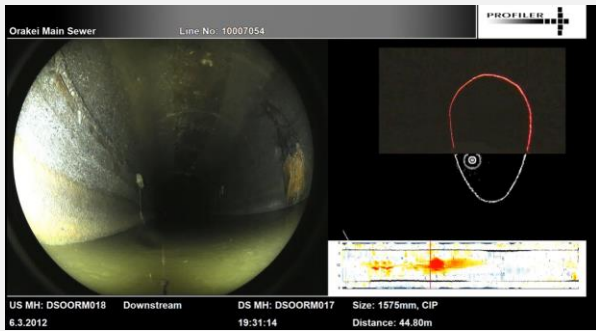
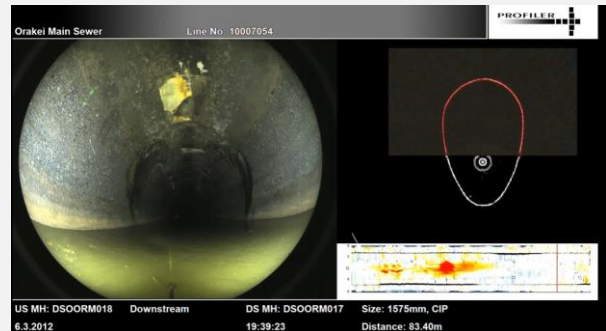
Localised aggregates and mortar missing from 2 to 4 o'clock of CH:44.8m

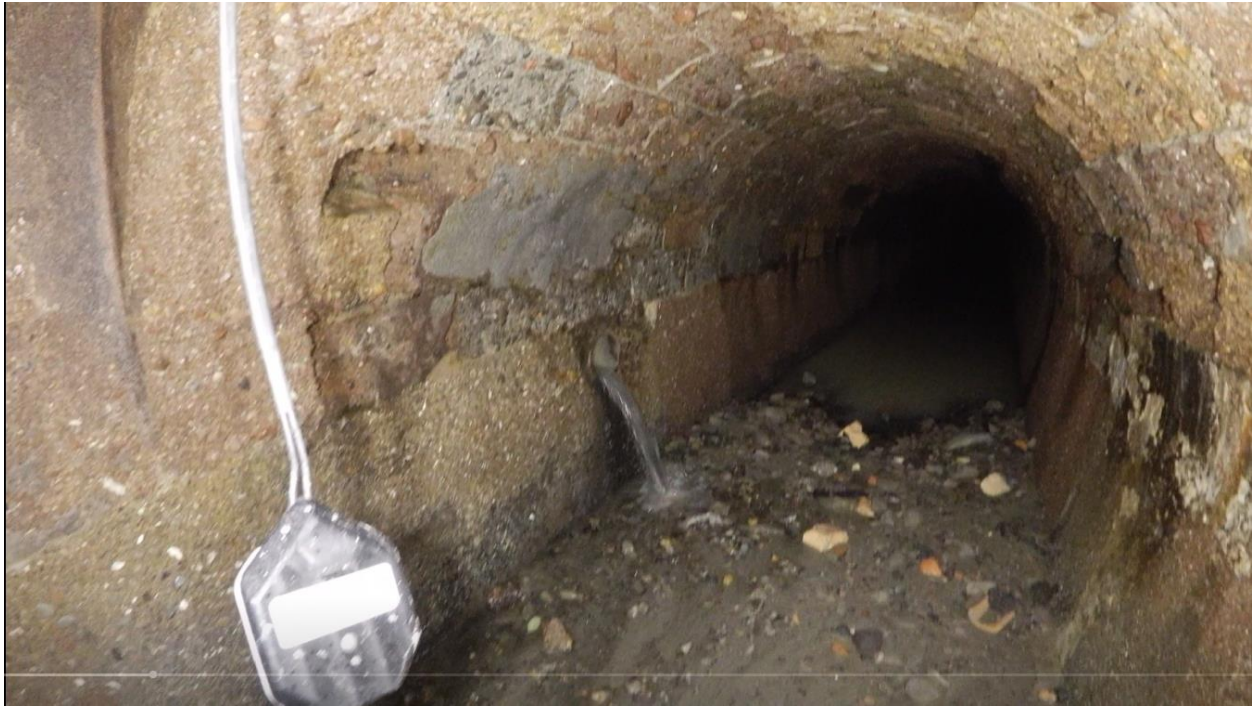
Figure 1 – Missing blocks adjacent to Manhole 15 (view is looking upstream)

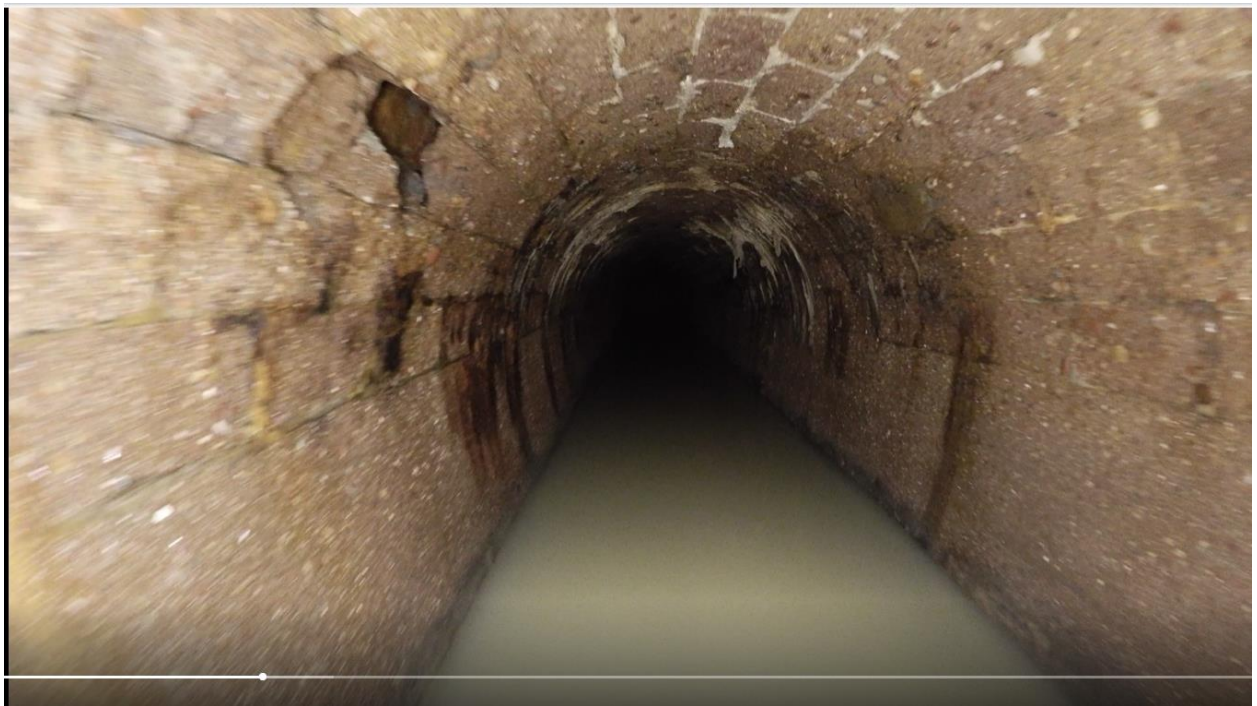
Figure 2 – Missing block between Manhole 15 and collapse (view is looking upstream, missing block is at 10 o'clock)

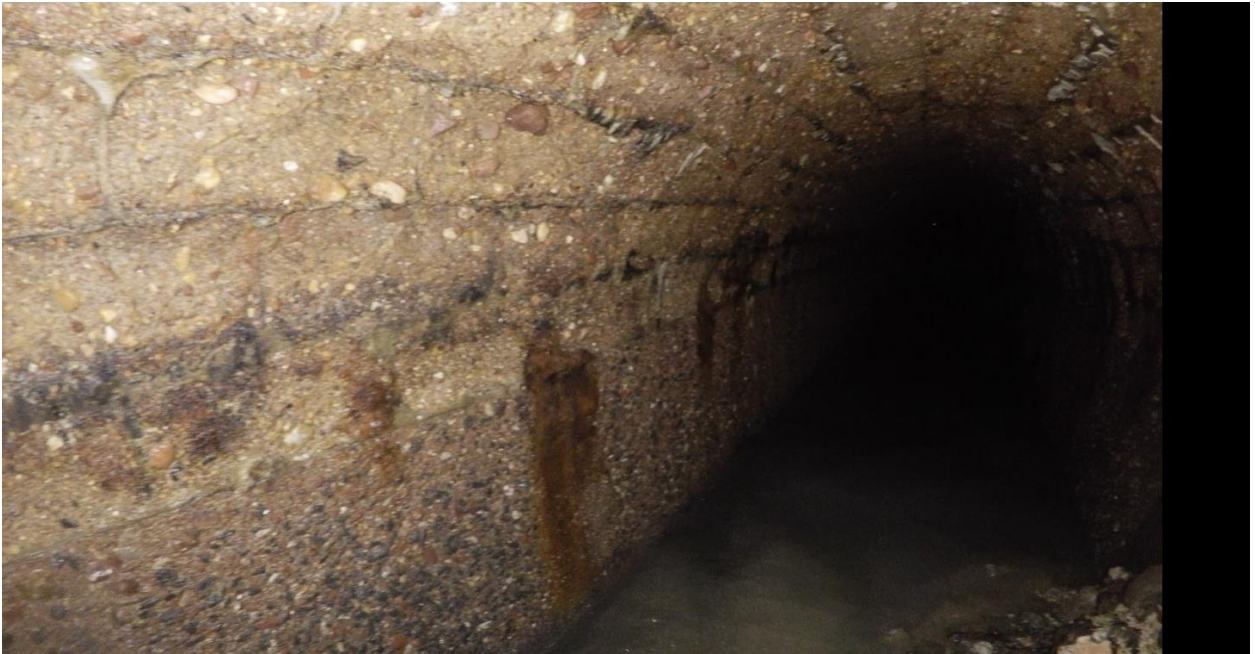
Figure 3 – View of Exposed Aggregate observed between Manhole 15 and the Collapsed Section

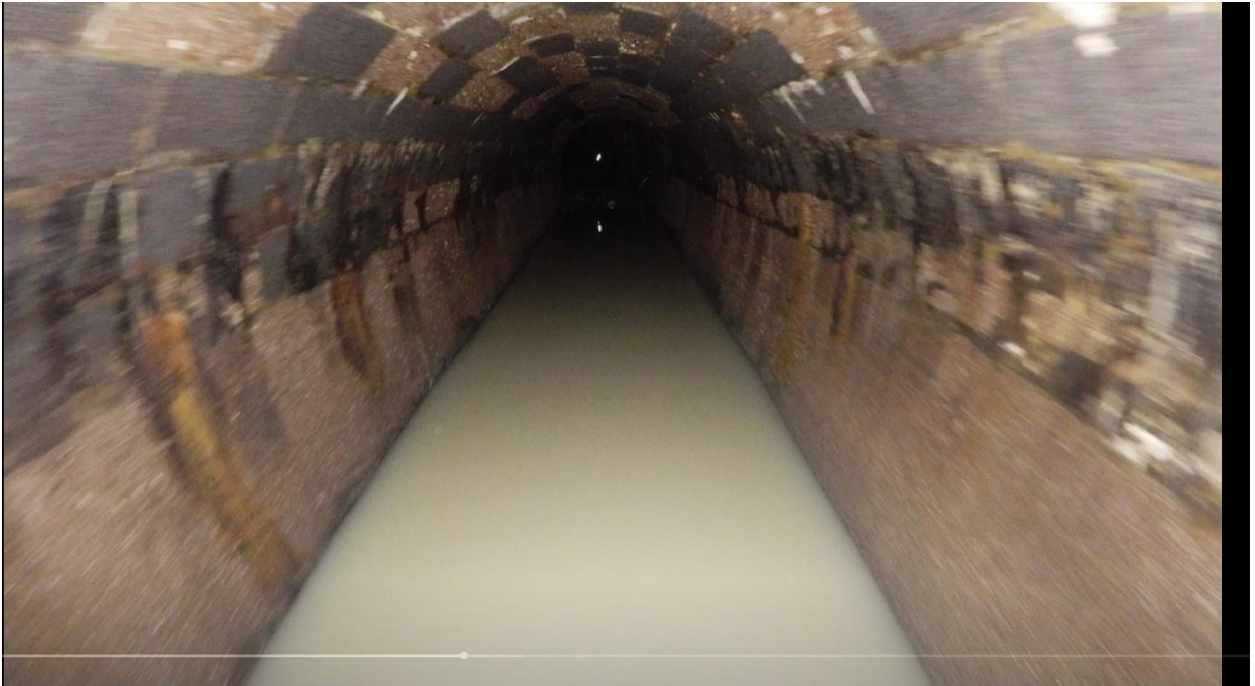
Figure 4 – View showing different blocks i.e., grey and brown blocks

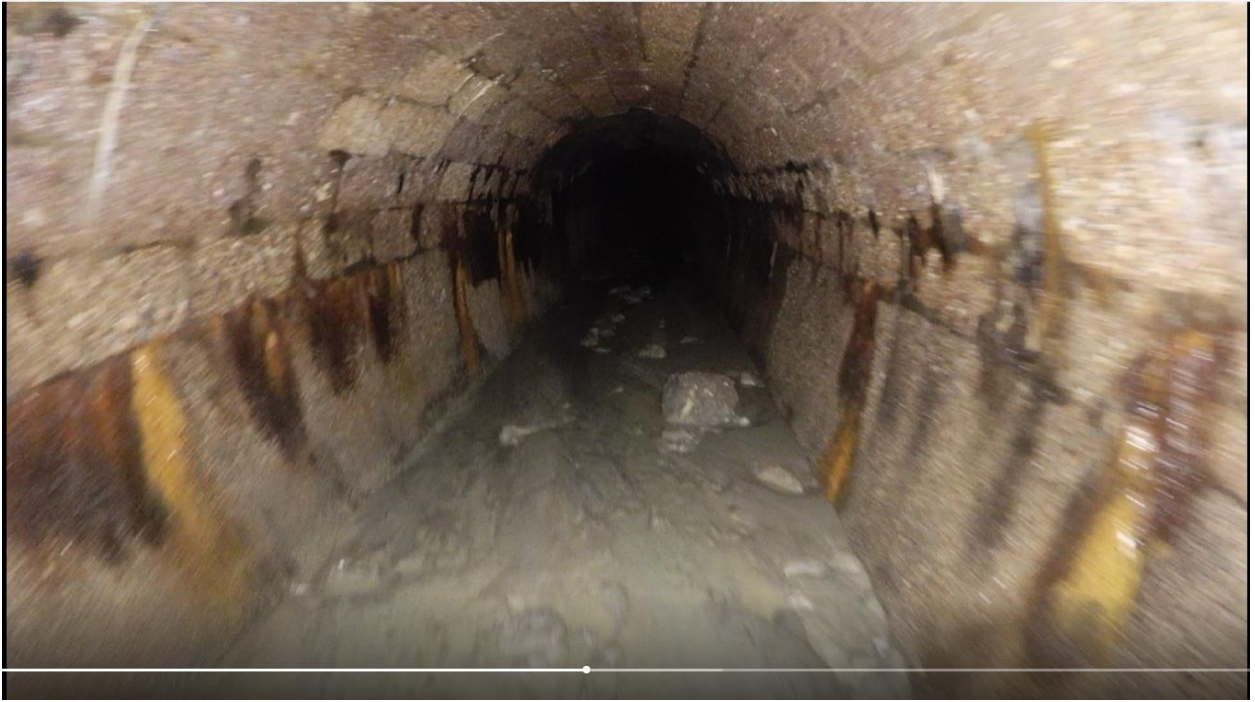
Figure 5 – General Condition of Sewer Between Manhole 15 & Manhole 14

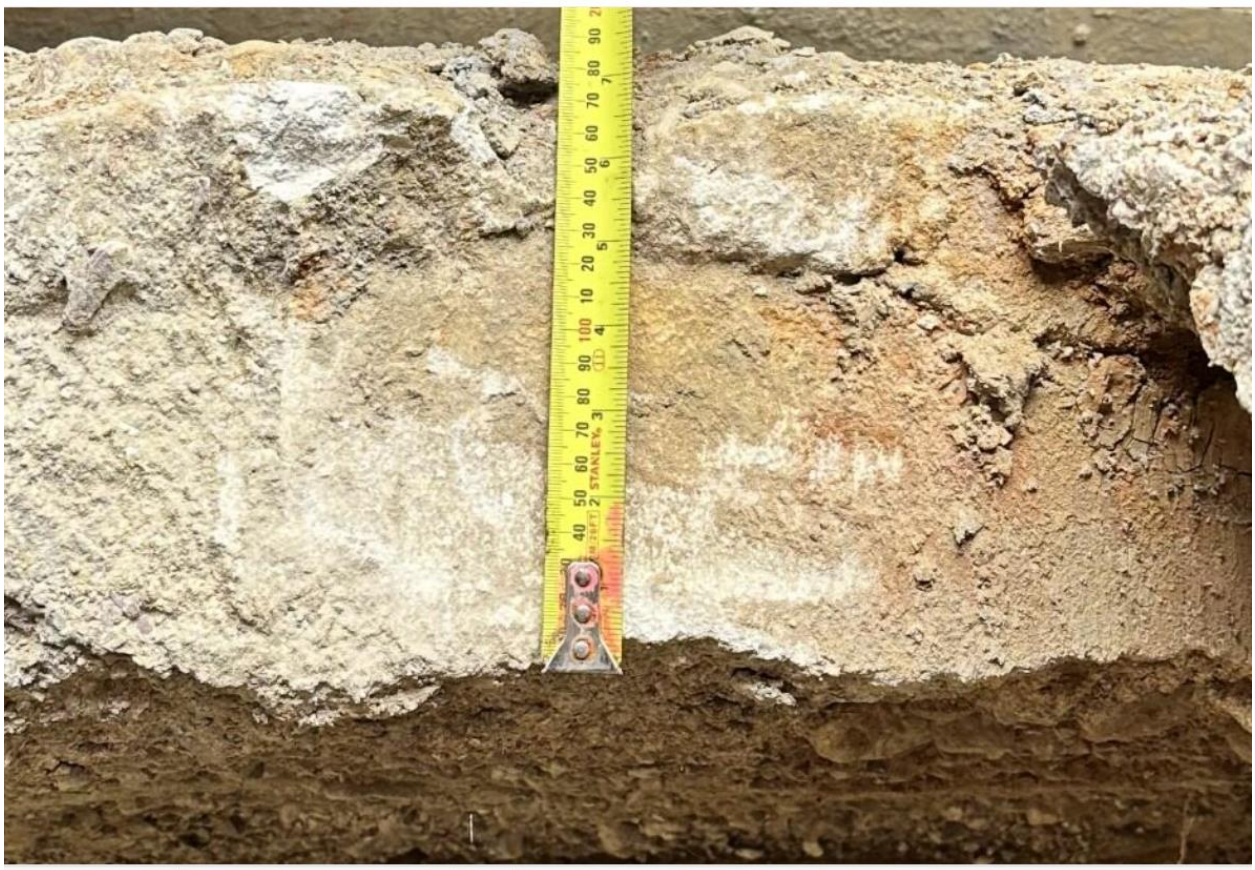
Figure 4 Typical block arch section in-situ

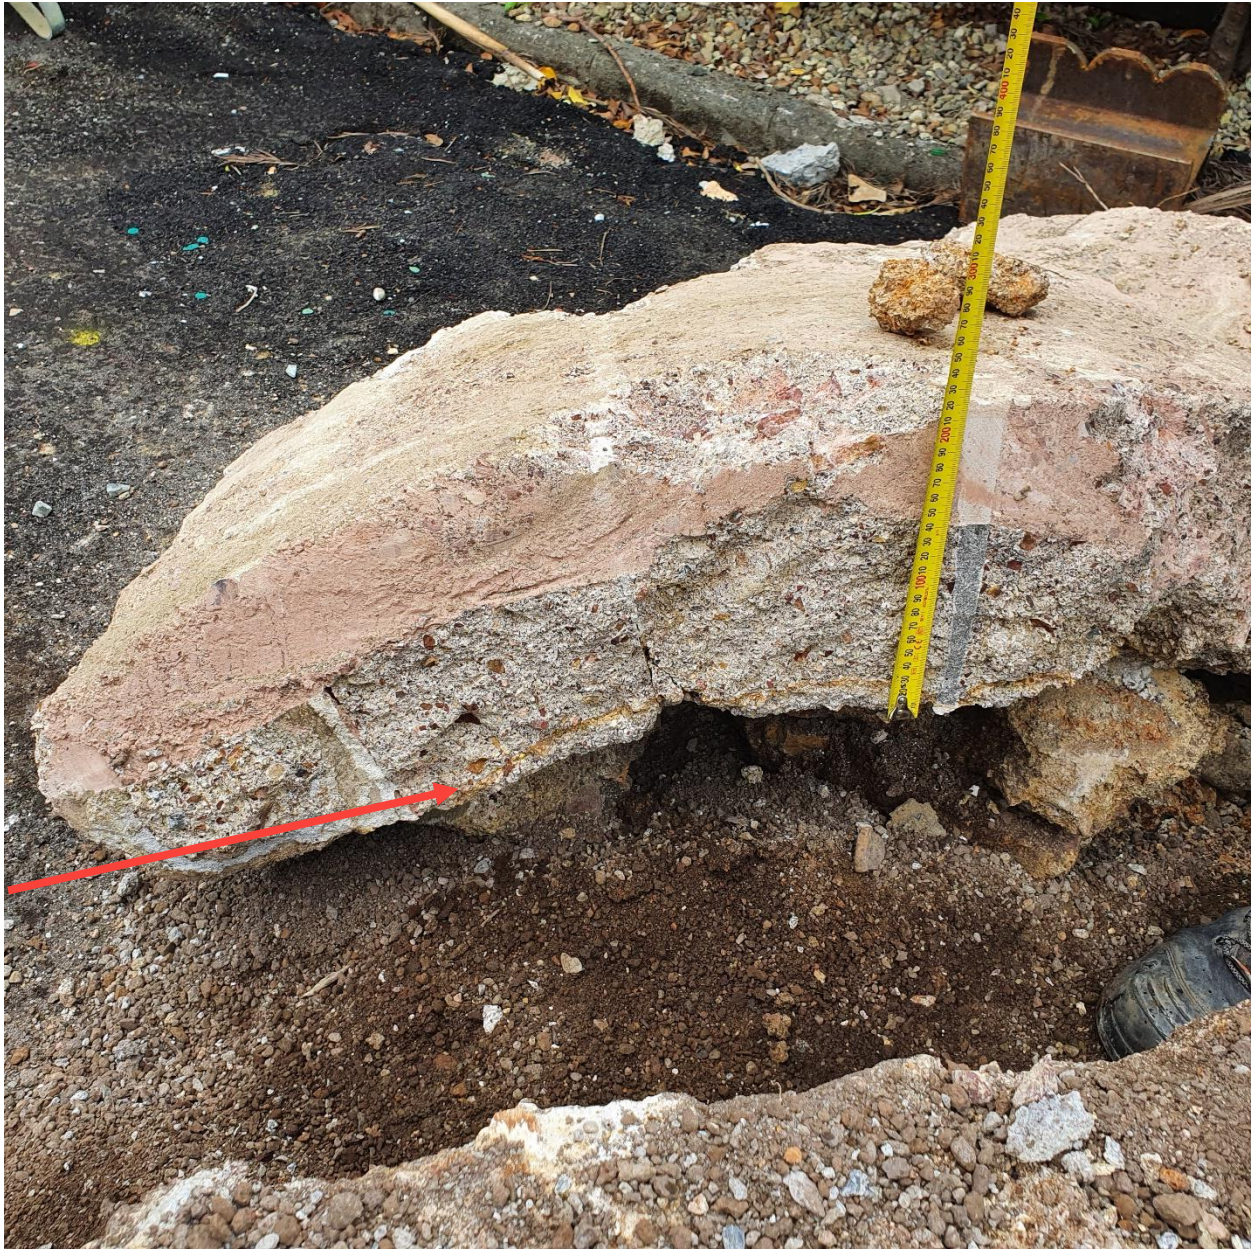
Figure 5 Typical block arch section after removal. Note the brown line indicating the extent of corrosion on the inside face (see red arrow).

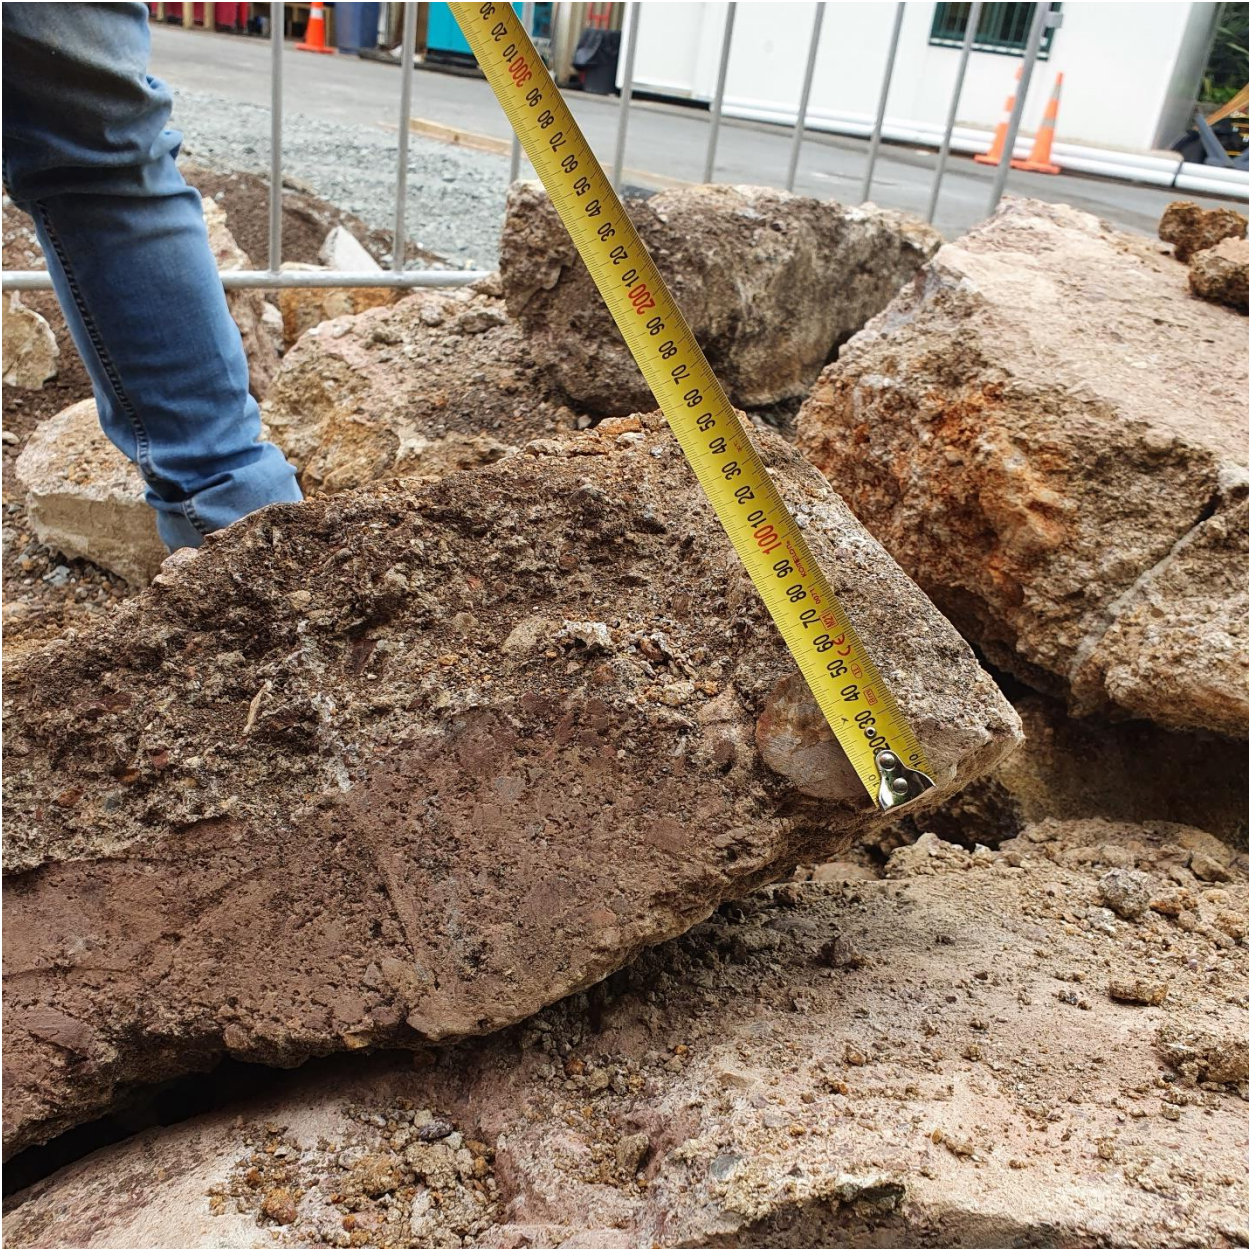
Figure 6 Measurement of concrete layer at edge of block arch

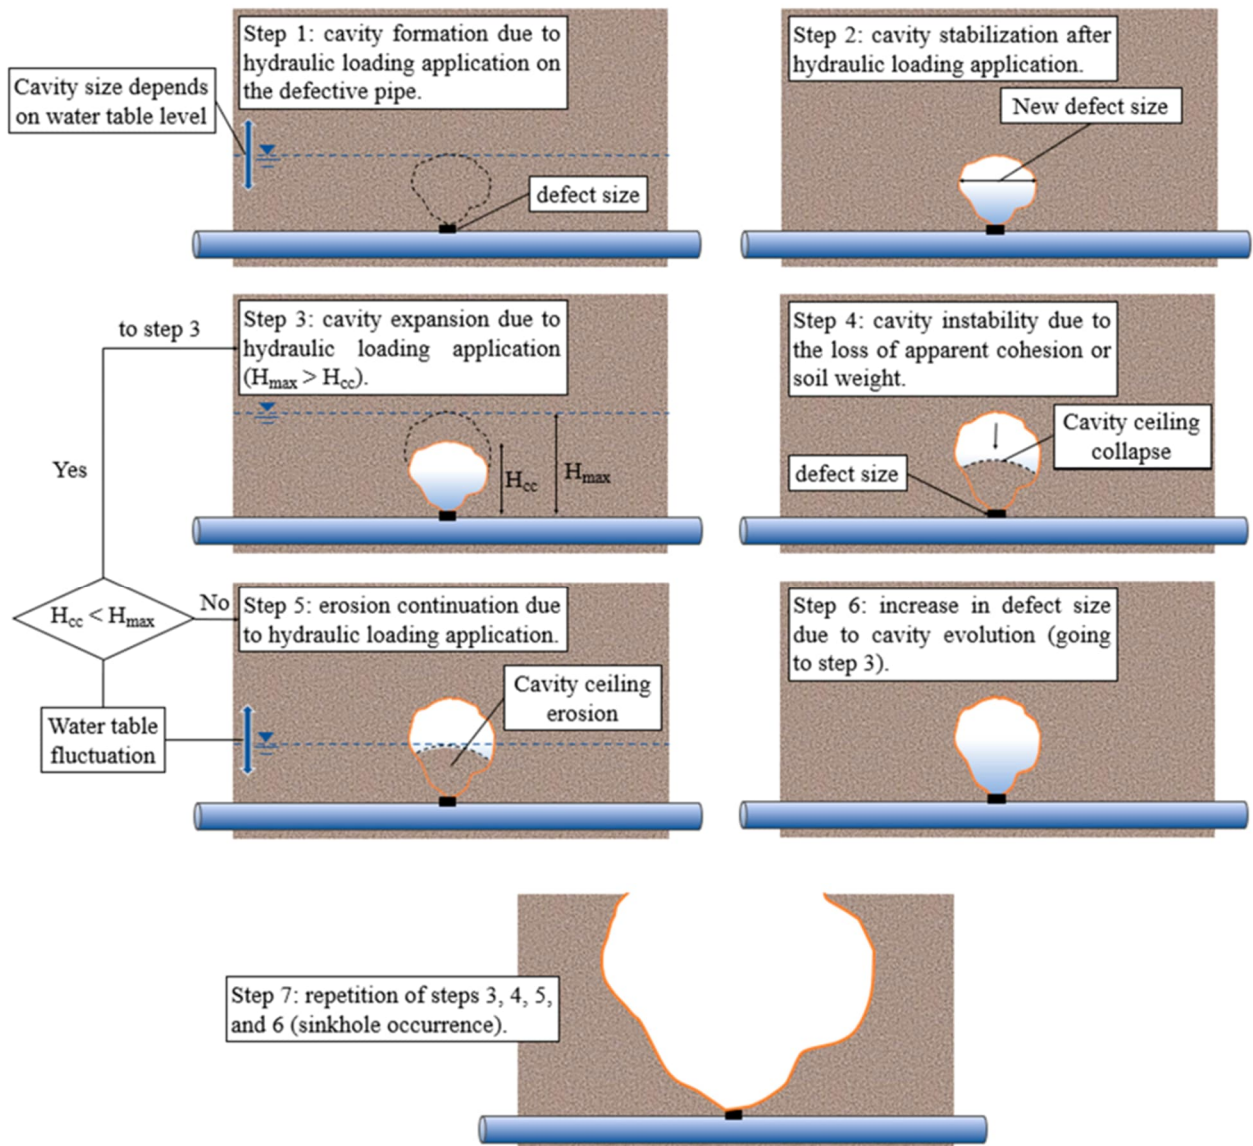
Figure 1. SEDP progression to sinkhole formation from Dastpak et al. (2023)

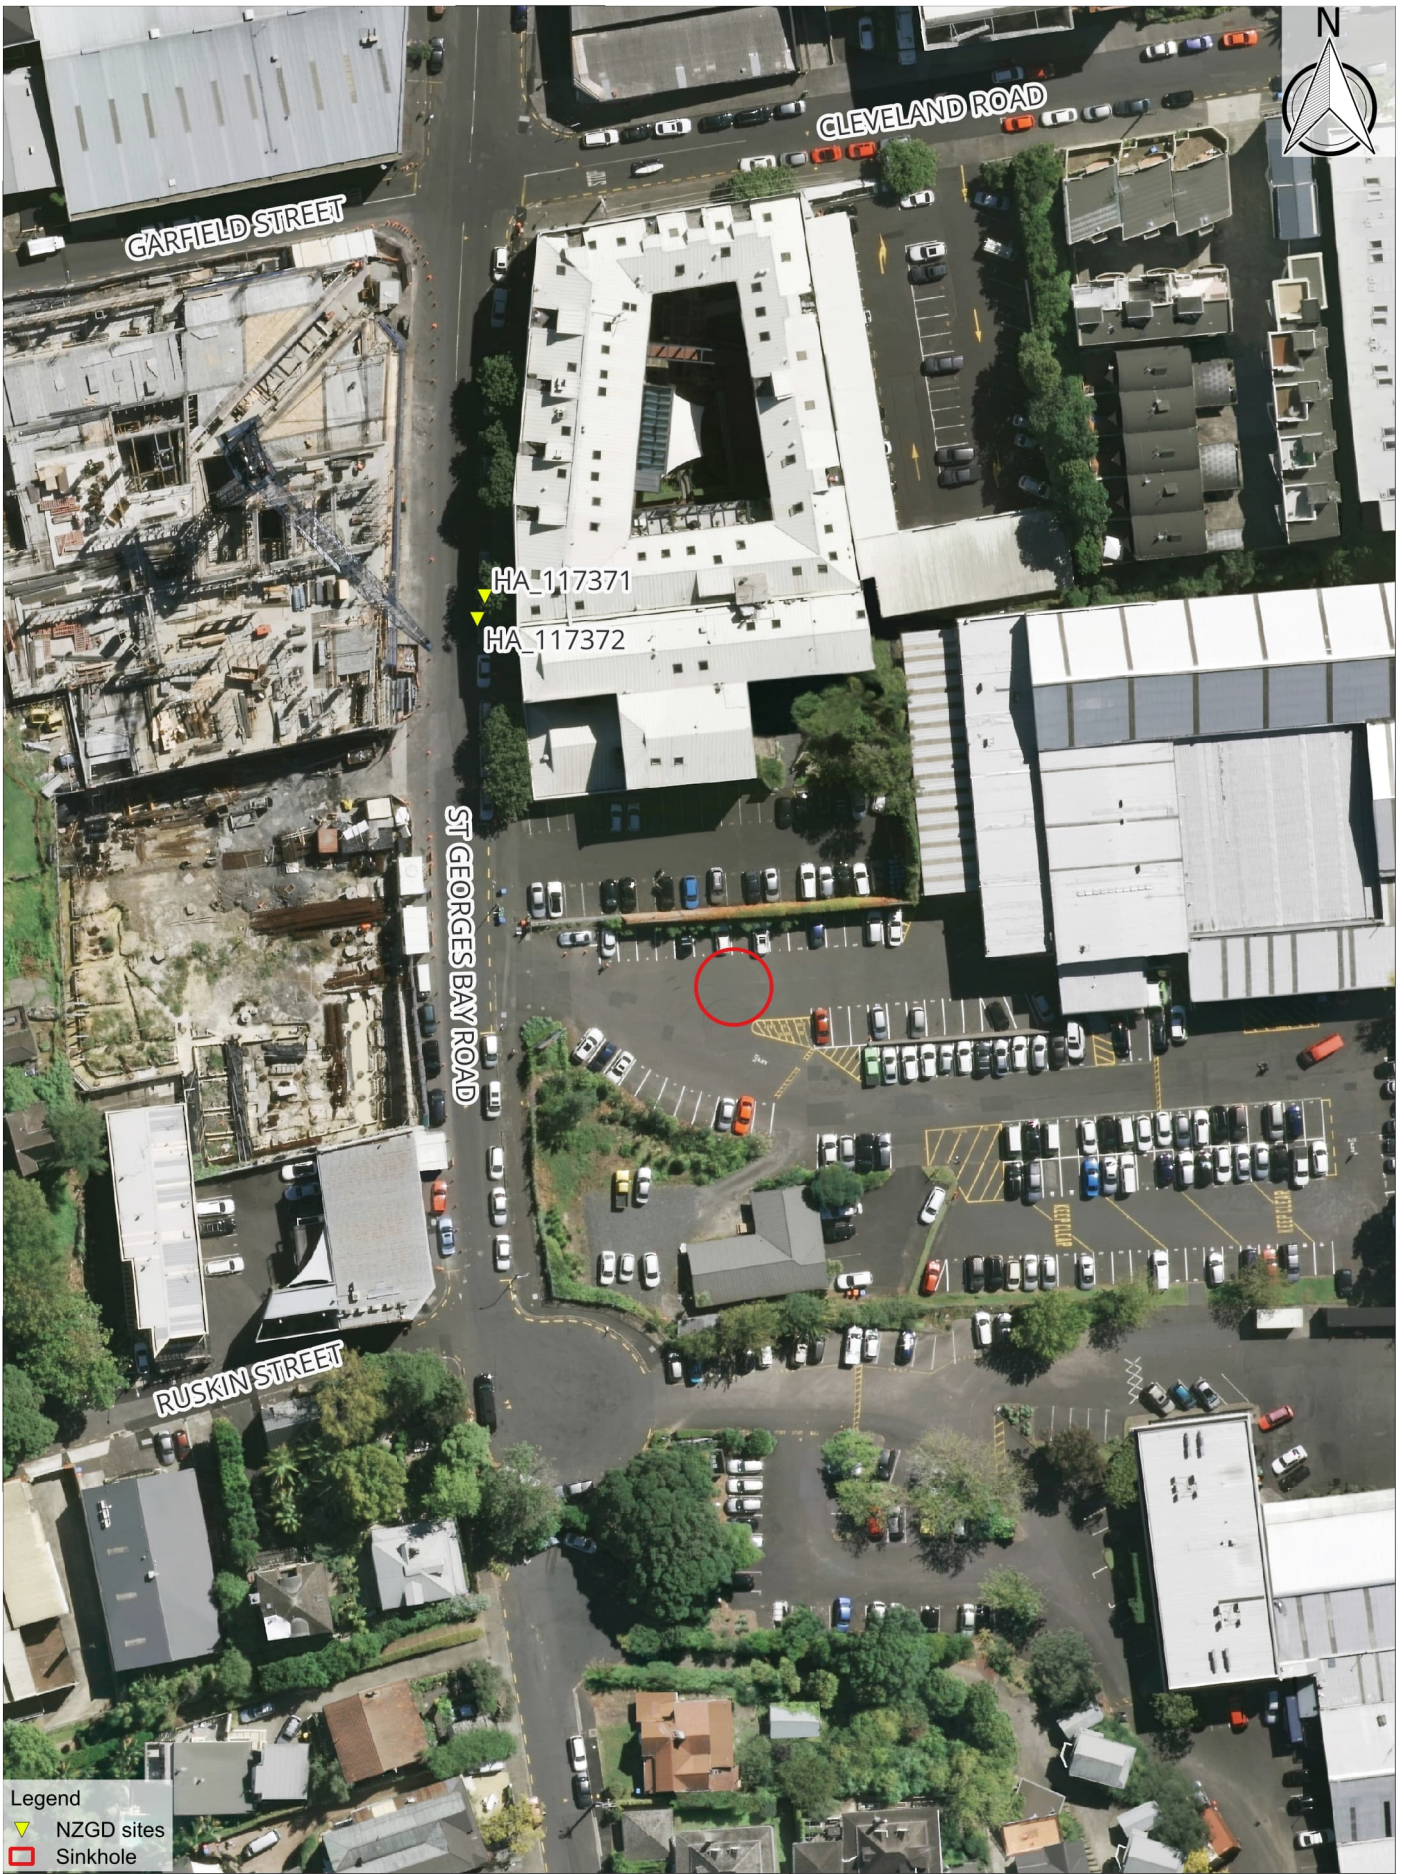
- Legend**
- ▼ NZGD sites
 - Sinkhole
