# **Arboricultural Assessment of Effects**

Trunk Sewer line construction in Herne Bay, resulting in alteration to street and reserve trees.

Prepared for	William Hung	Prepared by	Sean McBride
	Watercare		Director
	Victoria Street West	Date	9 June 2023
	Auckland 1142	Job ref #	2590

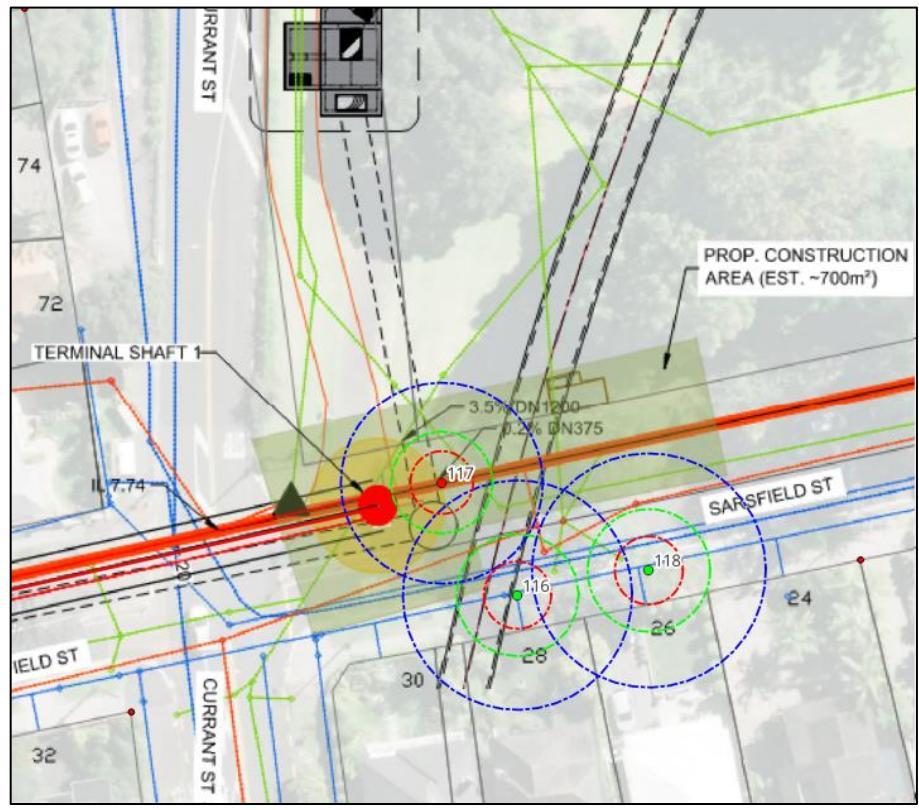
4.1 Starting from Shaft 1 and the area of works adjacent to and within Point Erin Park, the trees surrounding the works comprise three mature willow myrtles (Trees 116 to 118) that are within the road. Trees 116 and 117 are on the southern side, with Tree 118 being on the northern side and is closest to Point Erin Park. The trees are in good health; however, they have fair or poor branch structures. Figure 2 depicts the three trees in relation to the proposed works.

Figure 2 – Location of trees 116 to 118 in relation to Shaft 1

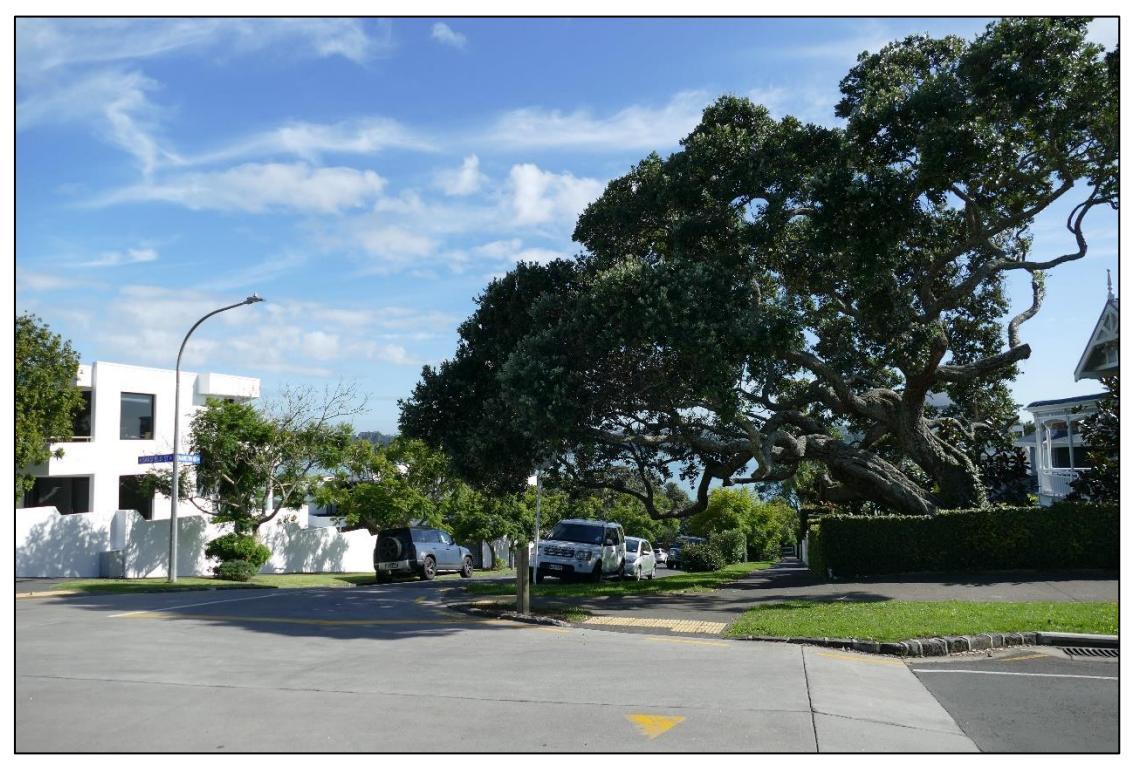
- 4.3 At the intersection of Hamilton Road, Sentinel Road and Lawerence Street, connections into new EOPs will be required. The most northern section of Hamilton Road is lined with early mature jacaranda trees on either side of the road, planted in a generous grass berm. The trees stand up to some 7 m in height and generally are in good condition. Within 61 Sarsfield Street (at the north-eastern corner of the street intersection) is a mature pōhutukawa tree that is listed as a Notable specimen under the Auckland Unitary Plan. Figure 3 depicts the notable tree and avenue of the jacaranda trees.

Figure 3 – Notable põhutukawa and avenue of jacaranda

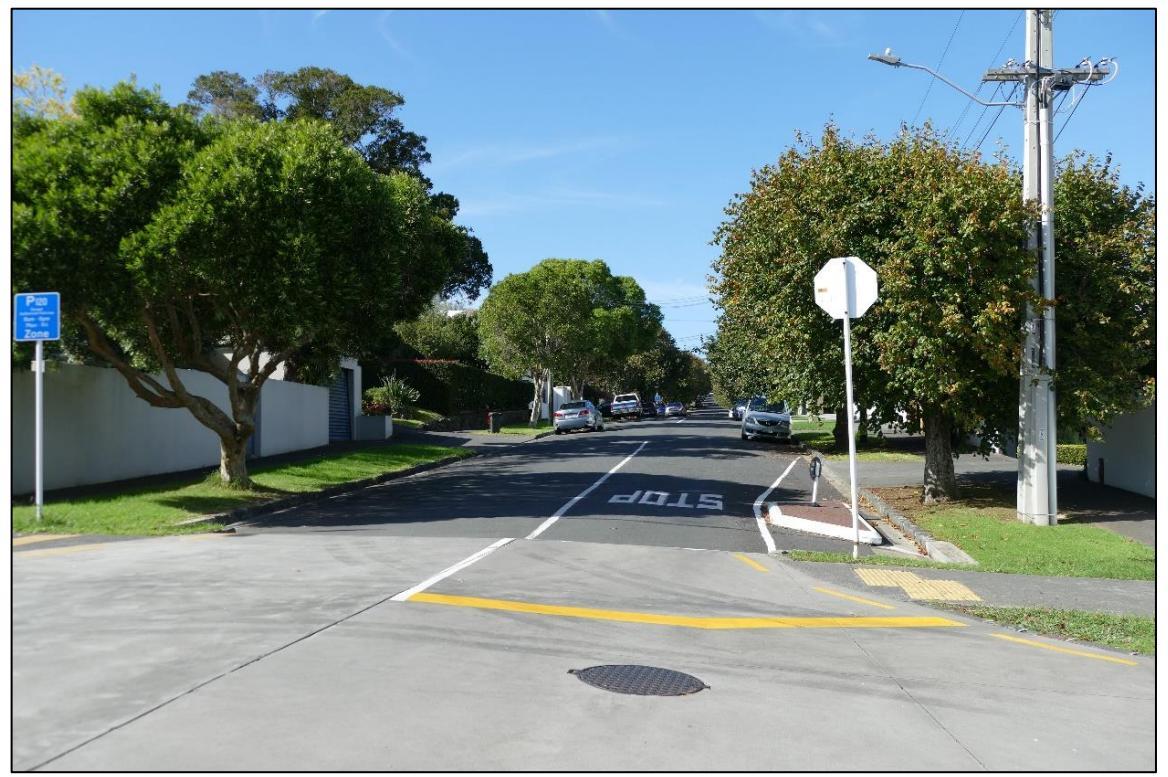
4.4 An avenue of mature lime trees, with the occasional water gum trees, are growing on either side of Sentinel Road, again within generous grass berms of up to some 2 m in width. The limes and water gums on the western side of the road have historically been reduce away from the overhead powerlines, creating a low and mop-top-like canopy in some instances. Many of the trees have canopies that are a few meters above the road, which are perhaps sufficient clearance for smaller vehicles parking, but insufficient for larger vehicles and trucks. The trees on the eastern roadside are taller and have a more upright form, with greater clearances over the road. The trees are generally in good health, with no obvious tree risk features that would warrant remedial works. Figure 4 is an example of depicting the lime avenue lined street.

Figure 4 – Lime and water gum trees along Sentinel Road

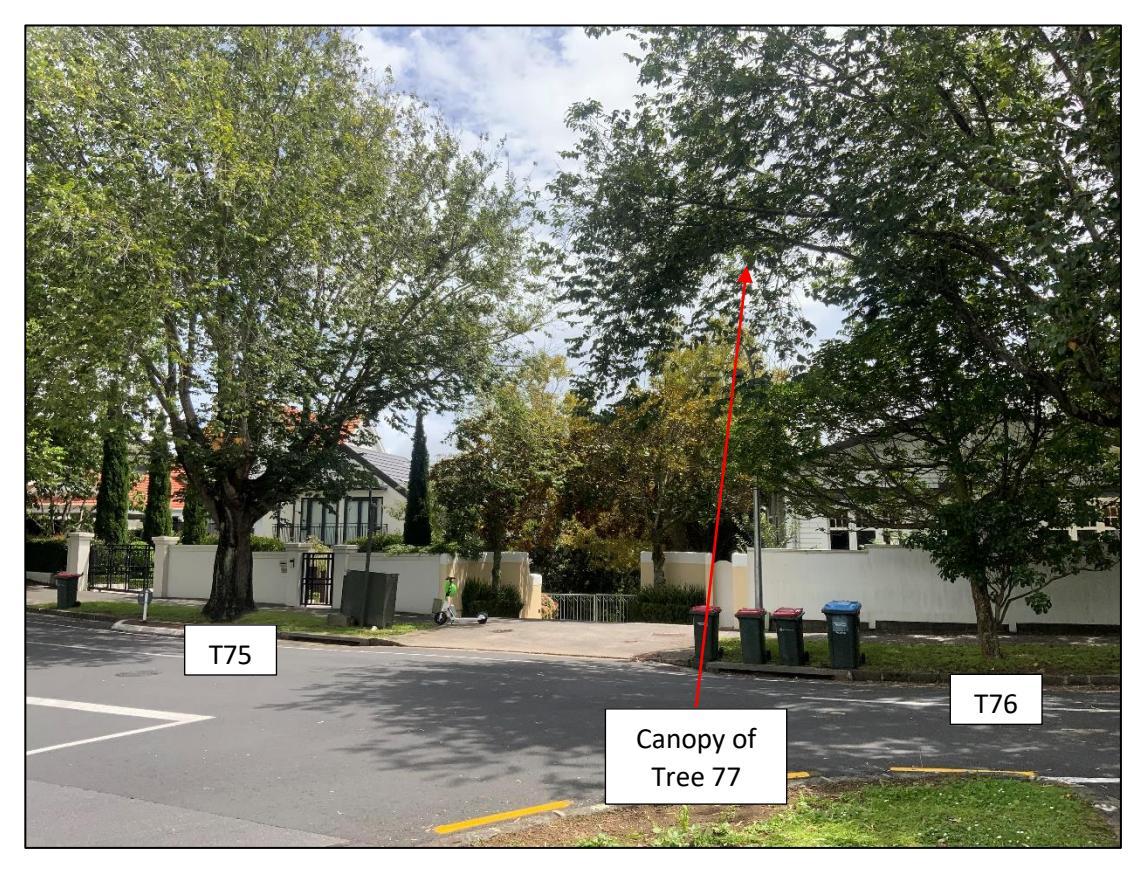
4.5 At the intersection of Sarsfield and Lawrence Street, two post-mature elm (trees 75 and 77), two willow myrtle and one pūriri are within the road berm, with canopies that enclose a large proportion of the intersection. The elms are significant specimens being large trees in the road reserve and are especially valuable as they have not been infected with Dutch elm disease, a vascular disease that can quickly lead to tree death. Figure 5 depicts the elm trees and the smaller pūriri.

Figure 5 – Trees 75 to 77

- 5.6 Overhead canopy pruning for trees 75 and 77 will be required to undertake the works, to enable sufficient space for excavators and cranes to remove debris and install materials. As a worst-case scenario, the elm limbs overhanging the shaft may need reduction by 3 to 4 m in length. The volume of pruning is minimal, and large pruning wounds back to trunks will be avoided. No sustained effects on tree health will result from the pruning.

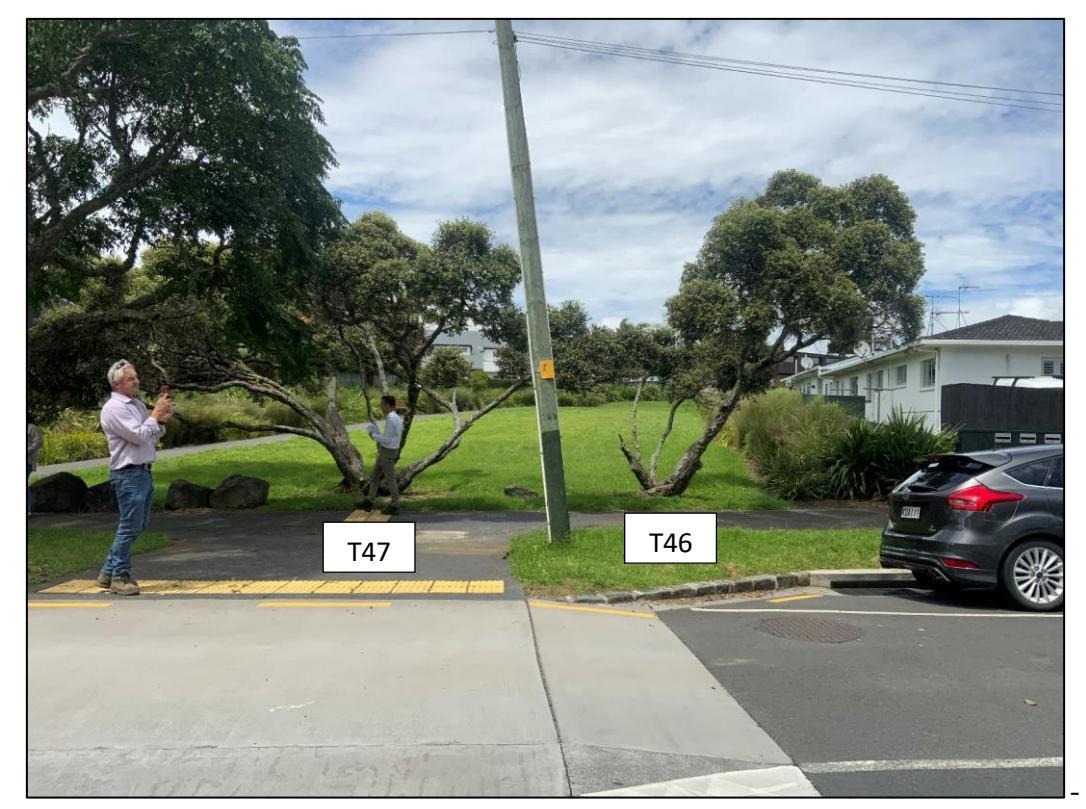
- 4.10 Number 12 Argyle Street is a property zoned open space informal recreation, and this will be utilised as a Construction Support Area. At the entrance, two 4 to 4.5 m tall Kermadec pōhutukawa trees are located within the reserve. They both have broadly spreading canopies and multiple trunks from the base. Two stems have been removed from the western tree (tree 46), and it has been crown lifted quite high. As a result of the historical pruning, the tree has fair form, at best. The eastern tree (tree 47) is more centrally located in the reserve road frontage and has better form. One limb, which has been 'lions tailed', heads towards tree 46. Figure 6 below depicts the two trees.

Figure 6 – Trees 46 and 47, at the entrance of 12 Argyle Street

- 5.31 The Salisbury Reserve yard will have a dedicated entrance and exit off the Argyle Road frontage, where two Kermadec pōhutukawa (trees 46 and 47) and one melia tree (tree 48) are present. Tree 46 is located near the western boundary of the site and is overall in good vitality, however, it is in poor form and with a fair branch structure. This tree is considered arboriculturally insignificant, and its removal will be required to service the contractors entering and exiting the yard. Within the site are three mature cabbage trees (trees 119 to 121), which are generally in fair condition. Two of the trees exhibit large basal decay, and the third tree is in fair form. Their removal will be required to establish the support area. By replanting tree species on a 1:1 basis, the greater ecosystem service benefits will be provided to the immediate area.

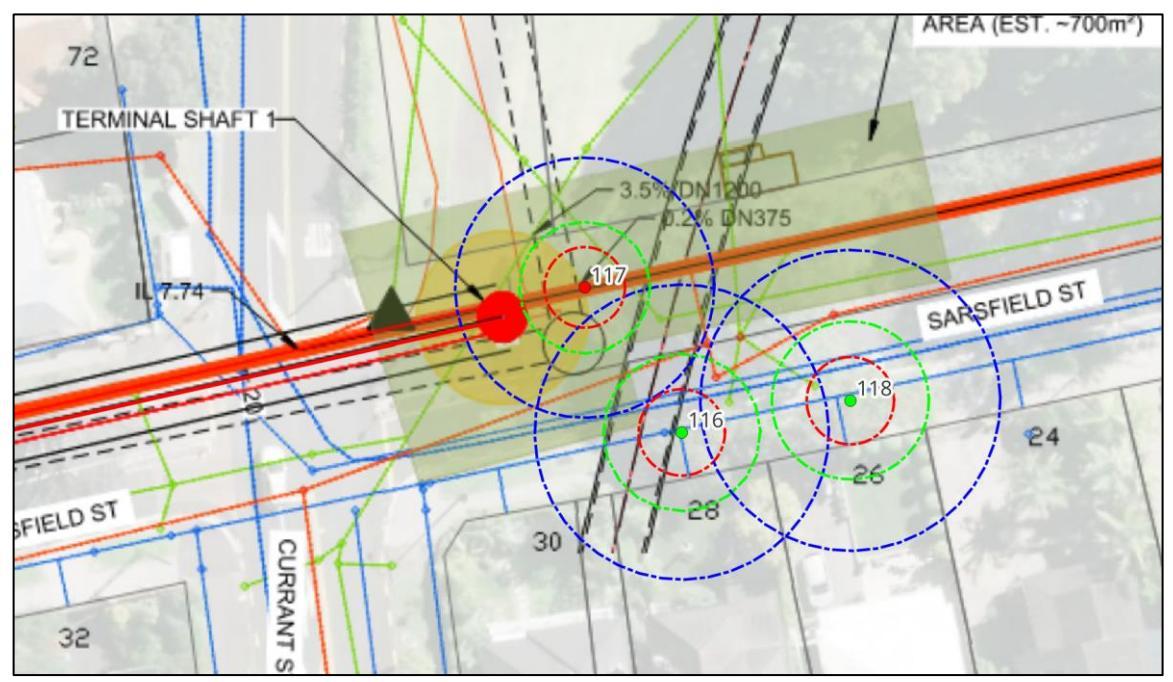
5.1 A total of eight shafts are to be constructed for the Project, which will require excavations in the road corridor between 11 m and 15 m in width (including working room outside the shaft footprint to construct). Shaft 1 lies within the footprint of Tree 117 (willow myrtle), and it will require removal Figure 7. It is also proposed to remove this tree as part of the Central Interceptor extension consent application currently processing by Council and outside of the scope of this Project. Retention of this tree is not feasible.

Figure 7 – Shaft 1 location in relation to trees 116 to 118

- 5.2 The excavations for the shaft are extensive and do not allow for any tree root retention that may lie within. The shaft location is outside of the Protected Root Zone area of both trees 116 and 118 (as defined by the Auckland Unitary Plan), however, it is within the Tree Protection Zone (TPZ) set out in the Tree Owner Approval Guide produced by Community Facilities at Auckland Council. The TPZ is calculated by measuring the trunk diameter at 1.4m and multiplying by 12. Given the inhospitable rooting environment beneath the road, significant root activity between the PRZ and TPZ is unlikely, and indiscriminate root loss for the construction works is likely to have minimal effects.

- 5.3 Overhead canopy clearance from trees 116 and 118 is currently sufficient for road traffic, however, an increase in clearance areas will be required. The extent of pruning in this instance is likely to comprise crown lifting to 4.5m and a careful reduction on the north canopy edges. When undertaken in accordance with accepted practice, insignificant effects will occur.

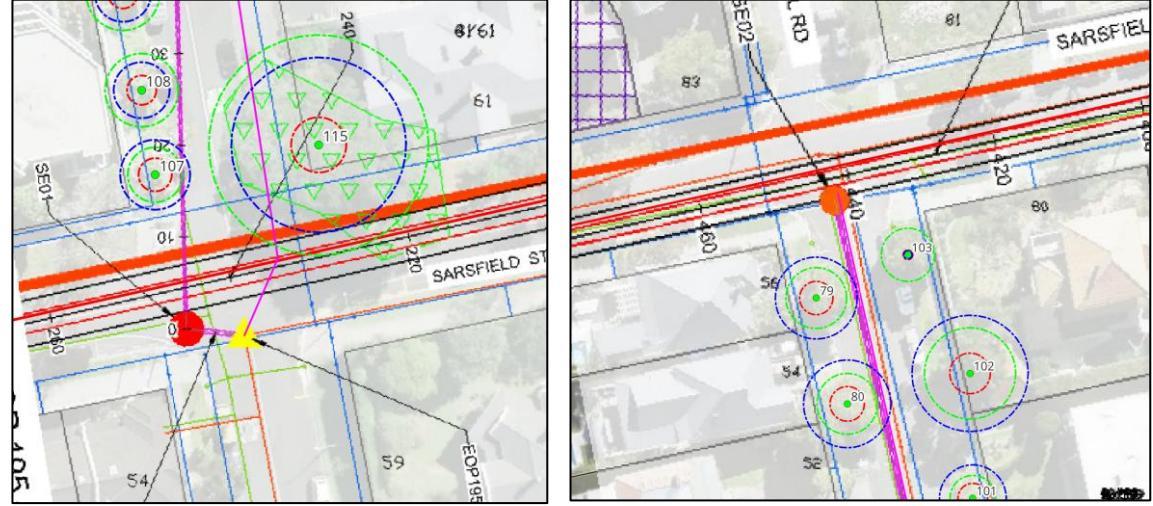
- 5.4 A secondary shaft (SE01) is to be constructed on the north-western corner of the intersection of Sarsfield Street and Hamilton Road. SE01 has been relocated further west to maximise the distance from a notable pohutukawa tree that is located at 61 Sarsfield Street. (Figure 8 tree 115). The manhole location is outside of both the PRZ and TPZ of trees in the road, as is the case of SE02 (Figure 9). With the pipe being installed using trenchless technologies, effects on the notable tree will be negligible (perhaps nil).

Figures 8 (left) and 9 (right) – SE01 in relation to the notable pōhutukawa (T115) and location of SE02

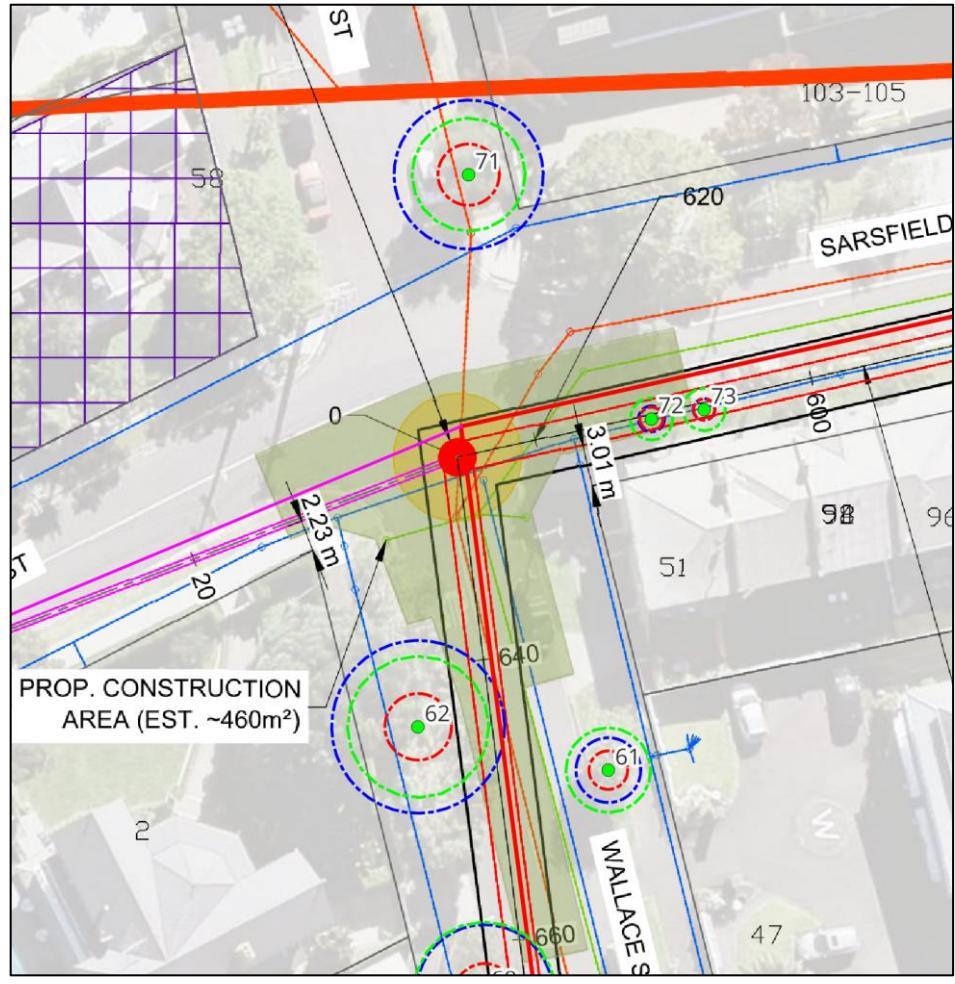
- 5.7 Proposed Shaft 2 is at the intersection of Sarsfield and Wallace Street, adjacent to a row of Kermadec pōhutukawa trees (tree 62 Figure 10. Excavations for the shaft location are well outside of the root zone of this tree group, and any effects from root zone disturbance will be negligible. The construction area for Shaft 2 will require crown lifting of these trees, to approximately 4.5m in height, and back to kerb line, however, there is scope to retain any large scaffold limbs that are present. The level of pruning can be classified as maintenance for the road corridor clearances.

Figure 10 – Shaft 2 location

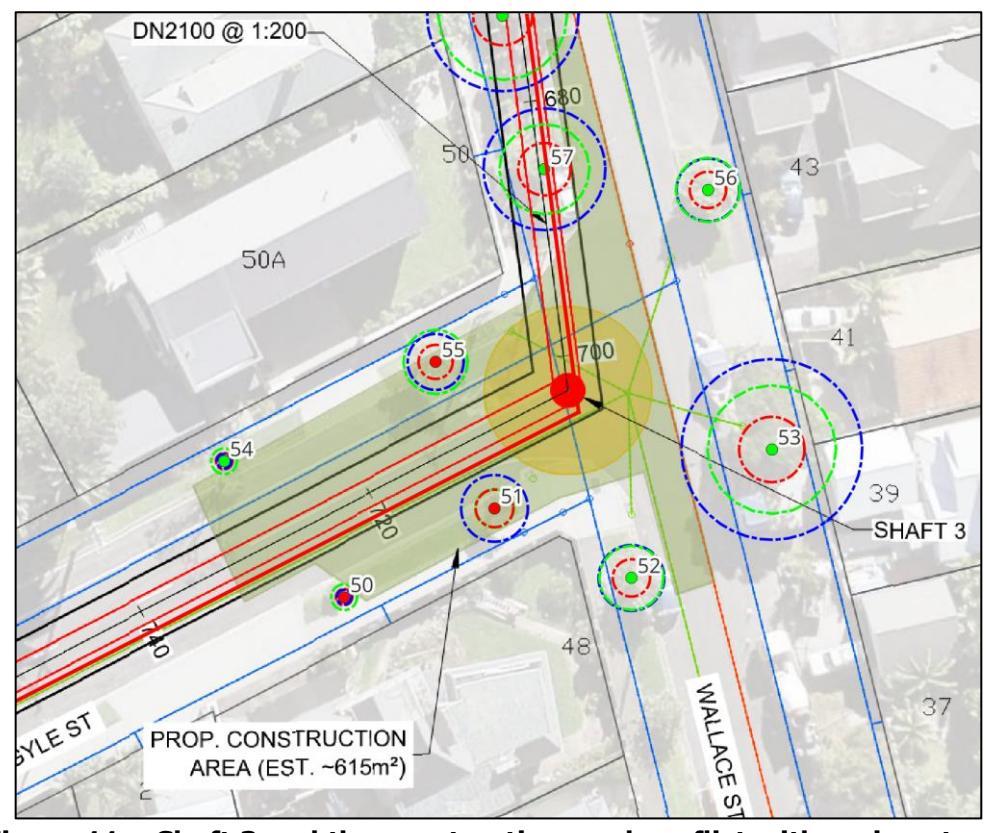
- 5.8 Shaft 3 is proposed to be located at the intersection of Argyle and Wallace Street and is similarly outside the PRZ and TPZ of street trees. This shaft has a large diameter and requires access for a crane and large excavators. Although street trees are clear from the excavations, the footprint of the construction area is where two Cherry (tree 51 and 55), one pseudopanax (tree 50), and one juvenile pōhutukawa (tree 54) are located and therefore these trees will need to be removed. The cherry trees are in fair health with twiggy deadwood present, and the pseudopanax and pōhutukawa trees are too small to reach protection status. Of the four trees, the pōhutukawa is worthy of relocation to another location in the street. The three remaining trees are arboriculturally insignificant, and their removal can be mitigated with replacement planting. Figure 11 depicts the construction area of Shaft 3

Figure 11 – Shaft 3 and the construction yard conflict with various trees

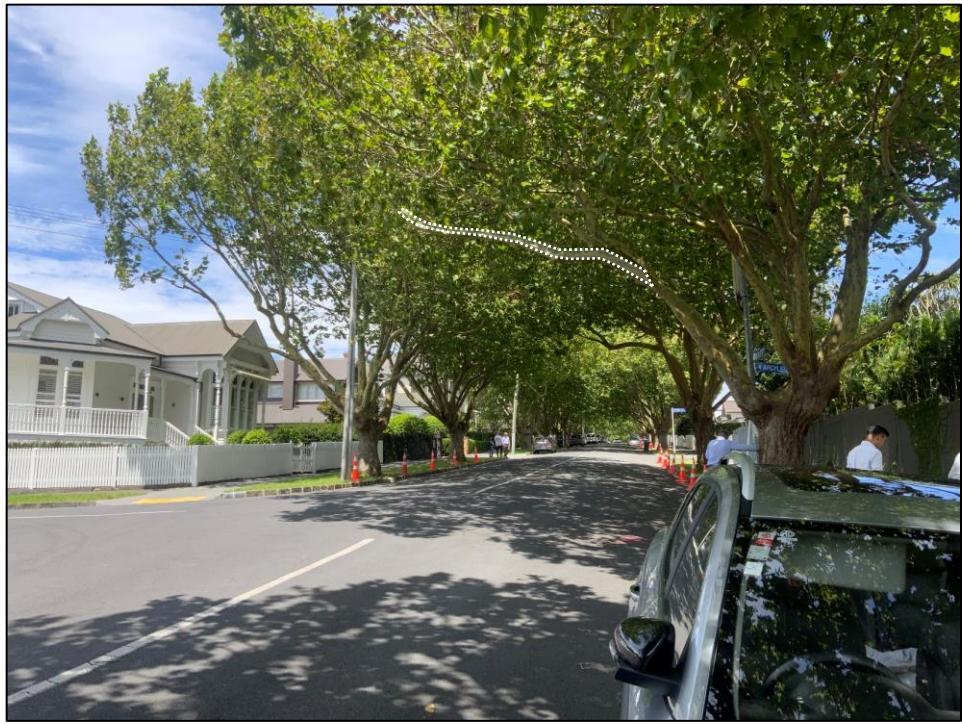
- 5.11 Proposed shafts 4 and 5 are on Herne Bay Road, at the intersections of Argyle (Shaft 4) and Upton Street (Shaft 5). Along Herne Bay Road are mature London plane trees that are assessed to be very good examples of the species in a road environment (trees 24, 25, and 27 to 31). The shaft sites and resulting root loss have been placed in a manner where minimal, perhaps negligible effects will occur, however as a theme for the Project, current overhead canopy clearance is insufficient. A crane is likely to be established between trees 28 and 29, for the 18 m to 19 m deep shaft to be constructed. Tree 28 has one limb heading in an easterly direction, which measures some 200 mm in diameter (at the point of attachment, where it connects to a similar-sized limb). Removal of this limb is proposed (Figure 12), as a worst-case scenario to undertake the Project.

Figure 12 – Branch proposed to be removed from tree 28, noting only the stem is indicated

- 5.12 Regarding pruning of tree 28, as the main branch divides into two stems of similar size, removing one will create a wound of similar size on the remaining limb. Best arboricultural practice includes ensuring the branch being pruned back to is at least 1/3 of the branch diameter that is being removed. The pruning, in this instance, conforms to this practice. The extent of foliage removed from this limb accounts for a small proportion of the overall canopy, therefore, effects on the tree by pruning this will be insignificant.

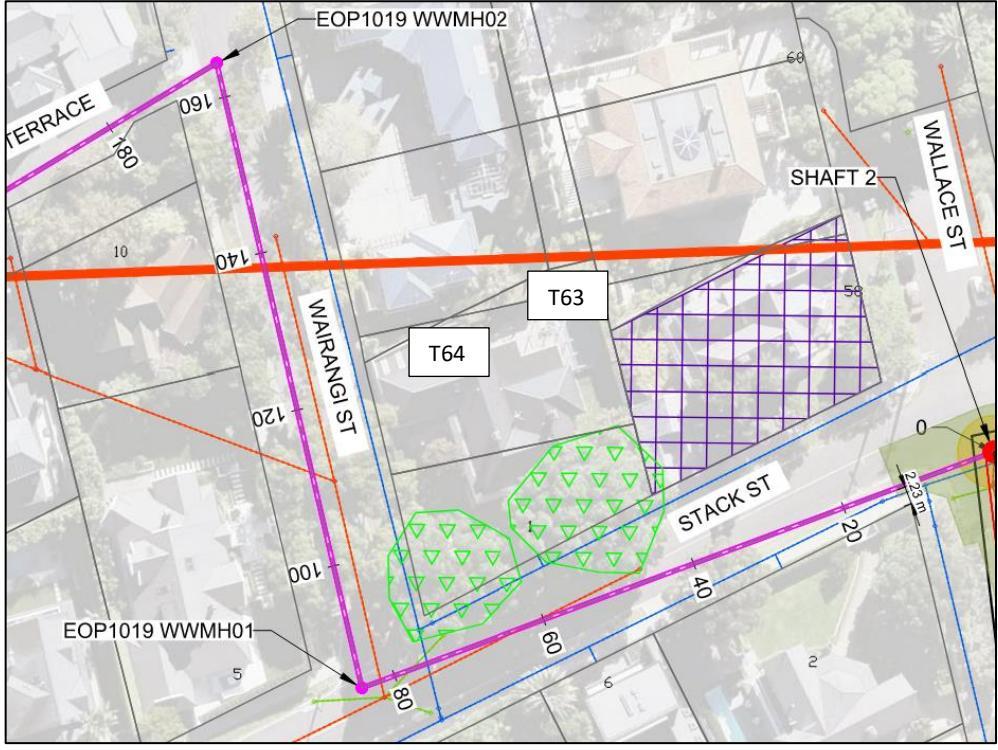
- 5.25 Along Stack, Wairangi Streets, and River Terrace, a 450 mm diameter pipe will be installed via trenchless methods. Two notable pōhutukawa trees are located within 1 Stack Street and undertaking the trenchless method at a depth of more than 7 m will ensure no roots are encountered. Excavations are, however, needed to install a manhole (and possibly a drilling pit) at EOP1019 WWMH01 (Figure 13). The manhole has been shifted further west, to a position where insignificant roots are likely to be encountered.

Figure 13 – Notable trees at 1 Stack Street (trees 63 and 64)

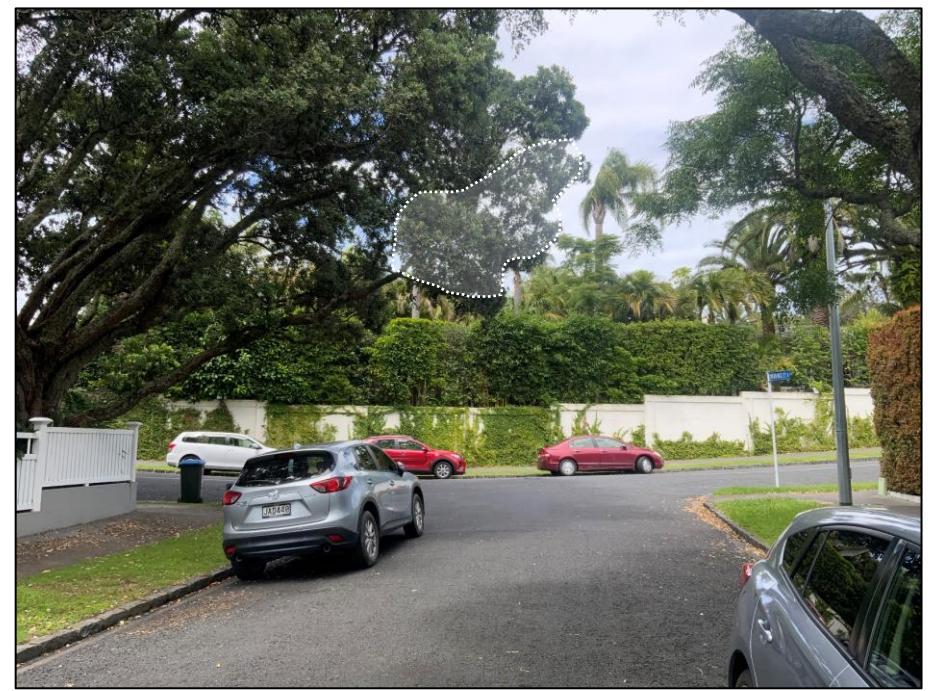
Figure 14 – Limb to be crown lifted (shaded out)

- 5.26 In addition to the excavations, light crown lifting of a limb that heads in a westerly direction of tree 64 (notable pōhutukawa) will be required. When pruning back to correct branch collars, the size of limb removal will almost certainly be greater than 50 mm in diameter, but less than 100mm. Figure 14 depicts the limb proposed to be crown lifted.

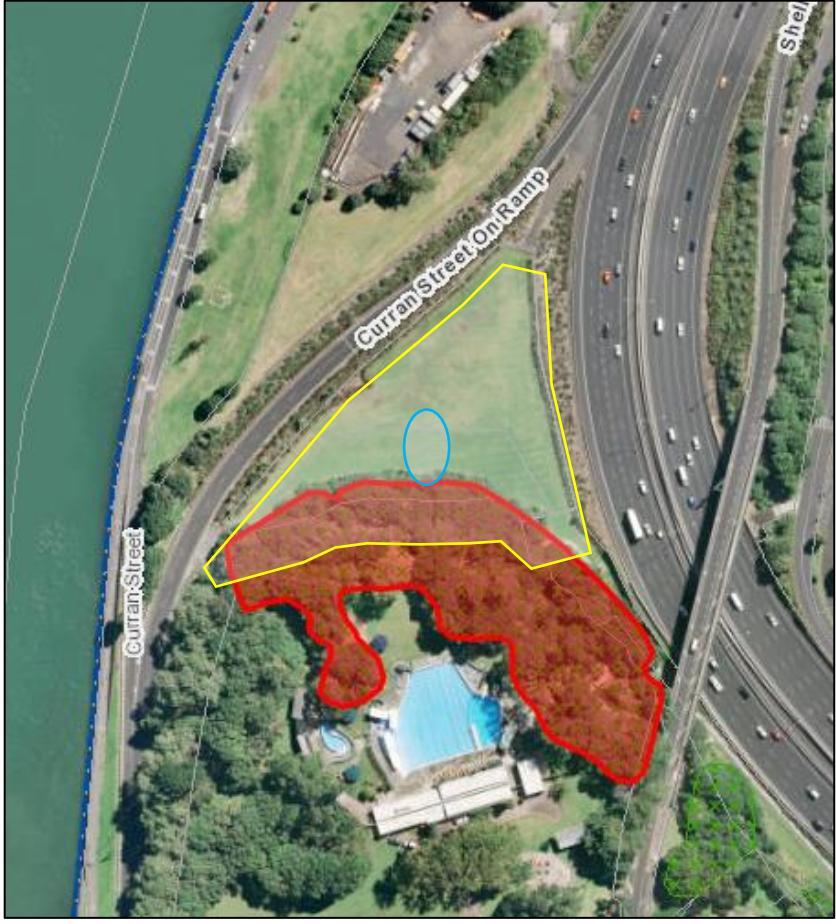
- 5.34 The second contractor's yard at 94 Shelly Beach Road, also known as the 94A-B Shelly Beach Road Site. This site is zoned Strategic Transport Corridor. Several years ago, the McDowell site was used for an infrastructure project, with access coming from the Curran Street on ramp. Surrounding the southern section of the site is a grouping of native trees (mainly pōhutukawa) that occupy the bank and at the bank toe. The vegetation in this area is within a Significant Ecological Area overlay. Three recently planted pōhutukawa are also present towards the middle of the site. Figure 16 below depicts the site and approximate location of the three trees.

Figure 16 – CSA2; three recently planted pohutukawa in blue

- 5.35 The three pōhutukawa trees are young specimens, likely planted in the past two to three years. As they are juvenile, it is recommended they be relocation elsewhere on the site. All tree relocation should be undertaken by suitably experience arboricultural contractors, with the work according to best arboricultural practice. The trees will require maintenance for a minimum of two years after relocation (i.e. watering during summer, re-mulching, stake re-tying, etc).
