WATERCARE SERVICES LIMITED

## **ŌRĀKEI MAIN SEWER EMERGENCY REPAIR AND TEMPORARY DIVERSION**

Land Use Resource Consent  
Application and Assessment of  
Environmental Effects

April 2024

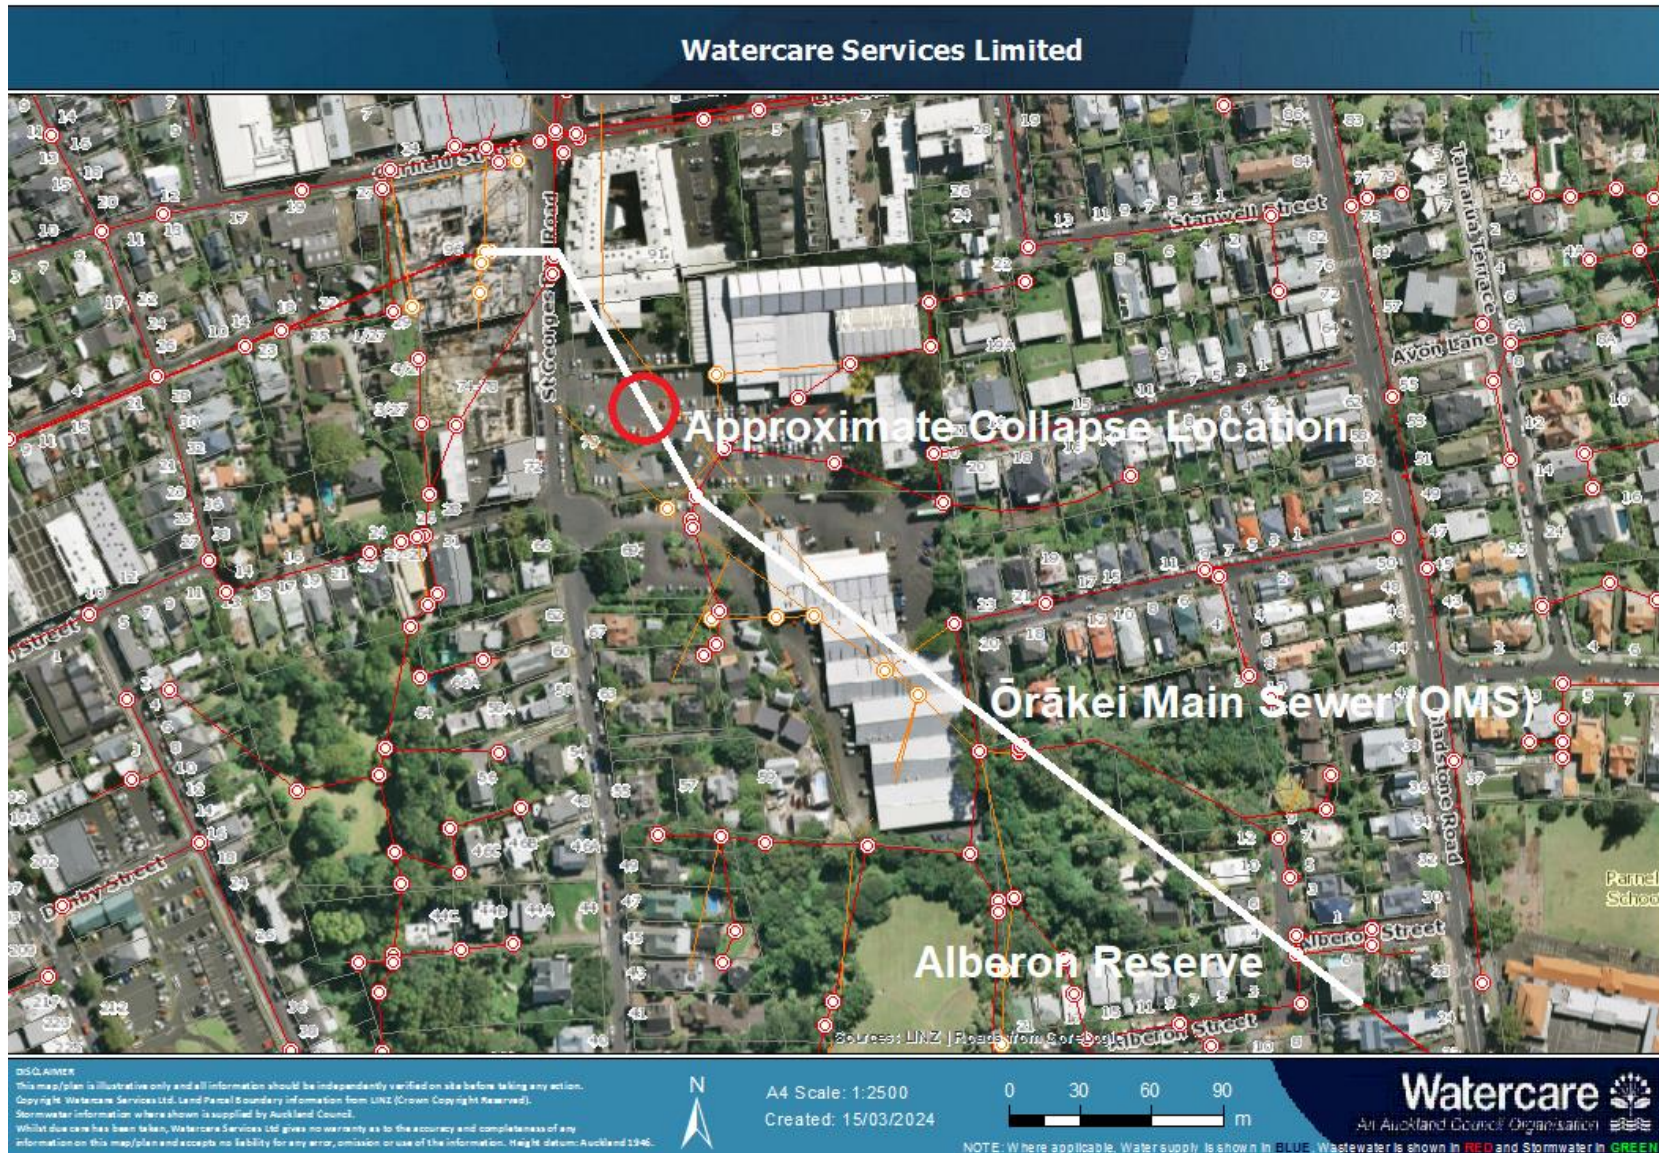
**Figure 1: Ōrākei Main Sewer collapse area.**

The collapse of the OMS caused a hole approximately 5 m wide and 13 m deep within the carpark of 79 Georges Bay Road, with rubble and material creating an approximately 25 m wide blockage within the OMS. All regular flows through the OMS were diverted and discharged into the Waitematā Harbour, predominantly via overflow outlets at Brigham (Daldy) Street, Bledisloe Wharf and Freyberg Wharf, with no wastewater or stormwater flows discharging to land at 79 Georges Bay Road.

Watercare propose to repair the OMS in the vicinity of the sink hole with a prefabricated glass-reinforced plastic liner. In order to mitigate further risks of sewer collapse, the liner will be installed between the manhole on St Georges Bay Road upstream of the collapse site through to the next manhole downstream of the sink hole.

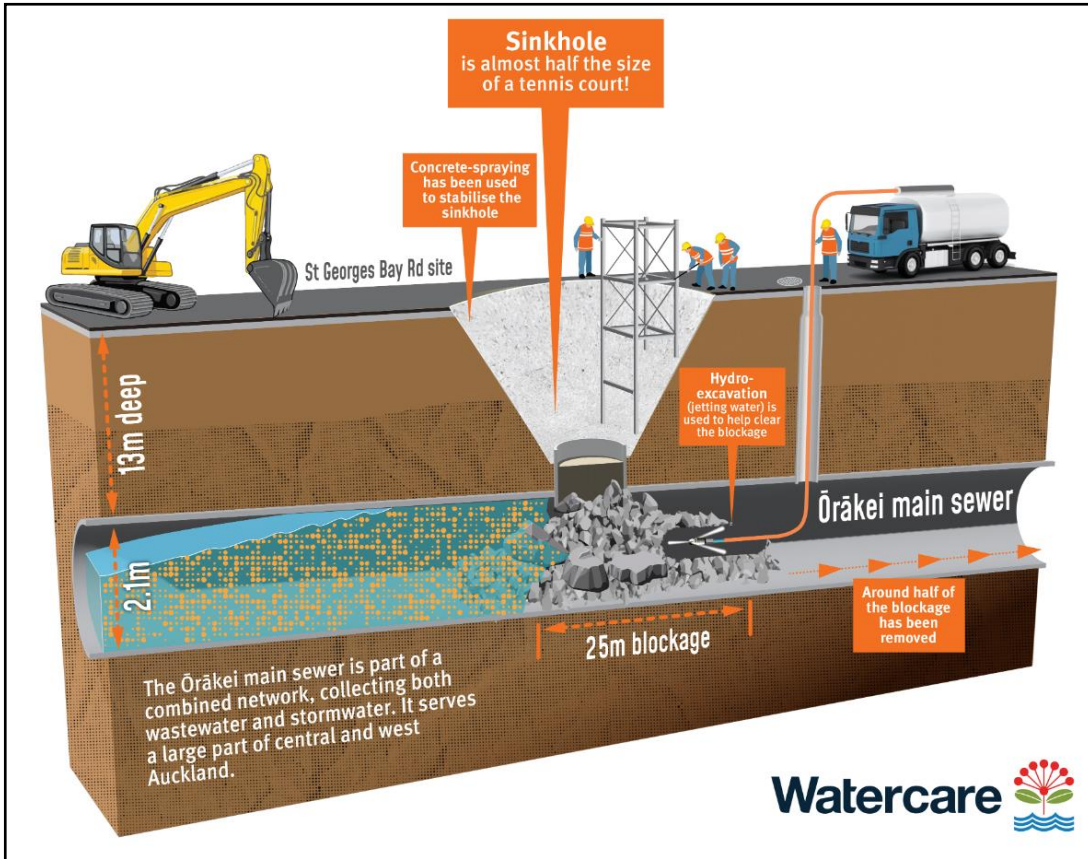
Figure 2: Schematic of the Ōrākei Sewer Collapse, stabilisation and rubble removal.

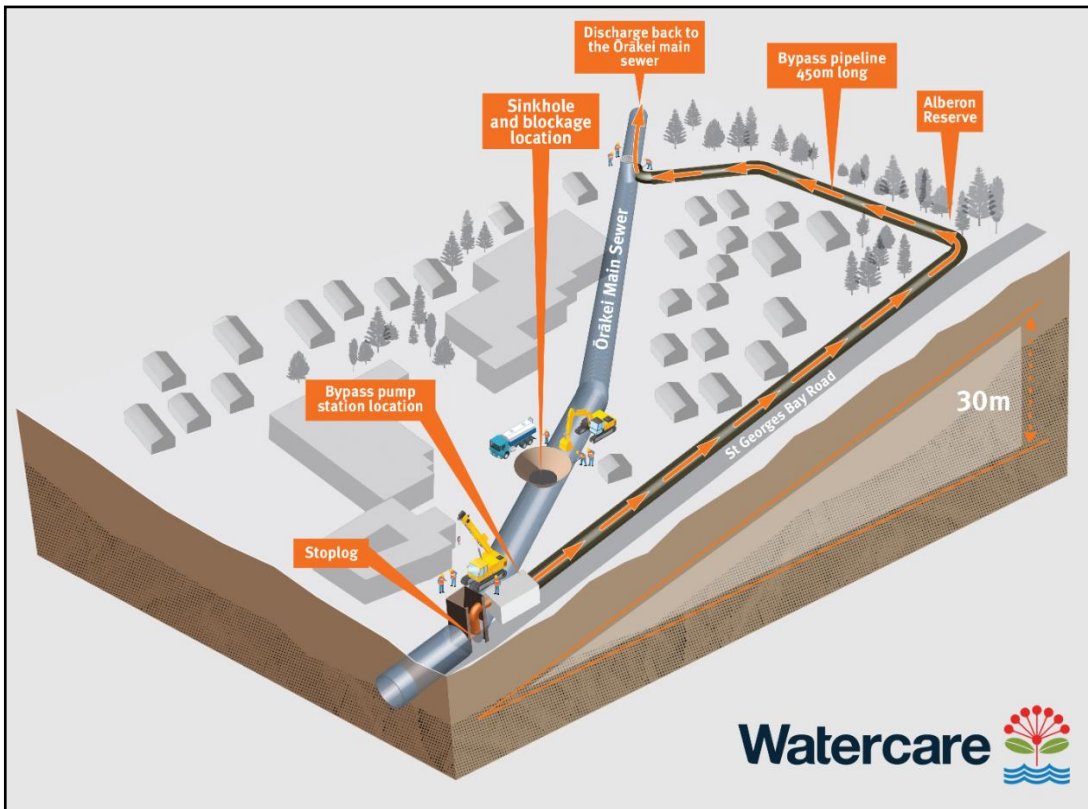
Figure 3: Schematic of the temporary diversion location.

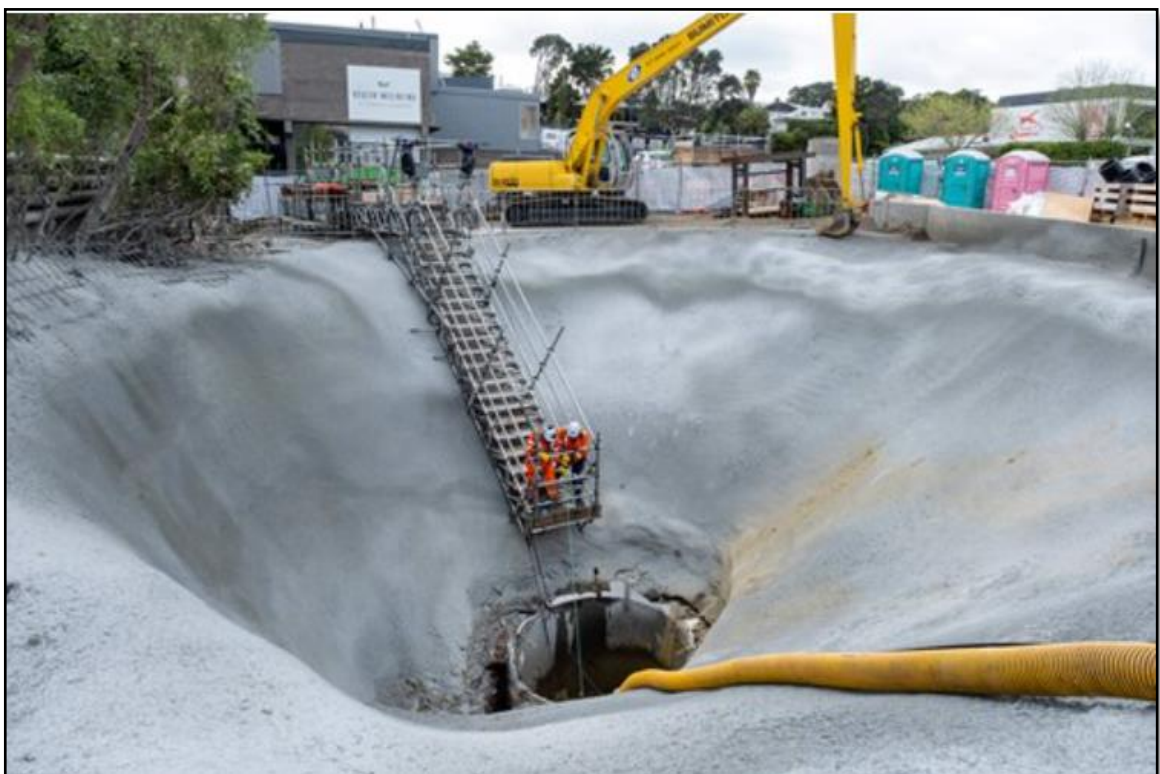
**Figure 6: Ōrākei Main Sewer stabilised sink hole.**

Watercare have stabilised the OMS sink hole using concrete-spray. This measure has effectively avoided further erosion of the sink hole and prevented loose sediment falling into the hole in the OMS increasing the blockage. The concrete-spray has also effectively minimised the potential for dust generation from the OMS sink hole site.

Upon completion of the OMS repairs, Watercare intend to fill the OMS sink hole with clean fill material. The fill will be compacted and sealed, and the carparking facility reinstated. The diversion pump and overland sections of the diversion pipe will be decommissioned. Watercare propose to undertake all necessary works to reinstate any damaged sections of St Georges Bay Road and footpath in accordance with Auckland Transport standards and the conditions specified in the National Code of Practice for Utility Operators' Access to Transport Corridors (2011). In addition, the development of a Reserve Reinstatement Plan is proposed, which will include measures to reinstate and re-plant indigenous vegetation within Alberon Reserve upon removal of the diversion pipe and access track.

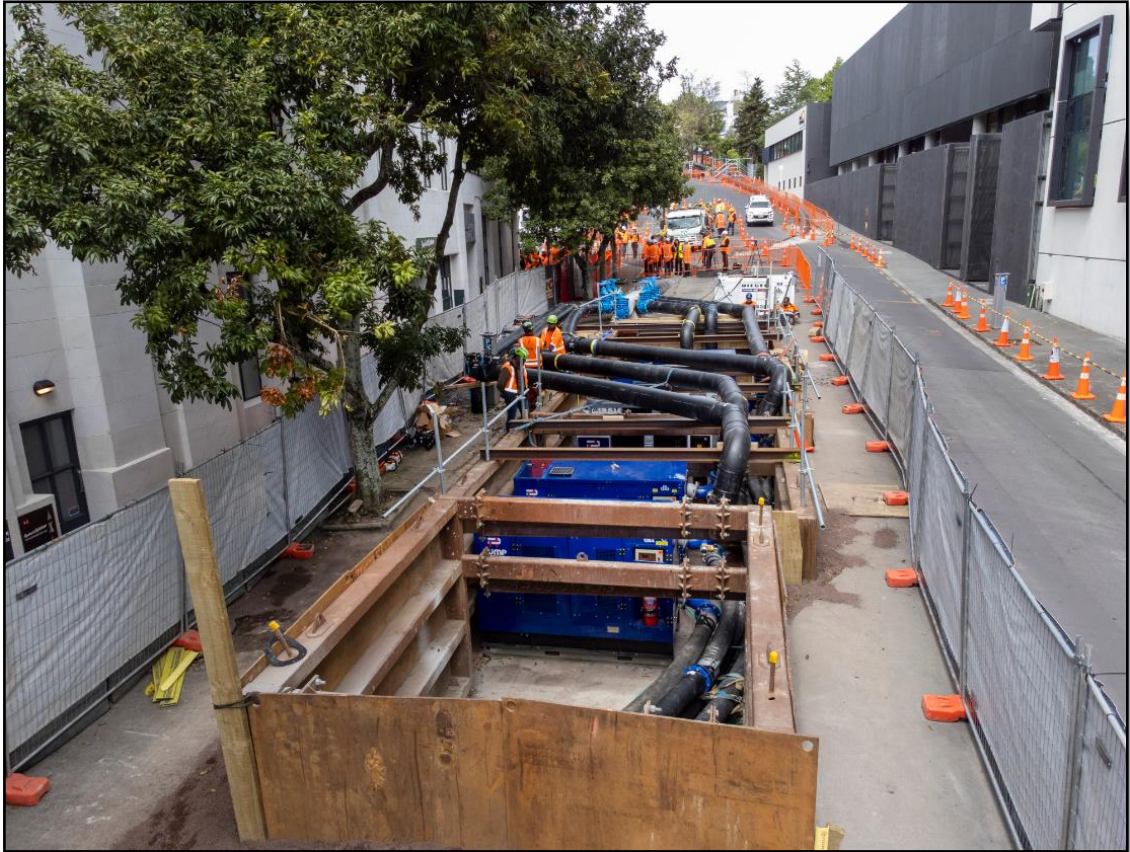
**Figure 7: Diversion pumps installed on St Georges Bay Road.**

In summary, Marshall Day notes that the operation of the generator and 6 diversion pumps produced a steady low frequency hum, with a distinct high-pitched tone at 4 kHz that was noticeable and dominated the noise environment in St Georges Bay Road in the vicinity of the pumps. The assessment indicated that while operational, the diversion pumps would likely be audible at several locations and had the potential to cause disturbance, affect worker concentration and result in sleep disturbance. Flow was restored to the OMS in late October 2023, following which no further nighttime use occurred. Watercare is seeking to authorise this retrospectively. However, no further consent for infringement of noise levels is sought going forward.

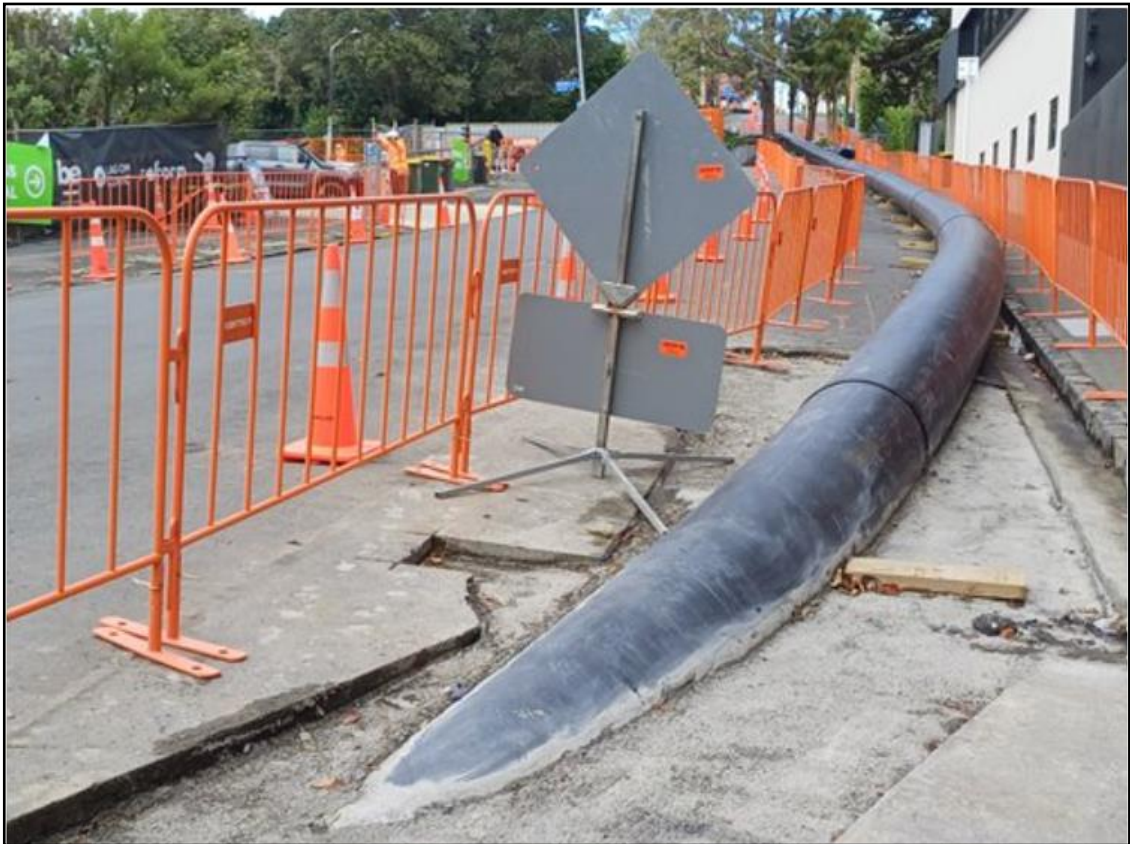
**Figure 8: Diversion pipeline located on the St Georges Bay Road Reserve.**

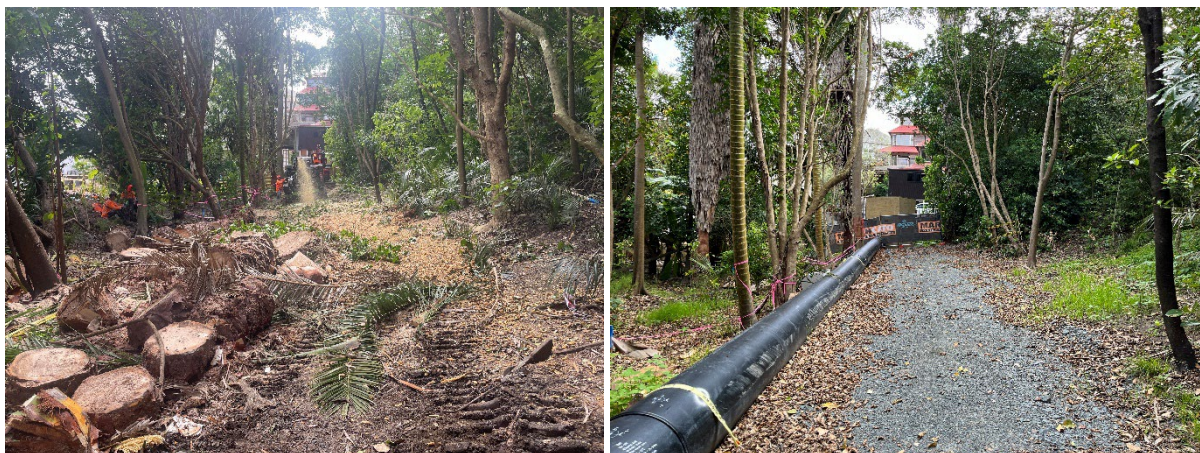
A total of 54 trees were felled within SEA\_T\_6062 as a direct impact of the installation of the WW bypass through Alberon Reserve (Appendix 6, Figure 3). These consisted of 18 native canopy trees including totara (*Podocarpus totara*), puriri (*Vitex lucens*), and nikau (*Rhopalostylis sapida*), and an approximated 20 native subcanopy trees including māhoe (*Melicytus ramiflorus*), and kanuka (*Kunzea ericoides*) with the remaining specimens being introduced species. A complete list of felled specimens is included in Appendix 6. The roots and foliage of various other trees were also pruned and/or damaged (Appendix 6). As this vegetation clearance was required for access, all woody debris and groundcover species were also removed from the ZOI (Figure 3). The total area of vegetation cleared was approximated at 810 sq m (Figure 1).

Figure 3: Vegetation clearance (Left) and temporary accessway and WW diversion (Right).

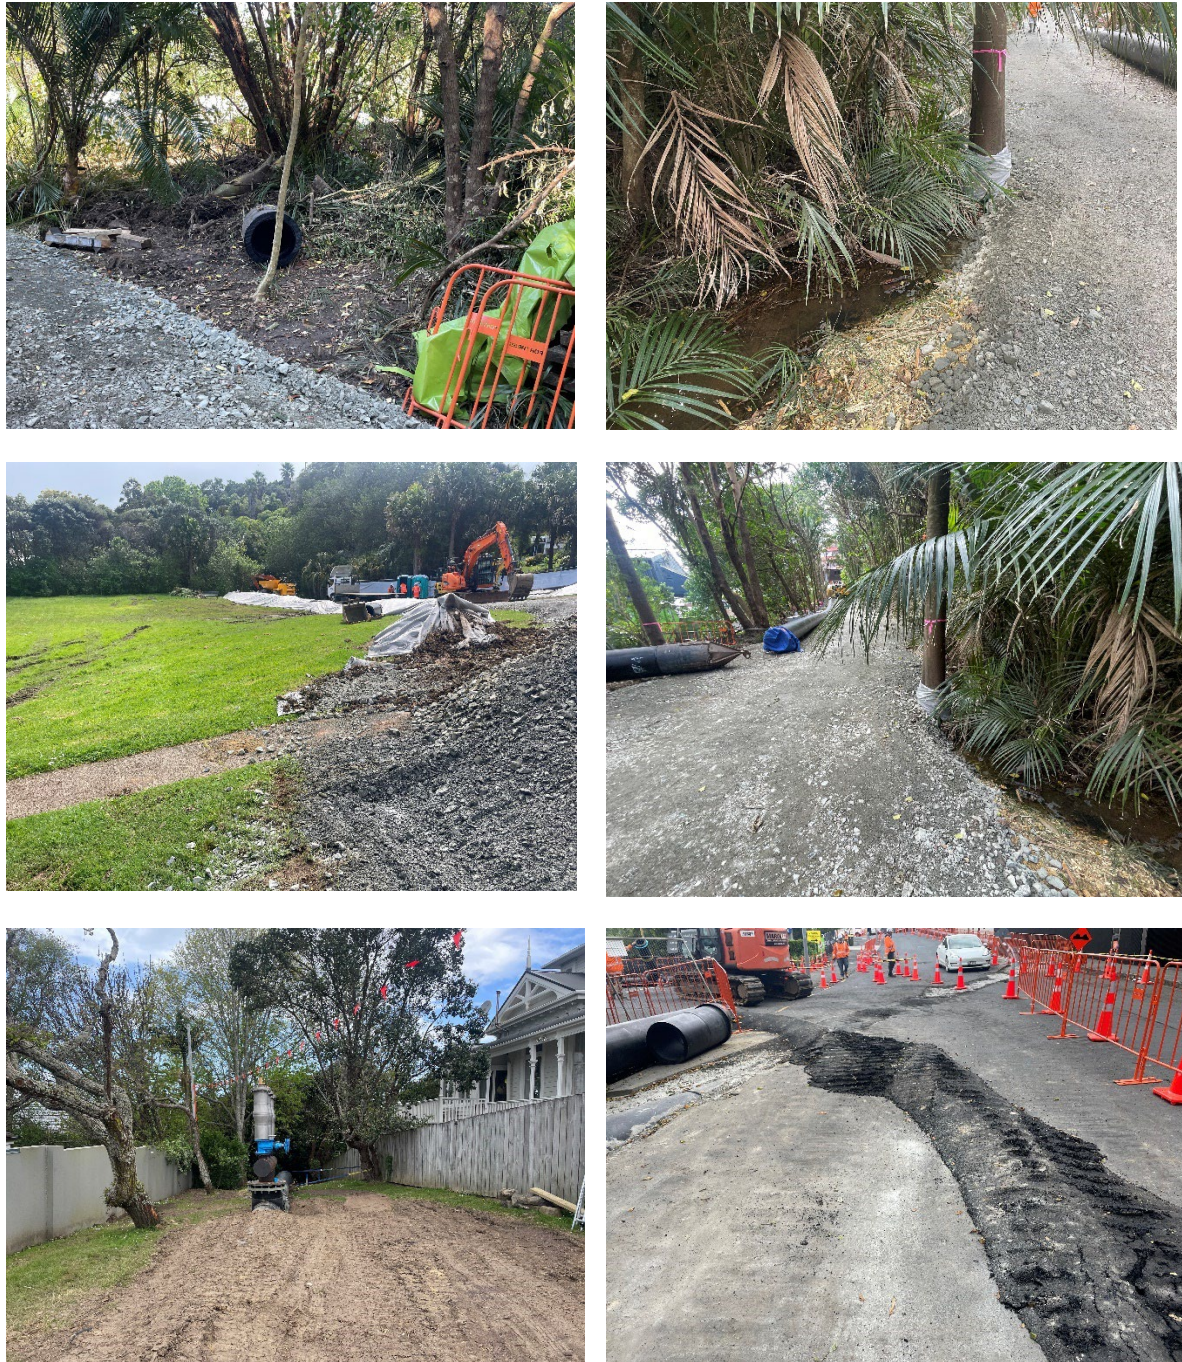
**Figure 1: Photo schedule of erosion and sediment control works required.**

9. It is recommended that a suitably qualified and experienced environmental scientist with ecological and erosion and sediment control experience undertakes fortnightly site inspections of the erosion and sediment controls, overland flow paths, nesting birds, and potential flooding impacts.

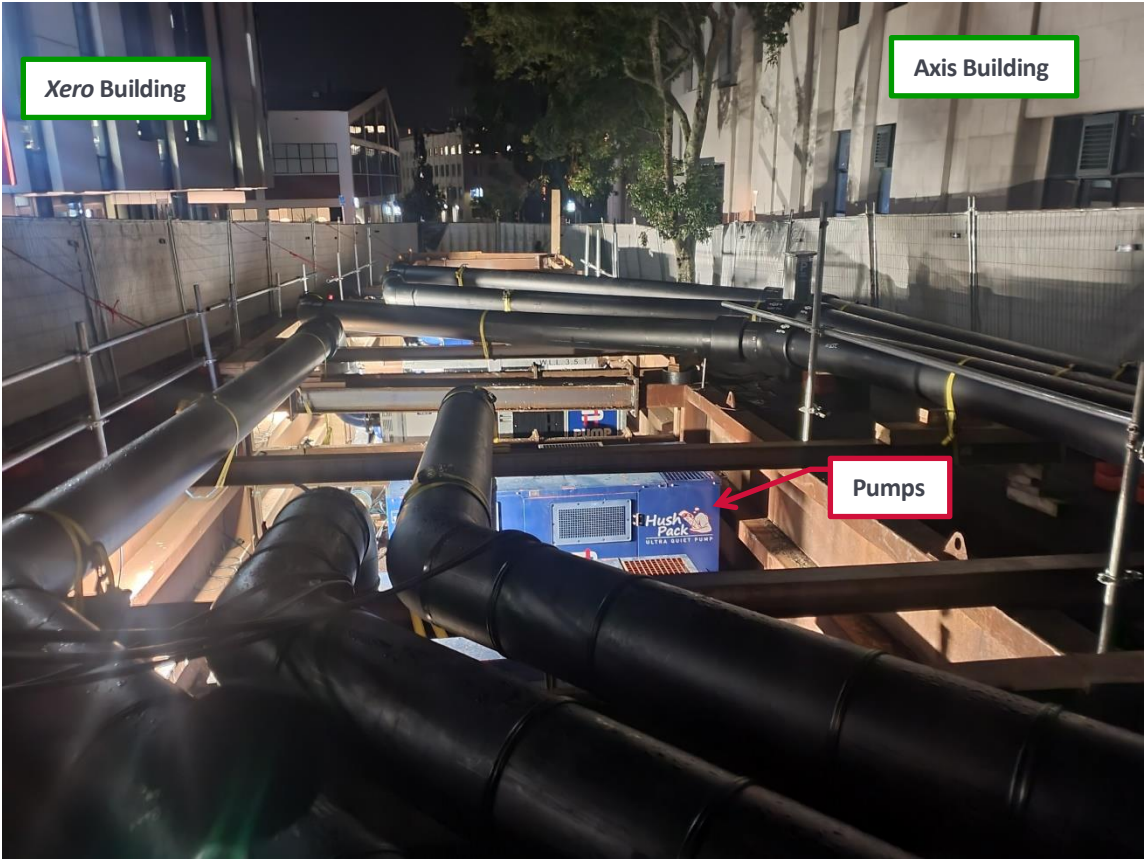
Figure 7: Trench containing six pumps relative to nearest buildings
