Application for Resource Consent

Central Interceptor - Storage Area

NES Soil - Controlled activity resource consent application and AEE

44 and 54 Greenwood Road, Mangere

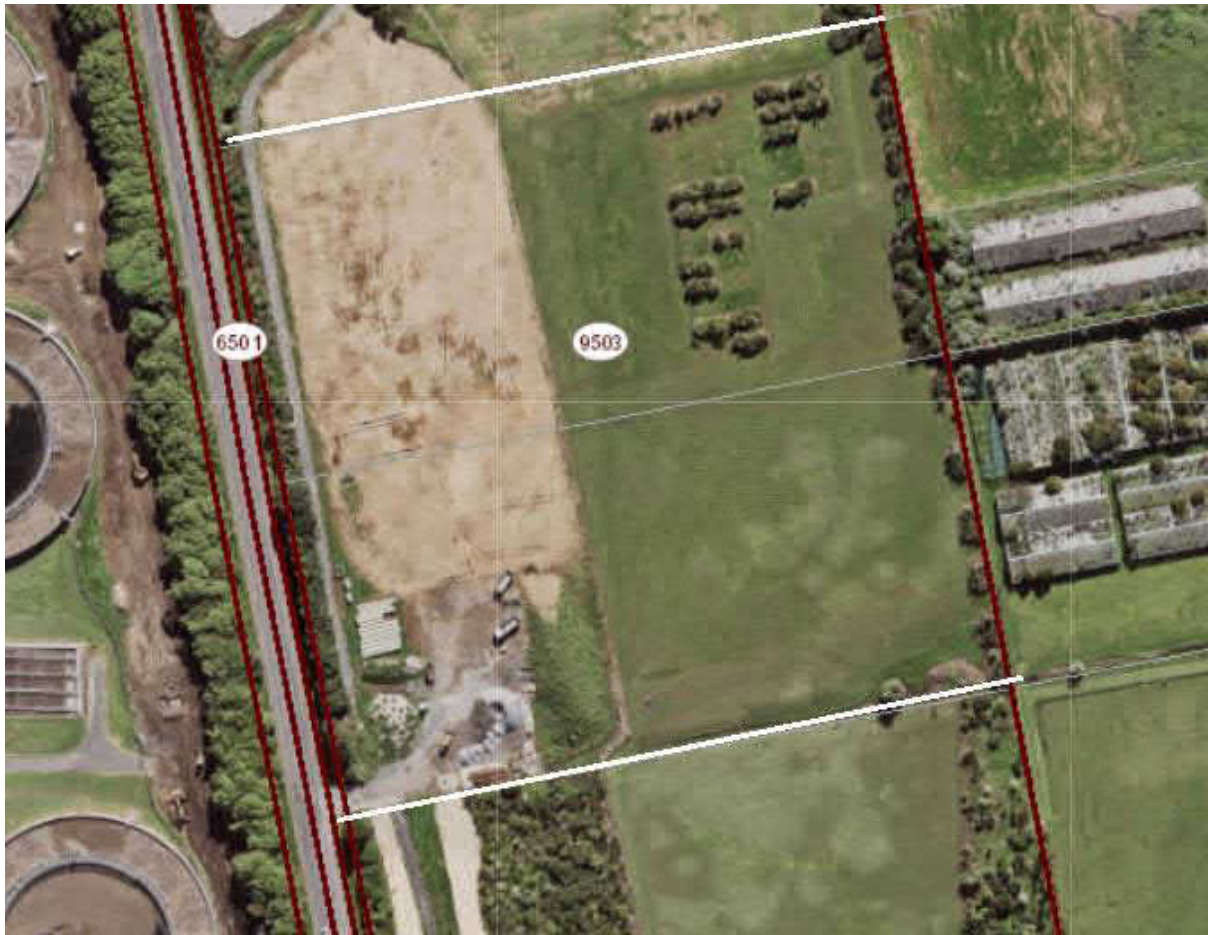
Figure 2.1: 'Area 2' of Designation 9503 (approximate site boundary in white). (Source: Auckland Council Geo Maps, 2020).

Construction materials are proposed to be stored at a site located at 44 and 54 Greenwood Road, Mangere Bridge. The site is located to the east of Watercare's Mangere Resource Recovery Facility (RRF) and is recognised as 'Area 2' in designation 9503 (see Figures 2.1 and 2.2 below).

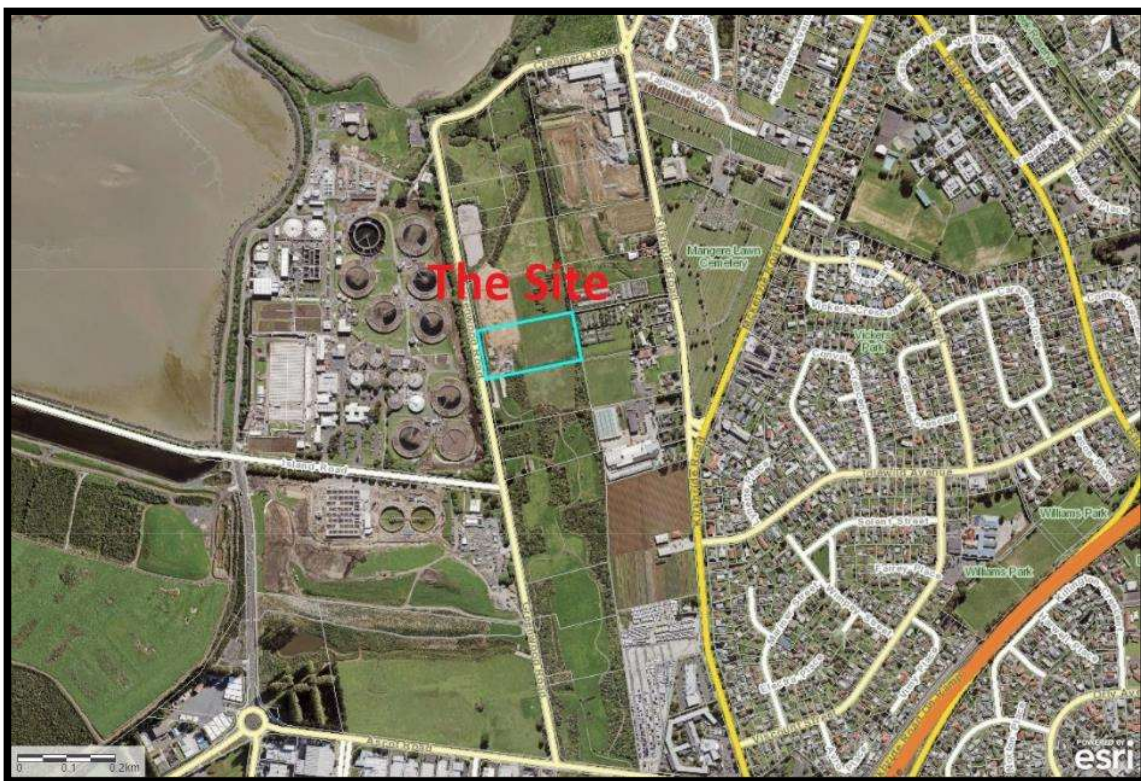
Figure 1: Site Location Plan

The overall site is located at 54 Greenwood Road, Mangere. Figure 1 shows the site location plan.

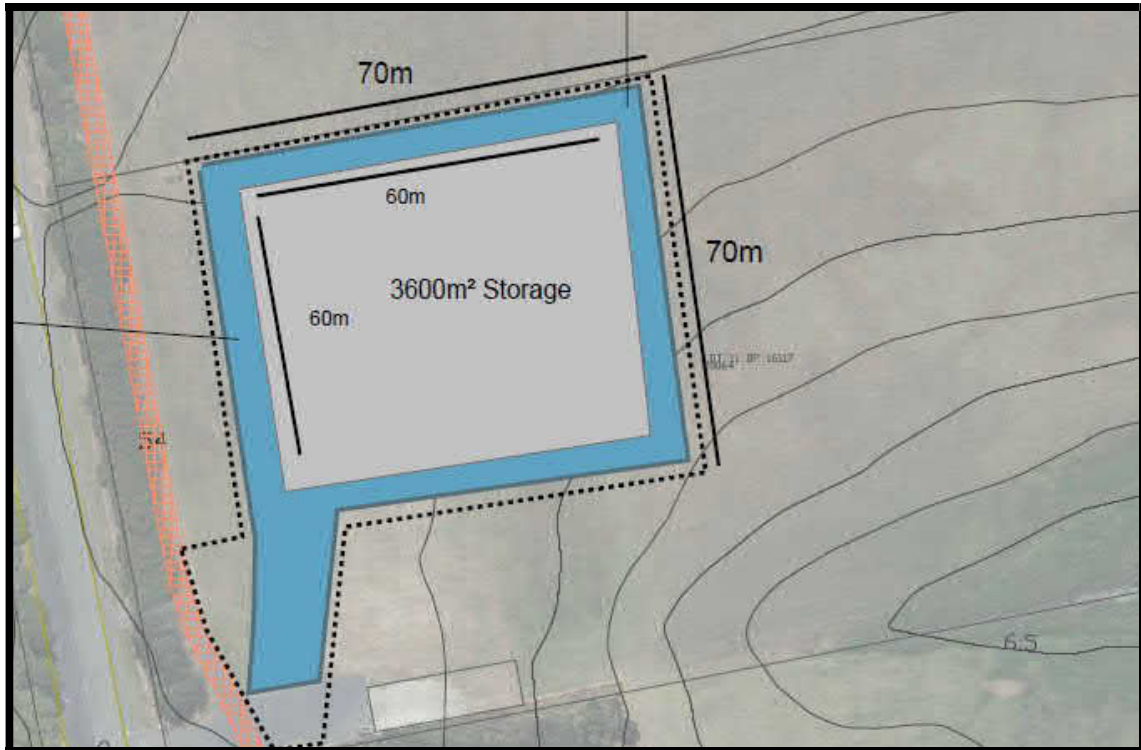
Figure 3: The 'piece of land' subject to the investigation.

The current plans for the site development are included in Appendix 1. The site is planned to be used as a basalt rock storage yard. This portion of the site where the site works are proposed to take place is the 'piece of land' subject to this investigation and is highlighted in Figure 3 below. The 'piece of land' is estimated to cover 4,900 m² of site as a whole, of which 1,400 m² will involve topsoil stripping to enable construction of a haul road for access. The 3,600 m² basalt rock storage area will be underlain with geotextile fabric, however the topsoil will not be stripped in this area. The earthworks volume proposed for these activities is estimated at 210 m³ of topsoil stripping for the haul road.

It should be noted that, for the purposes of this investigation, the 'piece of land' subject to this investigation is considered to be that area of the site where the HAIL activities are 'more likely than not' suspected to have occurred.

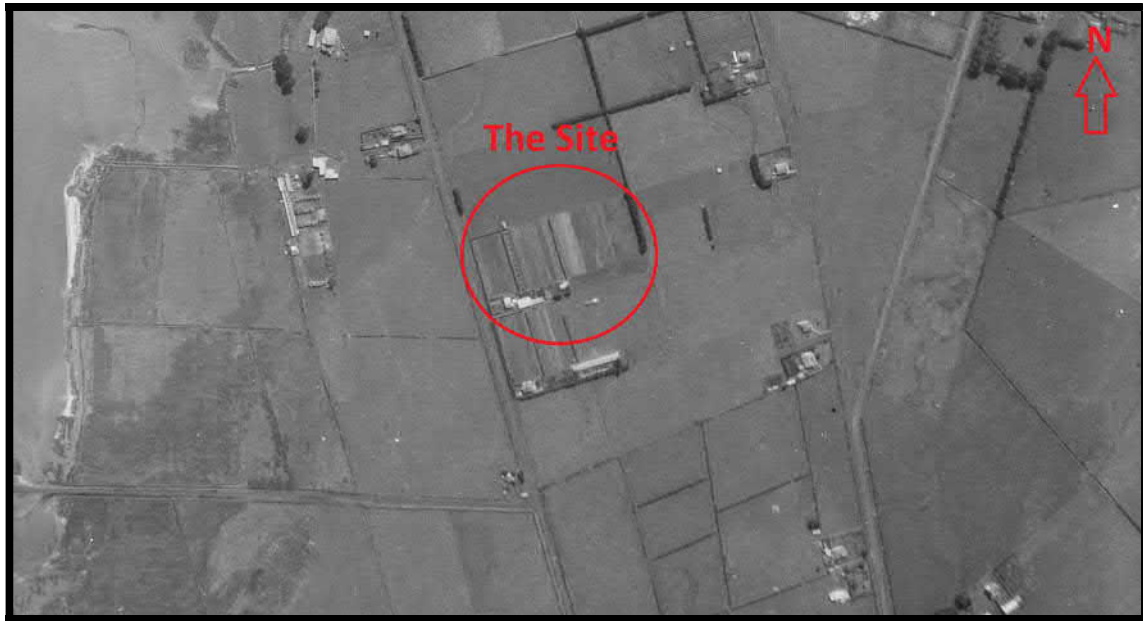
1940 – The site is a HAIL site with horticultural activities being undertaken there, with associated site buildings. The MWWTP is mostly undeveloped, and the land reclaimed from the sea.

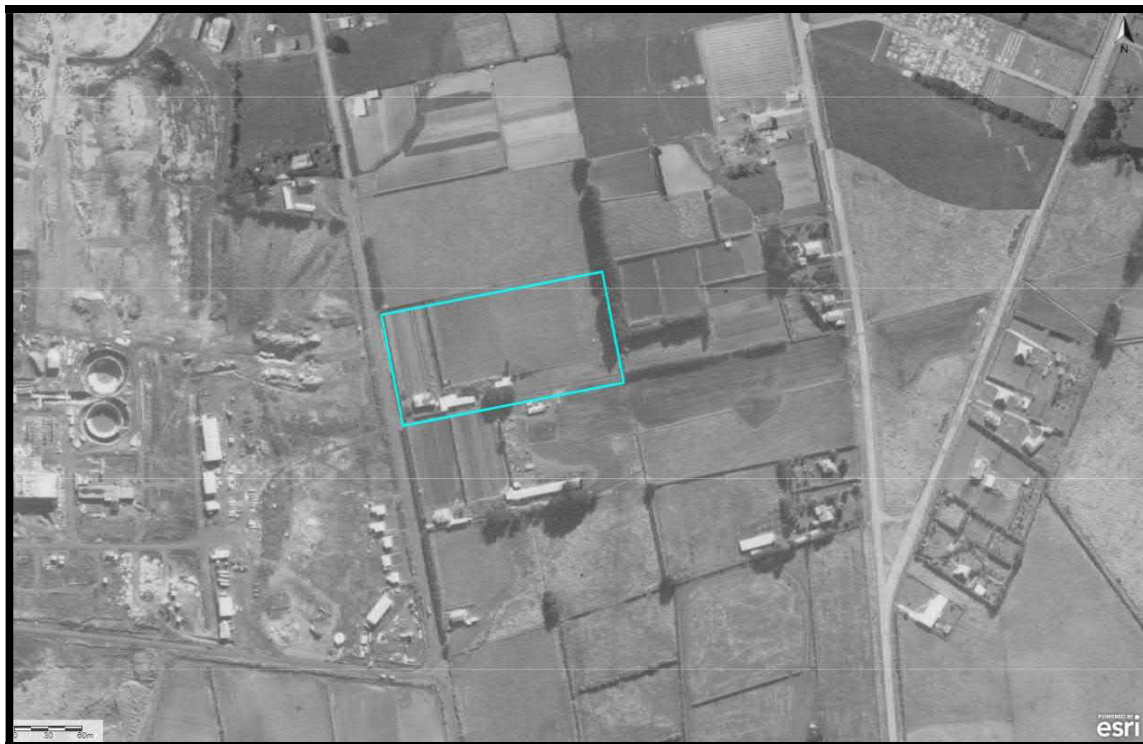
1959 – Horticultural activities (HAIL) are still present at the site. The surrounding land is more developed with more horticulture present. To the west, MWWTP is undergoing extensive earthworks.

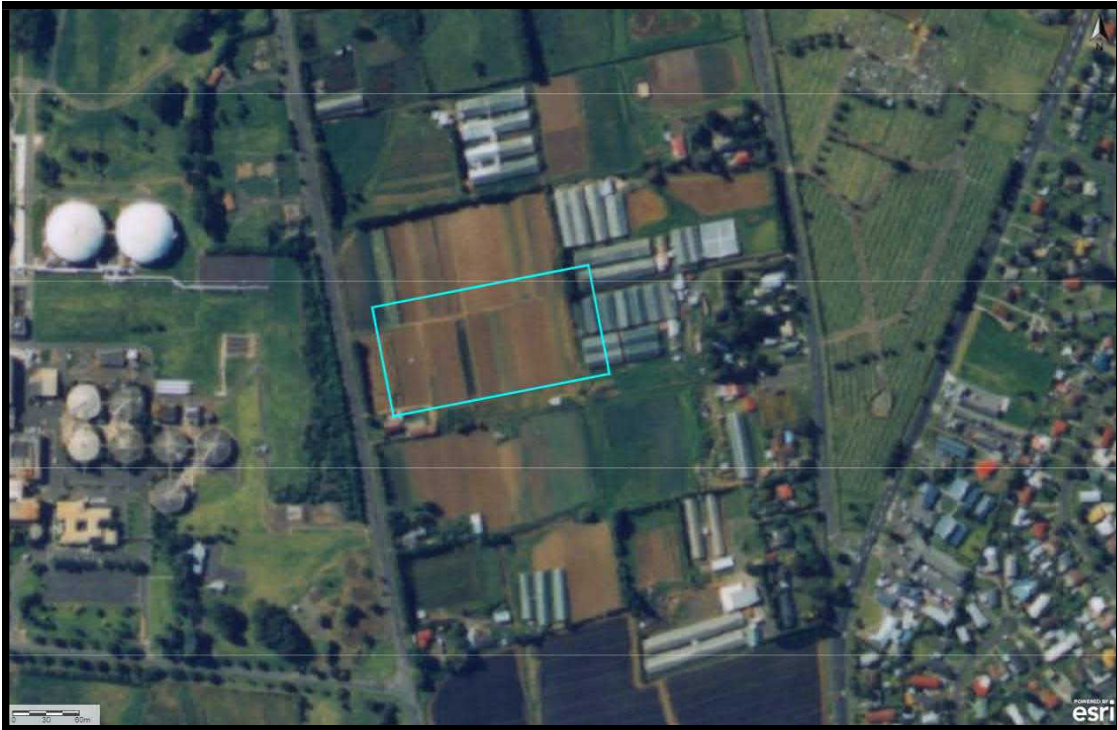
1996 – Horticultural activities (HAIL) are stil being undertaken at the site and in neighbouring properties to the north, east and south.

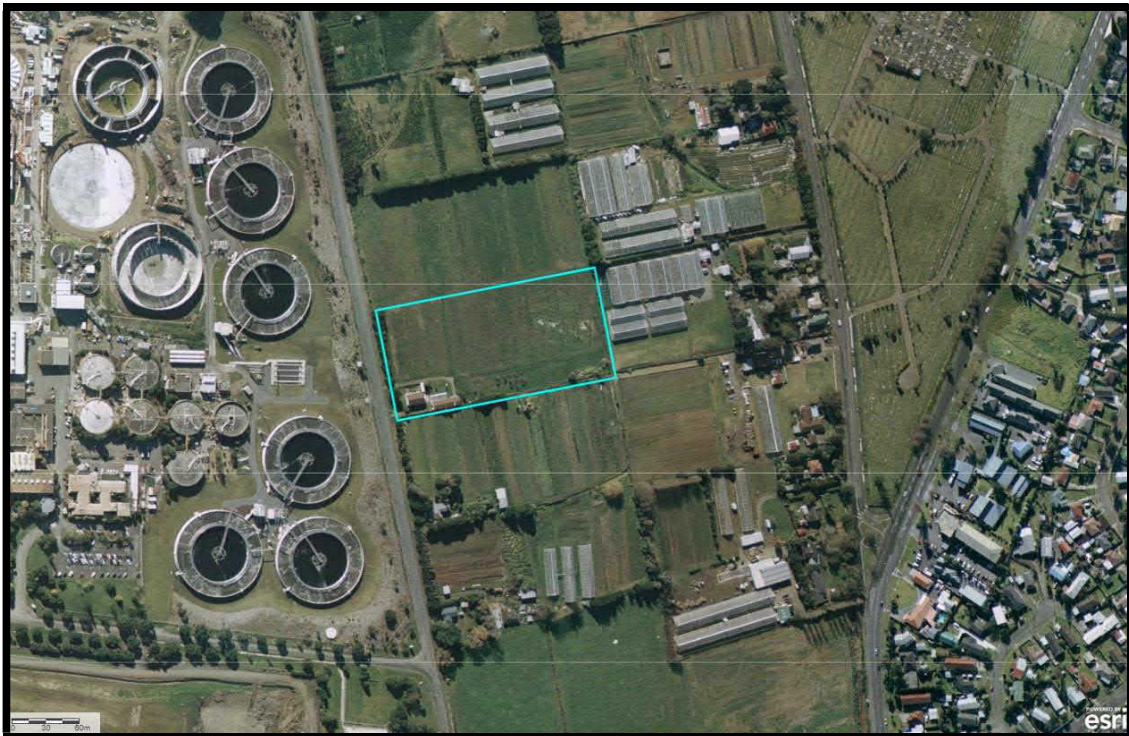
2001 – Horticultural activities appear to have ceased at the site. MWWTP has been developed further.

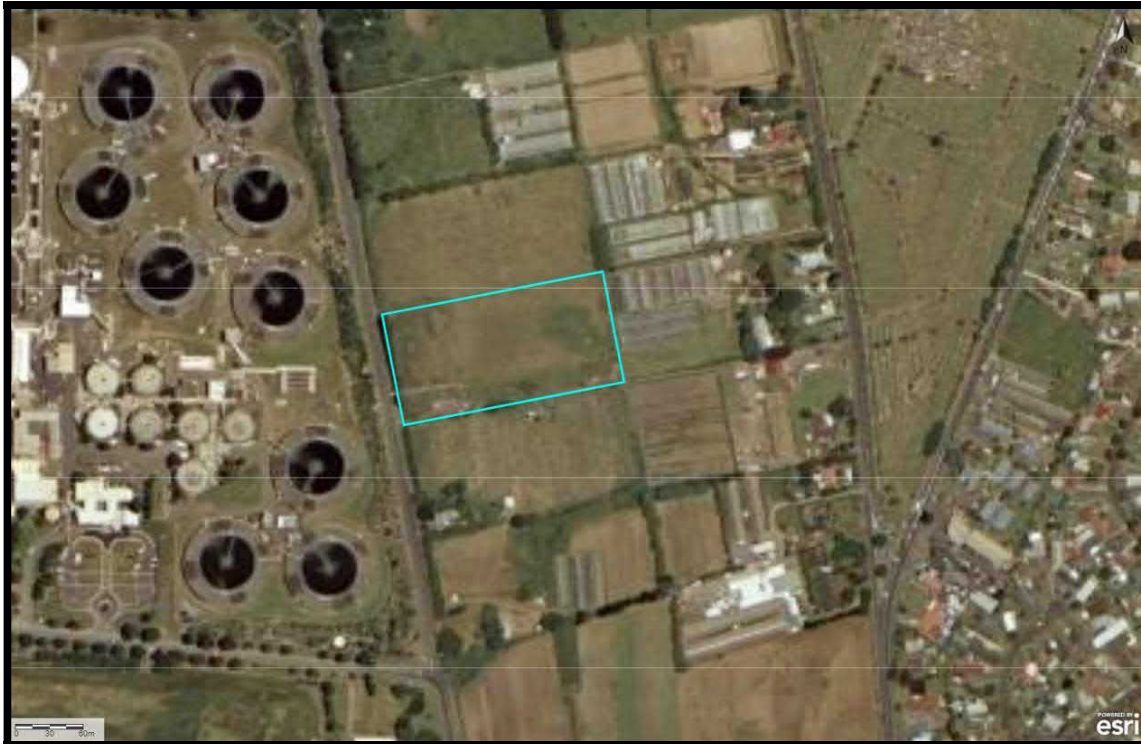
2003 – It appears that the buildings have been removed from the site, though the image is blurry.

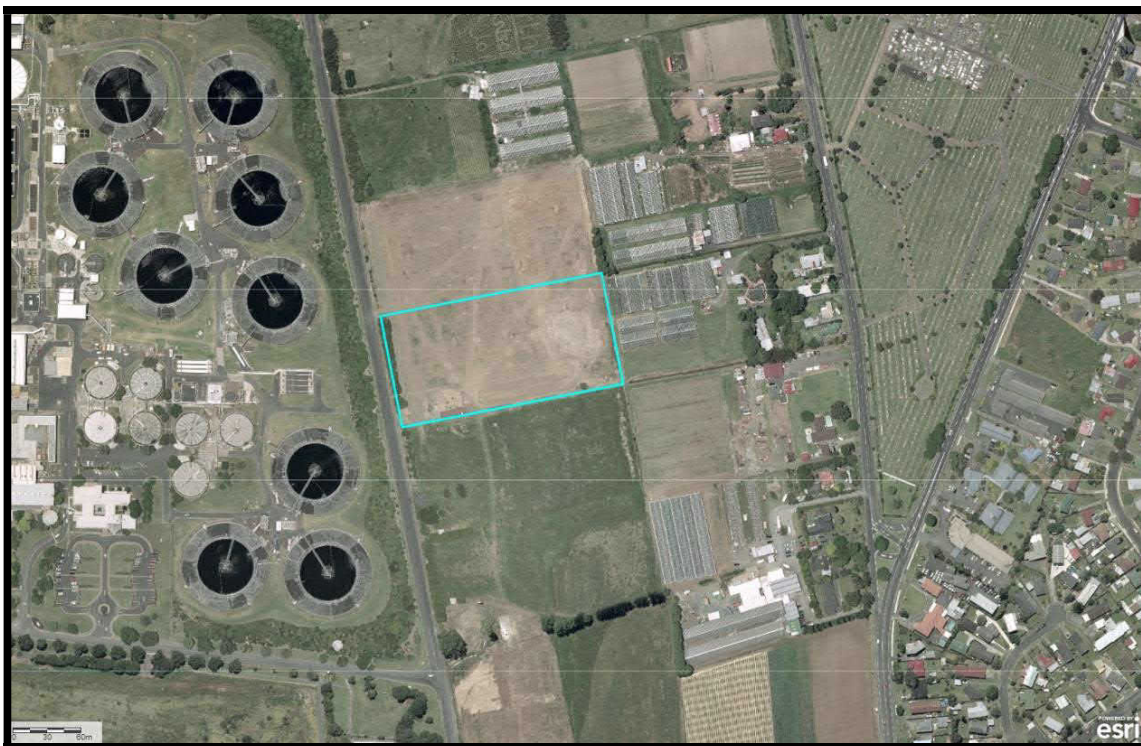
2006 – It appears that the site and its neighbouring site have been ploughed over, potentially mixing and blending surface soil contaminants.

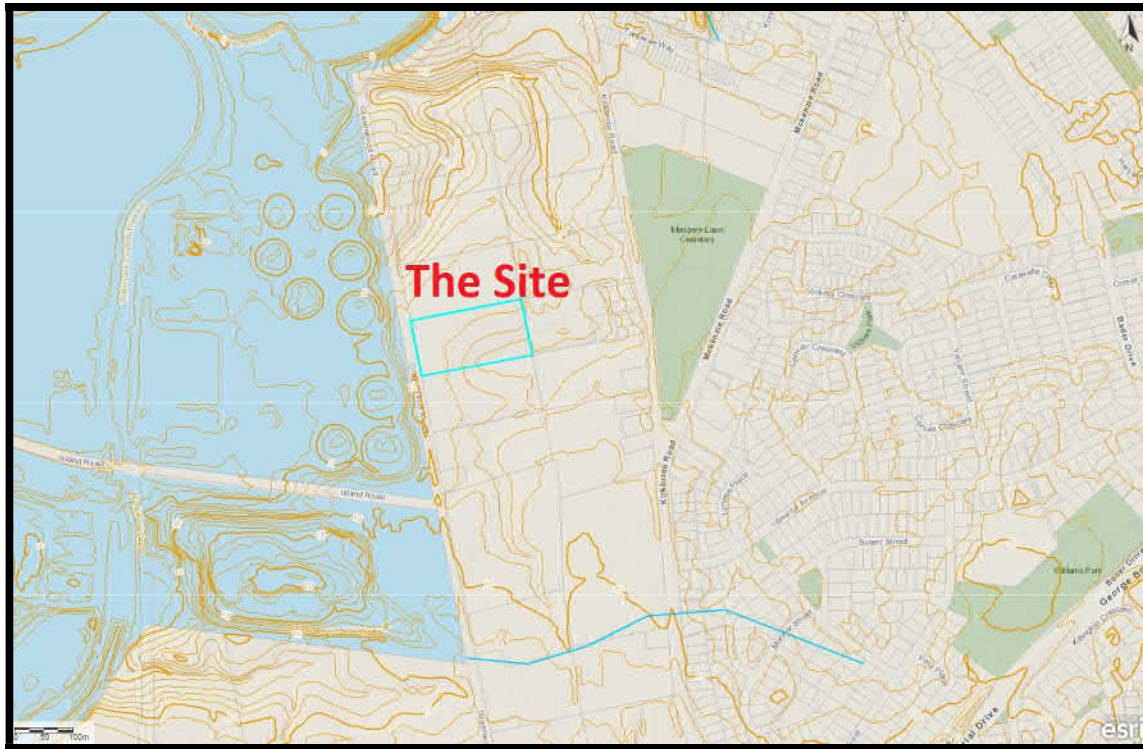
Figure 5: Site Topography

The site itself is generally flat with some undulations, and an elevation of approximately 9 m above sea level. The contours and hydrology of the site and area surrounding the site are presented in Figure 5¹⁹ below.

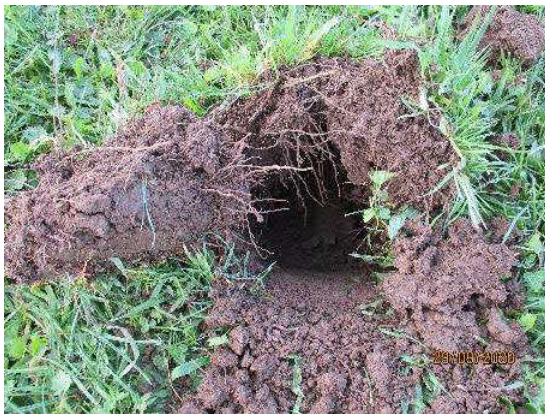
Seven surface topsoil samples were taken from the top 0.15m of the proposed site. The site was observed to be completely grassed over and in tidy condition on the day of the inspection and sampling round. At the site entrance a concrete building platform was observed to be present but the buildings had been removed from the site previously, and may have contained asbestos in the building materials. The weather was blustery and the ground surface was wet with pools of water present on the day of the walkover.

Image 1: The topsoil at the site was sampled

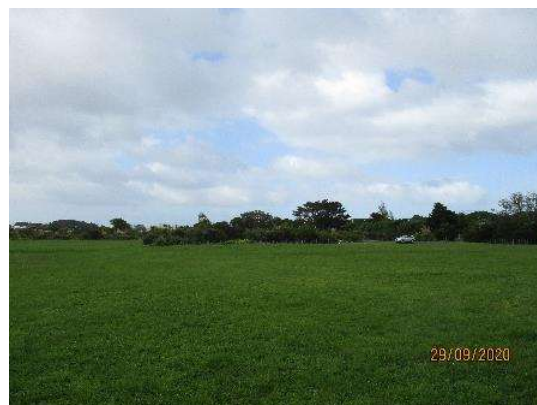
Image 4: The site surface was grassed over

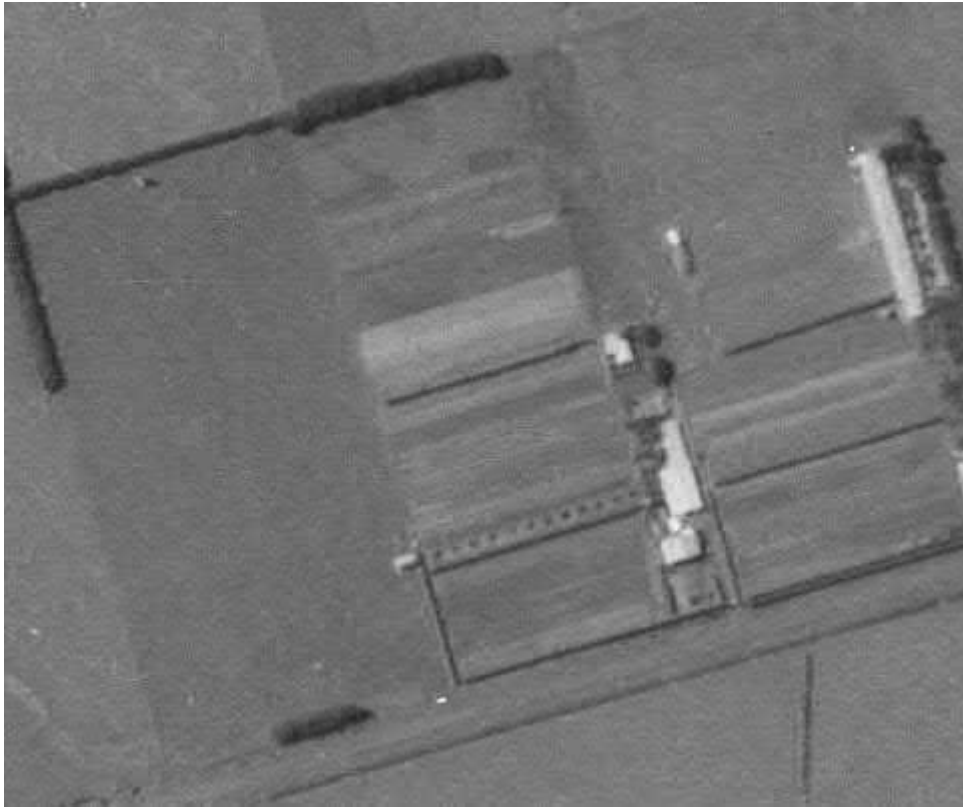
Records indicate the site 54 Greenwood Road, Mangere Bridge, has been utilised for historical horticultural activity. This was undertaken as early as 1940 which is visible in the aerial below. This activity is still visible in aerials from 1996.

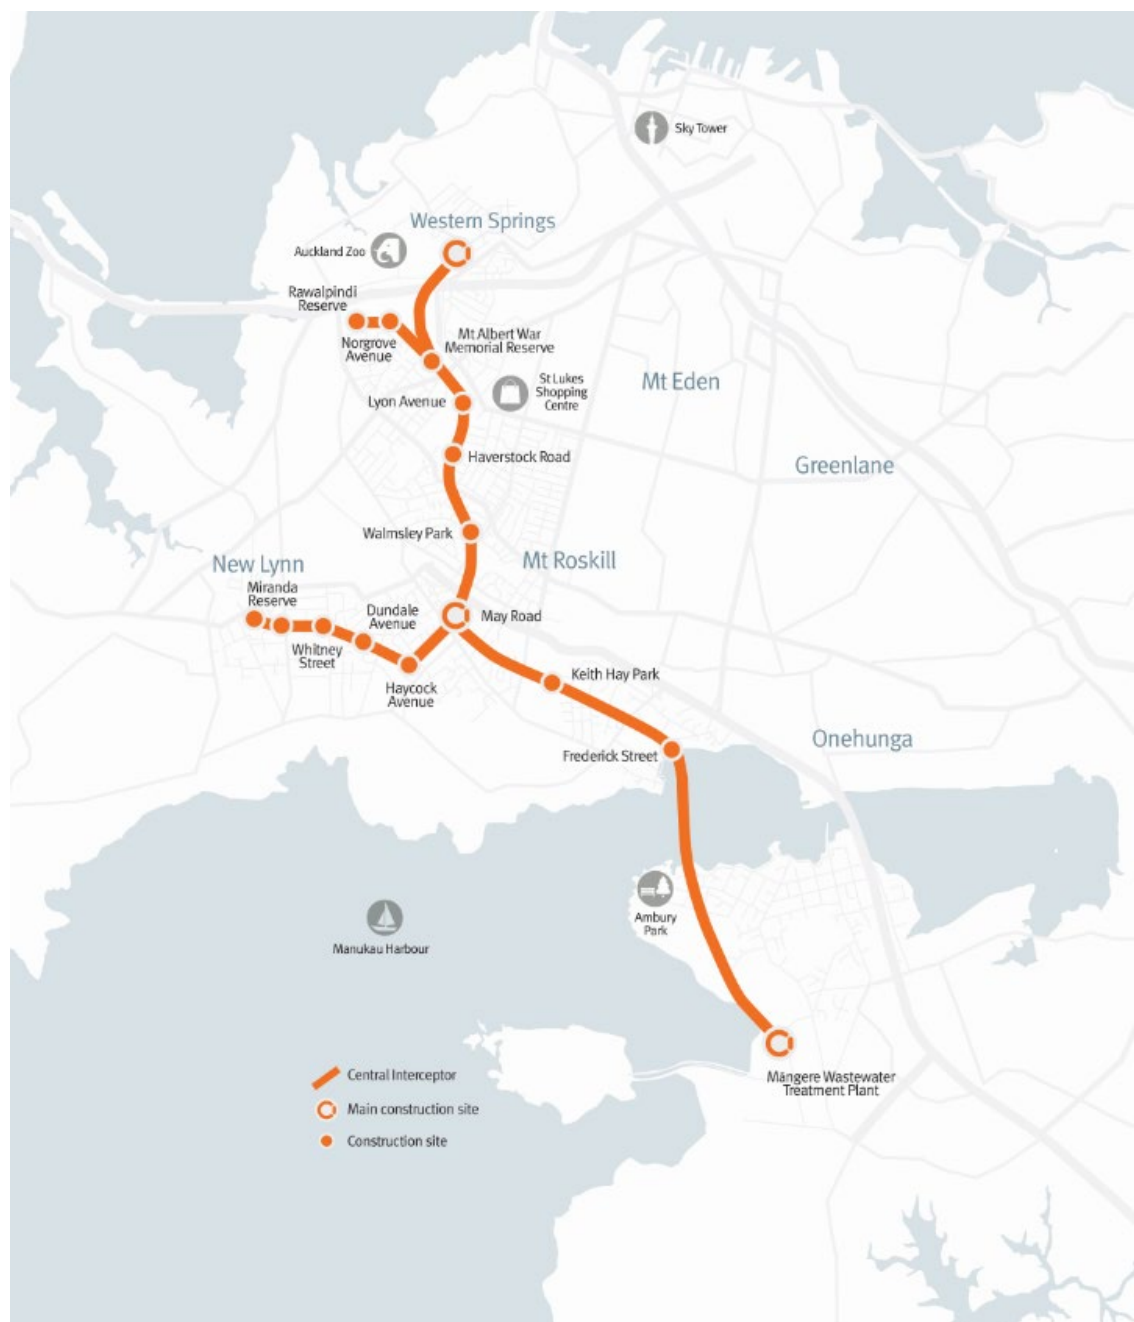
Figure 2: Central Interceptor project alignment and shaft sites

The Central Interceptor main project works involve the construction and commissioning of a bulk wastewater interceptor and associated activities. In summary, the Project involves constructing a 13 km gravity sewer tunnel with two link sewer tunnels extending from the main tunnel westward, a series of connections to the existing trunk sewer network to pick up wastewater flow, and a new pump station at the Māngere WWTP. Figure 2 provides a general location plan.

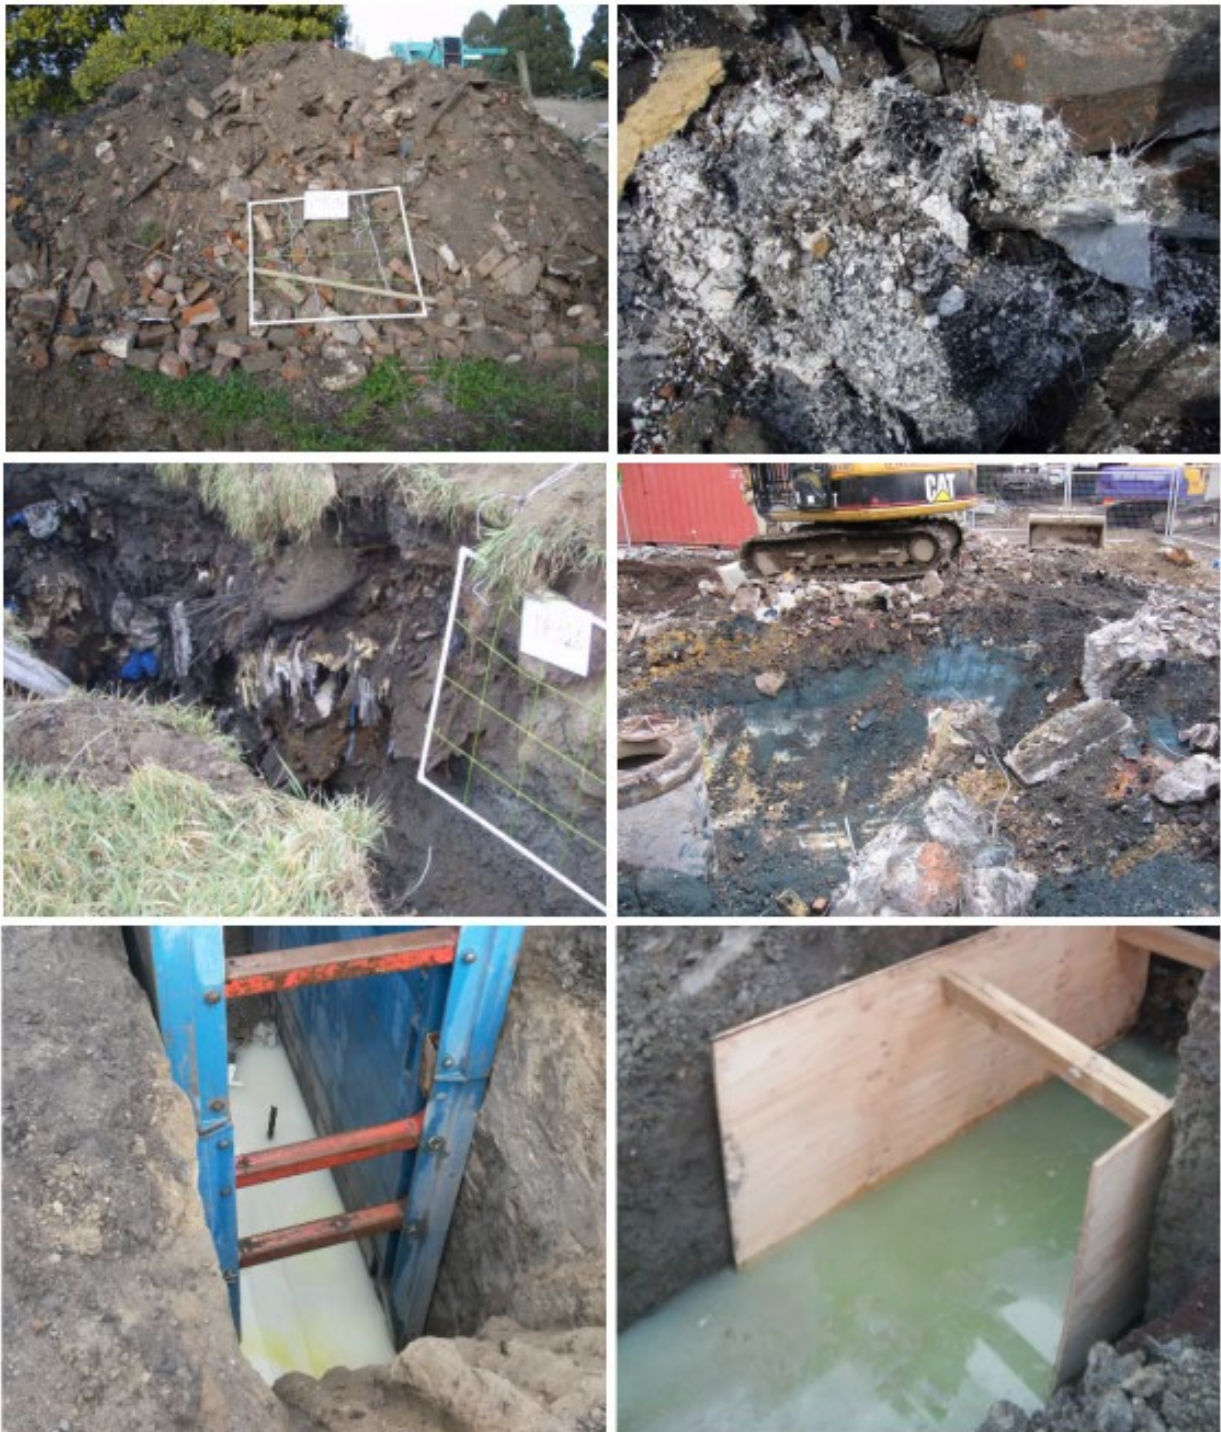
Figure 3: Contamination photos, clockwise from top left: excavated construction rubble; excavated potential ACM; 'blue billy' cyanide staining beneath concrete; green stained groundwater; white stained groundwater; municipal waste filling.

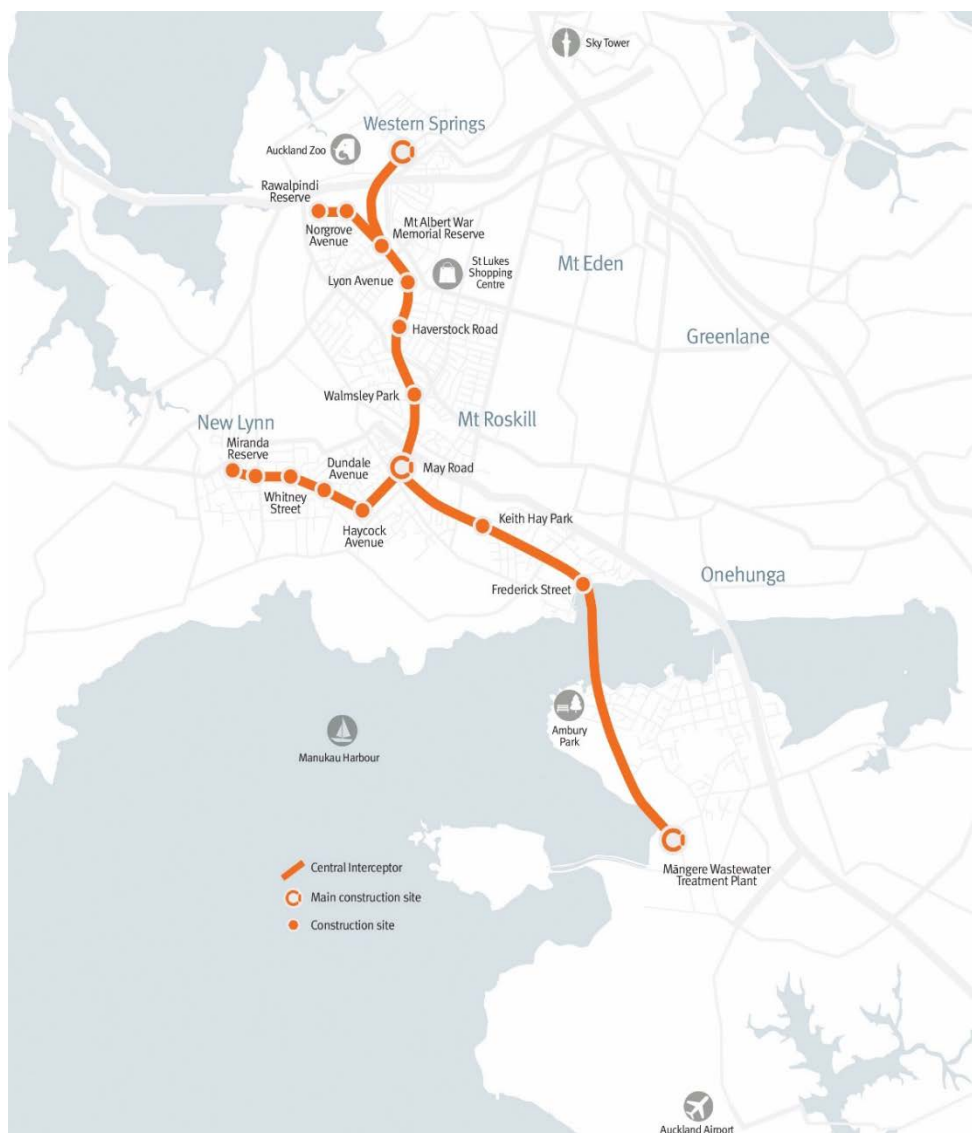
Figure 1: Central Interceptor alignment

The Māngere Pump Station site is the southern-most of the 16 shafts sites on the main tunnel alignment and will connect the Central Interceptor to the Māngere WWTP (refer to figure 1 below).

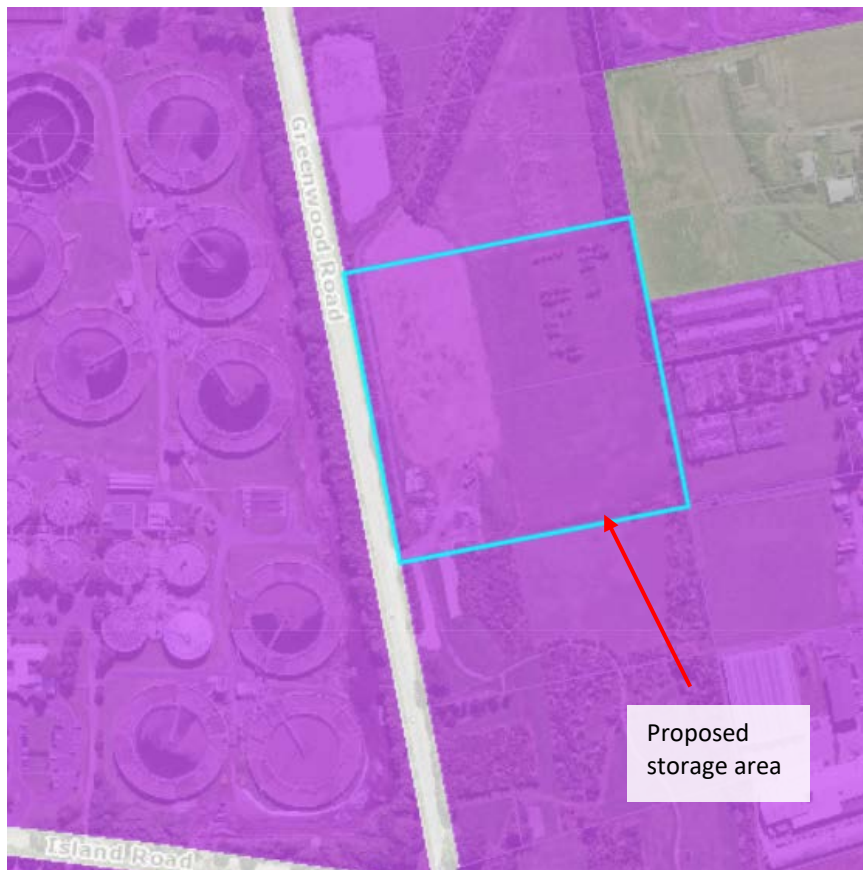
Figure 9: Unitary Plan Zones

Under the AUP, the site is located in the Business Light Industry Zone and is not subject to any overlays. Rules for activities within the Business Light Industry Zone are set out in Chapter H17.
