Land Contamination Assessment

May Road Development

Prepared for May 1 Limited

Prepared by Beca Limited

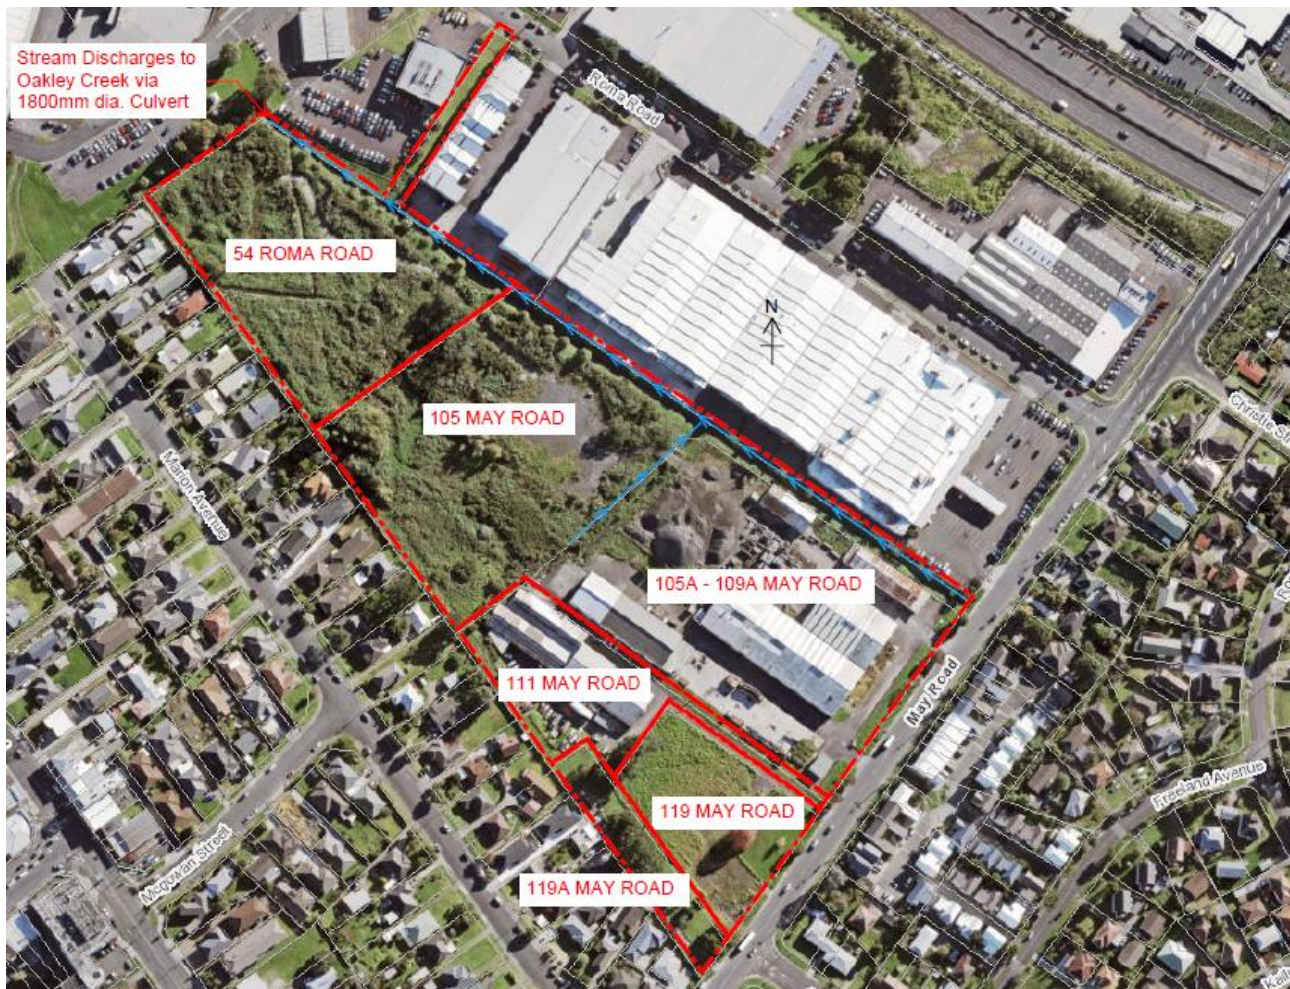
Figure 3: Site Parcels (red) and Main Drainage Channels (dashed blue) (Image Source: Nearmap Australia Pty Ltd)

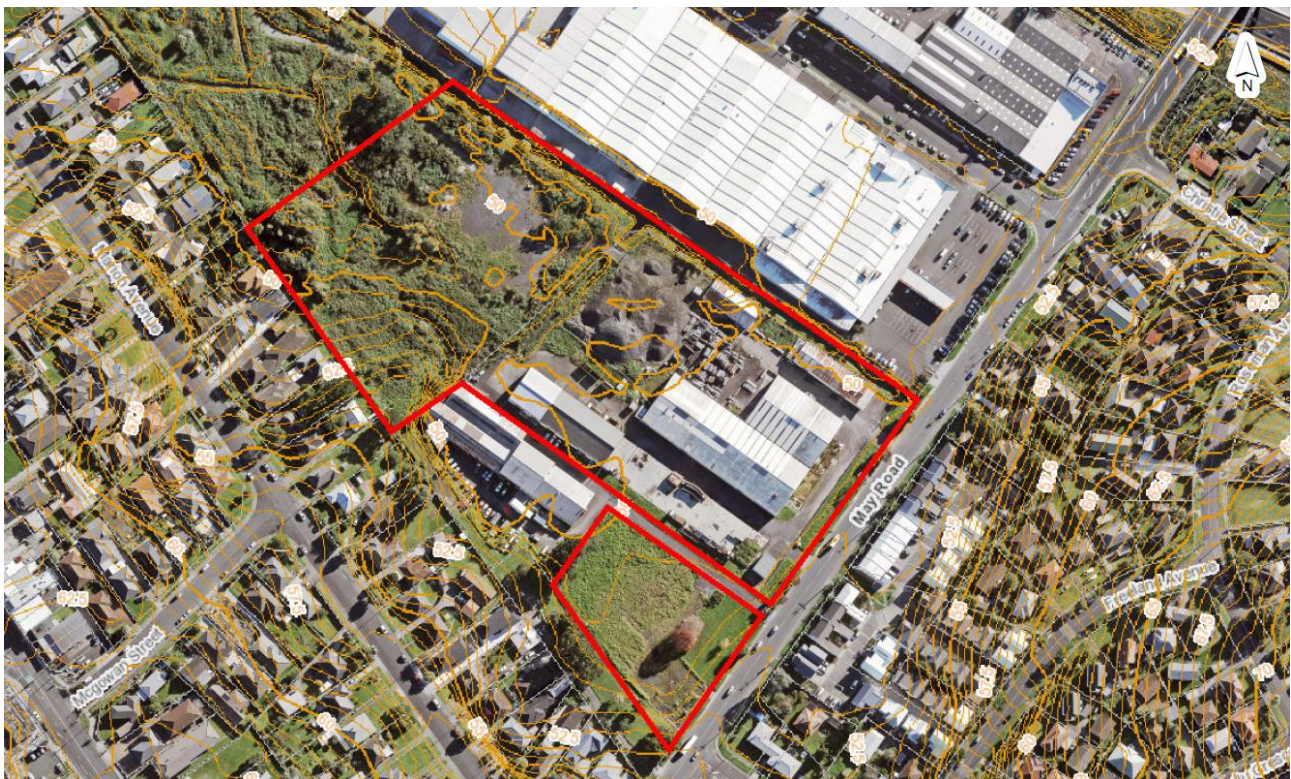
The topography of the Site is relatively flat between elevations of 49 and 51 mRL, and rises gently to the west, with a low-lying area in the north-western corner of the 105 property. A plan showing the topography of the Site is included as Figure 4. The summit of Pukewīwī/Puketāpapa/Mount Roskill, with an elevation of 110 mRL is located approximately 400 m to the east of the Site.

Figure 4: Site Topography (Image Source: Auckland Council GIS Viewer)

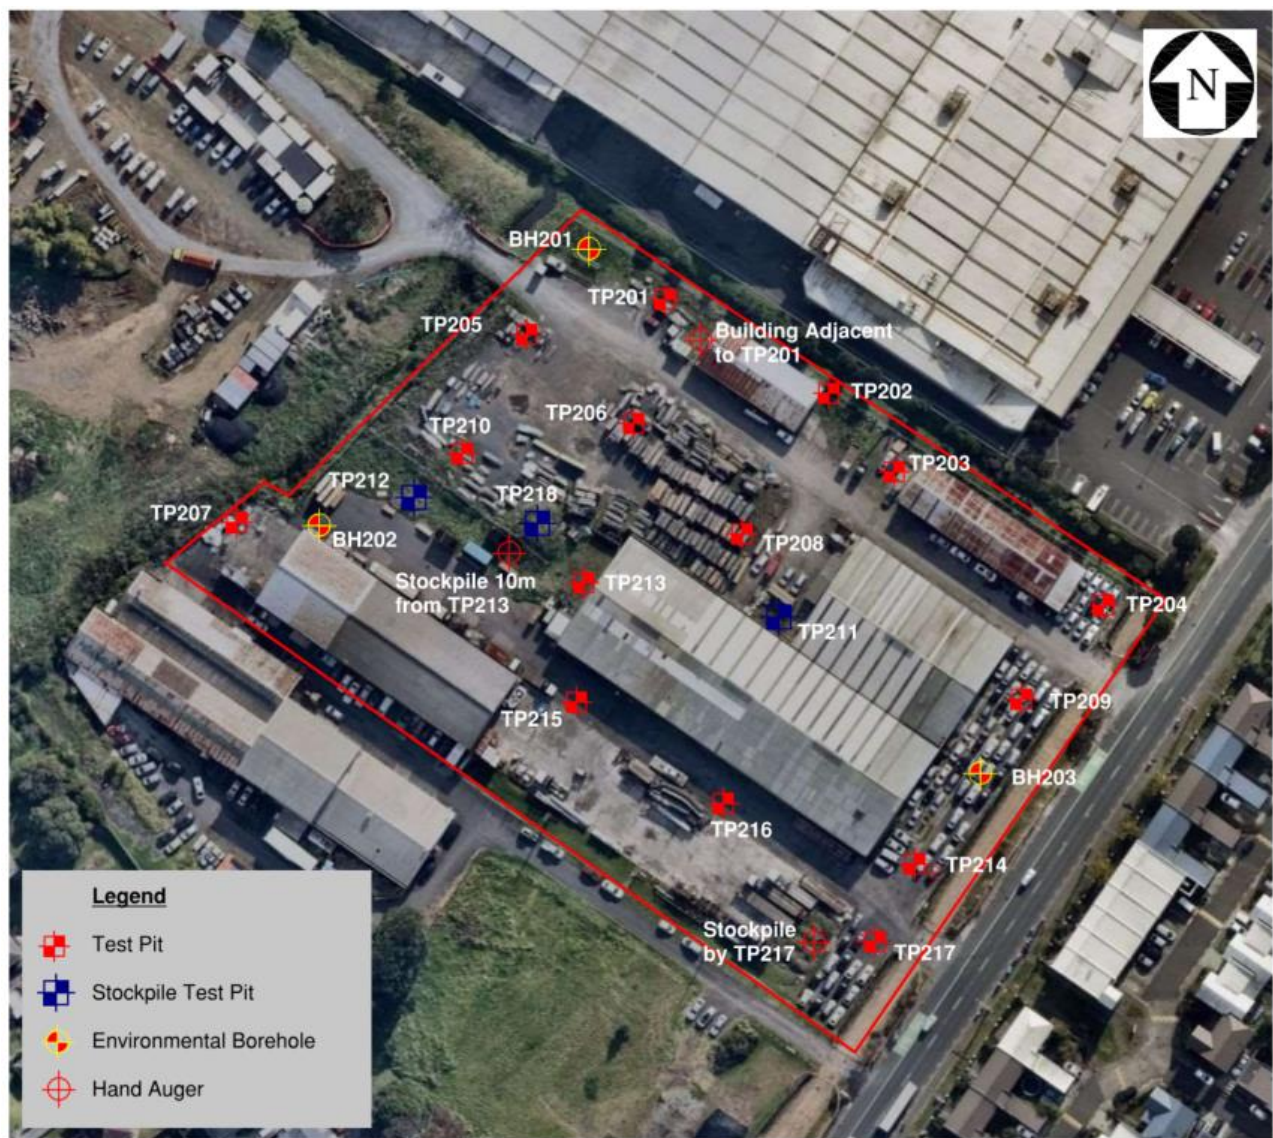
The investigation was undertaken between 19 October and 9 November 2020. Soil samples were collected from 34 test pits, 3 boreholes, and 3 hand augers. Three groundwater samples were collected from the three installed boreholes. Test pits were excavated using a 15 tonne excavator and boreholes were drilled using a sonic drill rig. Site Investigation Plans are included as Figure 7 and Figure 8.

Figure 7: 105A-109A May Road Exploratory Hole Plan. Image Source: NearMap

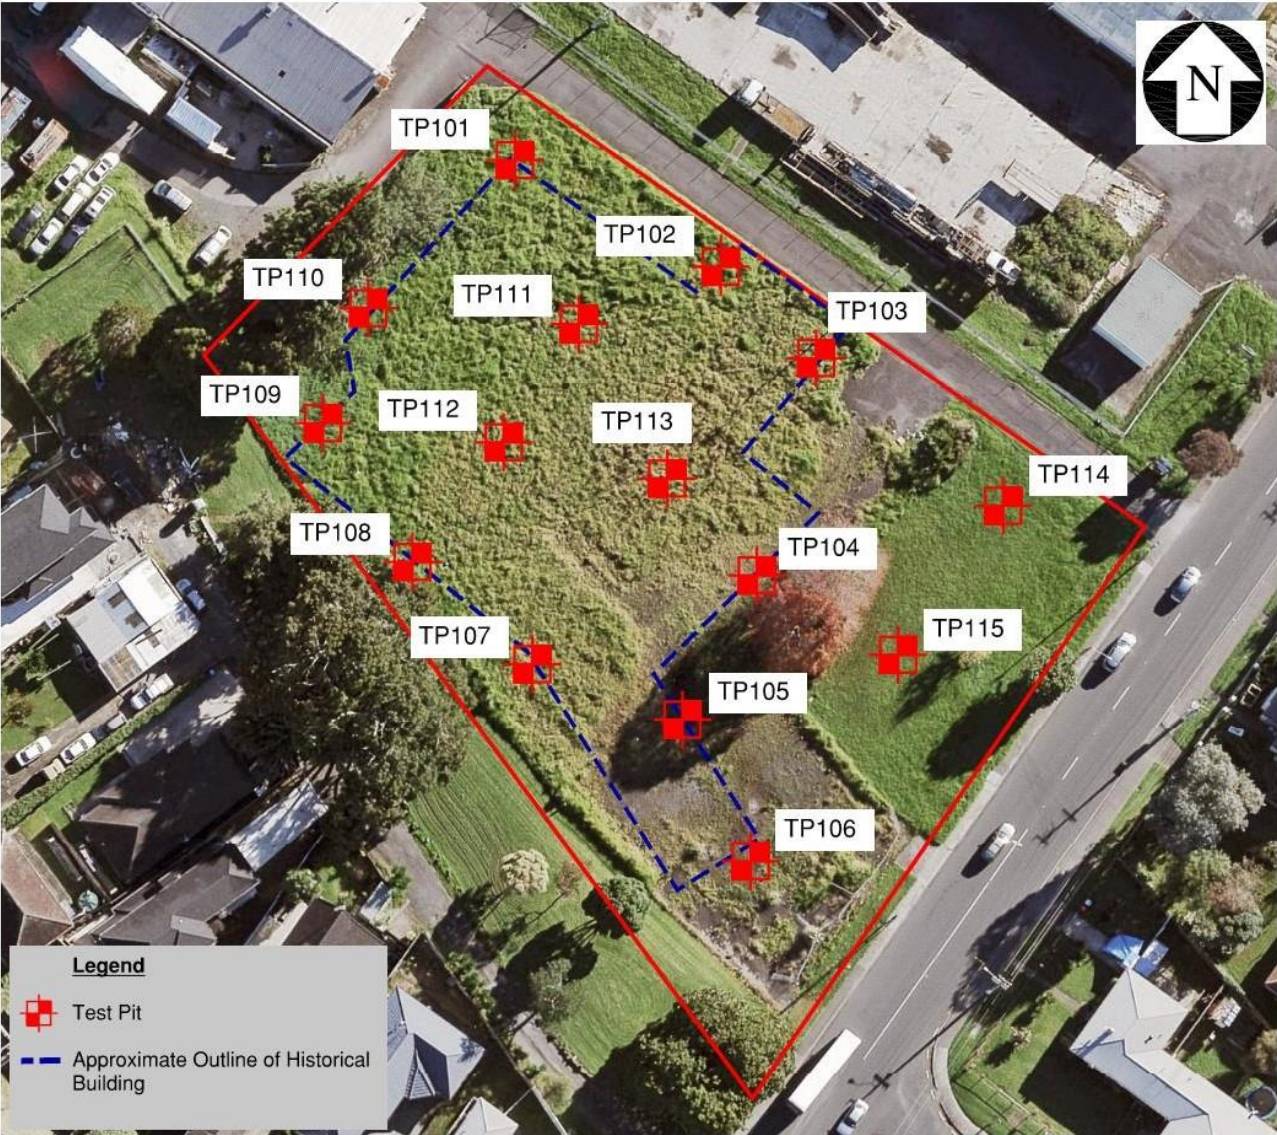
Figure 8: 119 May Road Exploratory Hole Plan. Image Source: AC GeoMaps

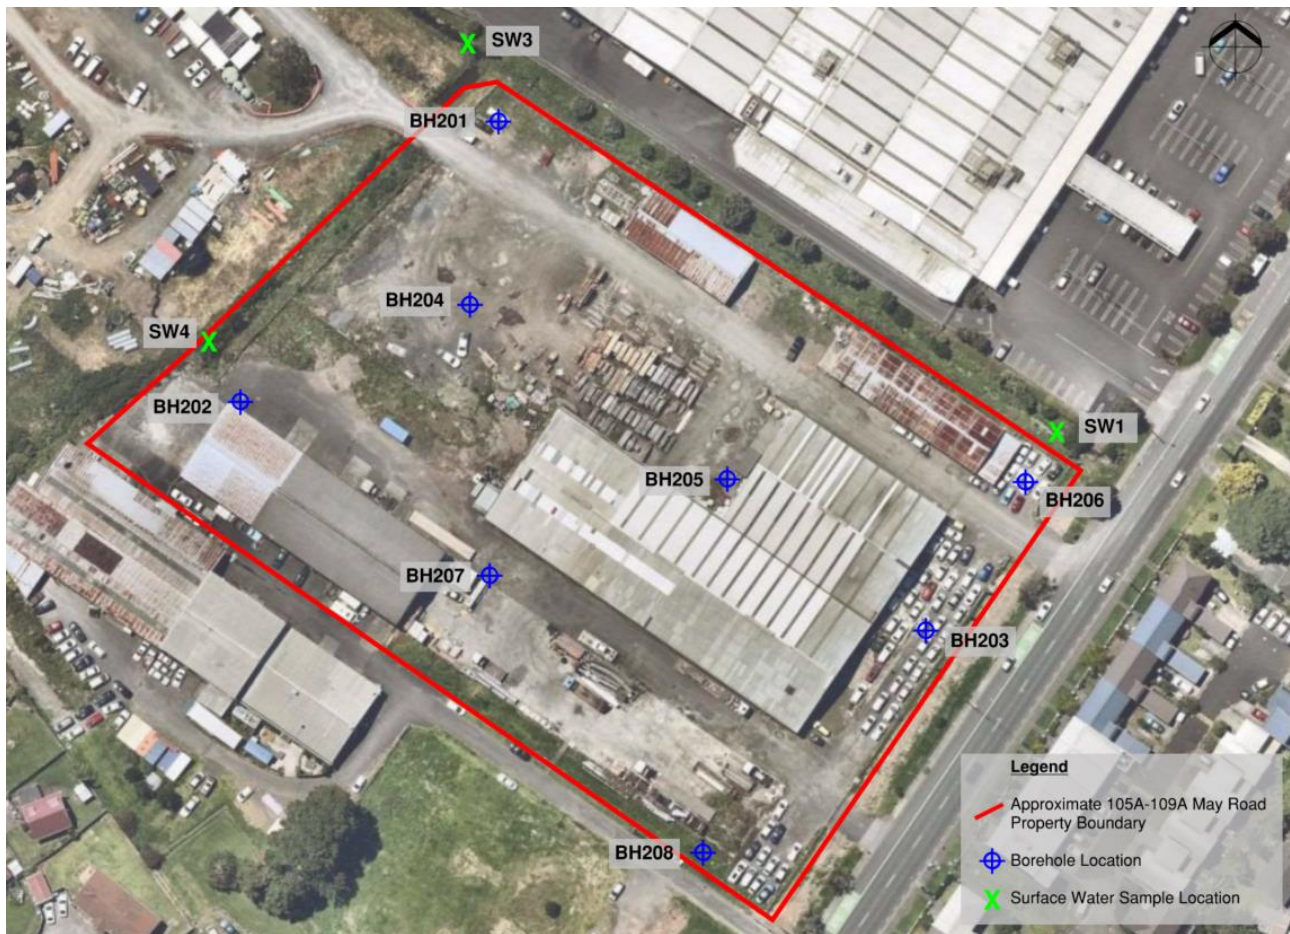
The drilling and piezometer installation of an additional five boreholes was undertaken on the 29 and 30 March 2021 using a Geoprobe CPT rig. Groundwater and surface water sampling was undertaken on the 12 and 13 April 2021. A sample location plan is included as Figure 9.

Figure 9: 105A-109A May Road Phase 2 Sample Location Plan (including BH201-BH203 from Phase 1) (Image Source: Nearmap Australia Pty Ltd)

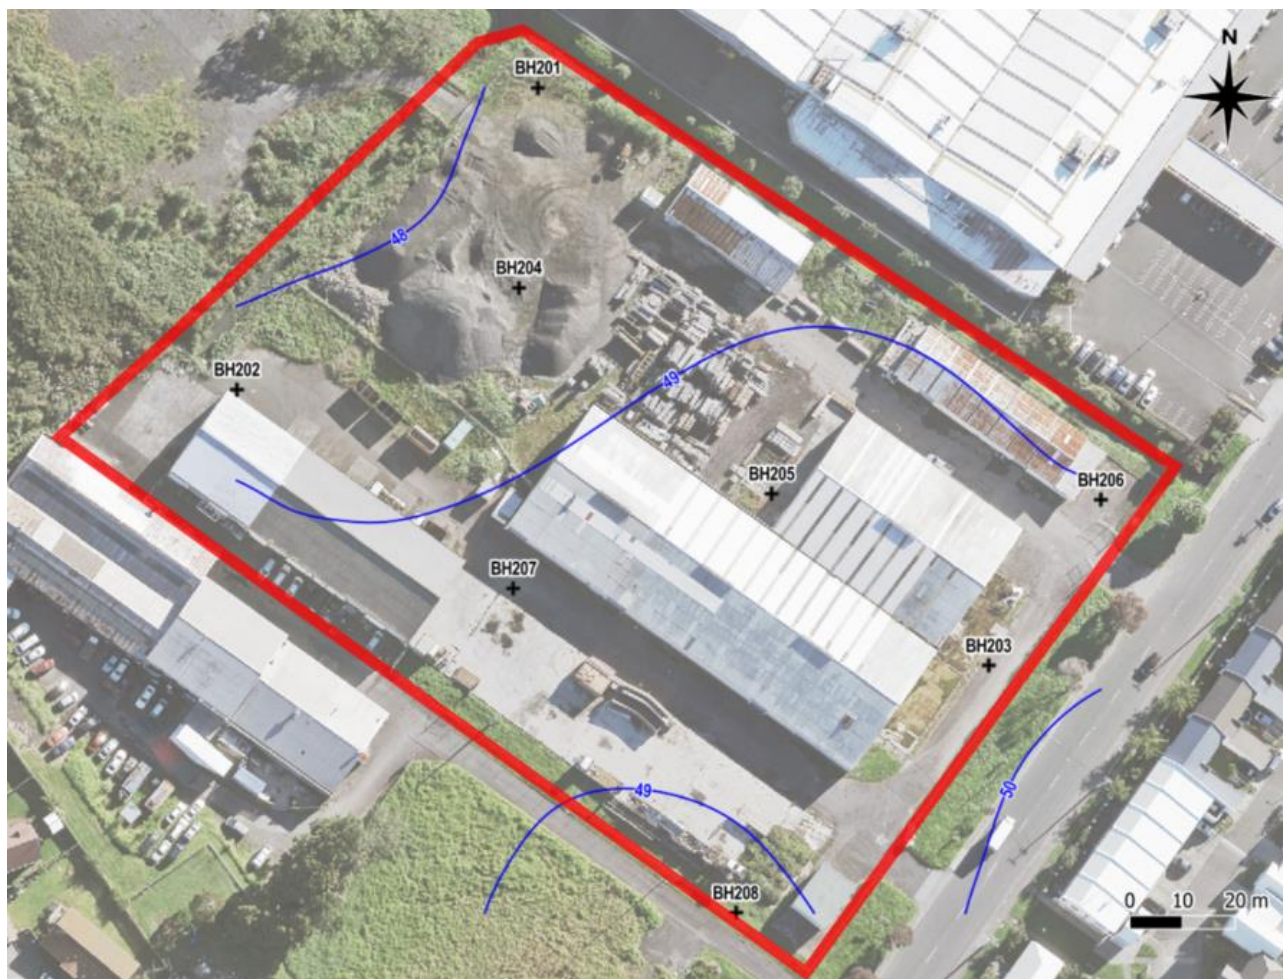
Initial measurements of groundwater level at eight locations across the 105A-109A property indicate groundwater flow is to the north/ north-west, with groundwater levels varying between 49.7 m RL in the east of the site and 48 m RL in the west/north-west, as shown in Figure 10.

Figure 10: Indicative Groundwater Contour Plot (April 2021 Monitoring Results)

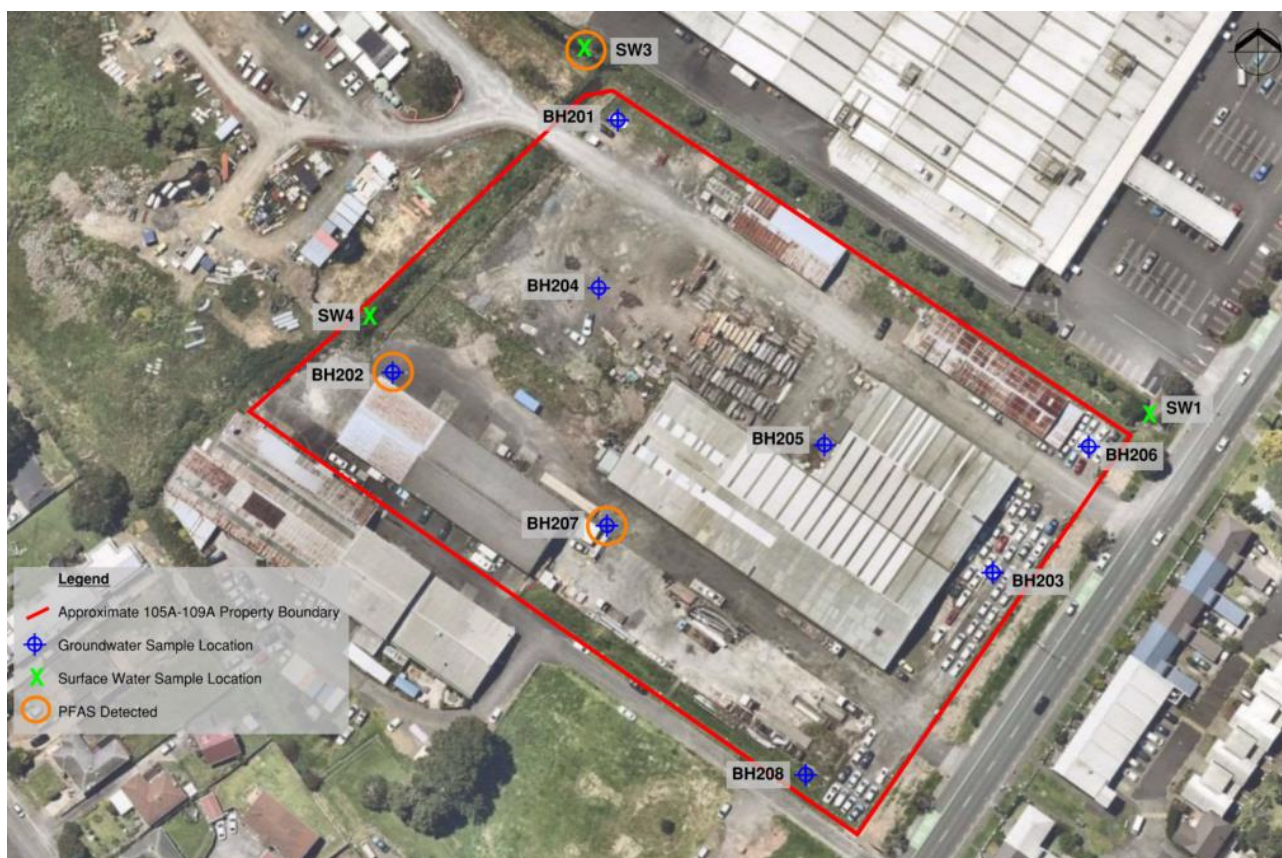
Figure 11: Plan illustrating sample locations with PFAS detections (Image Source: Nearmap Australia Pty Ltd)

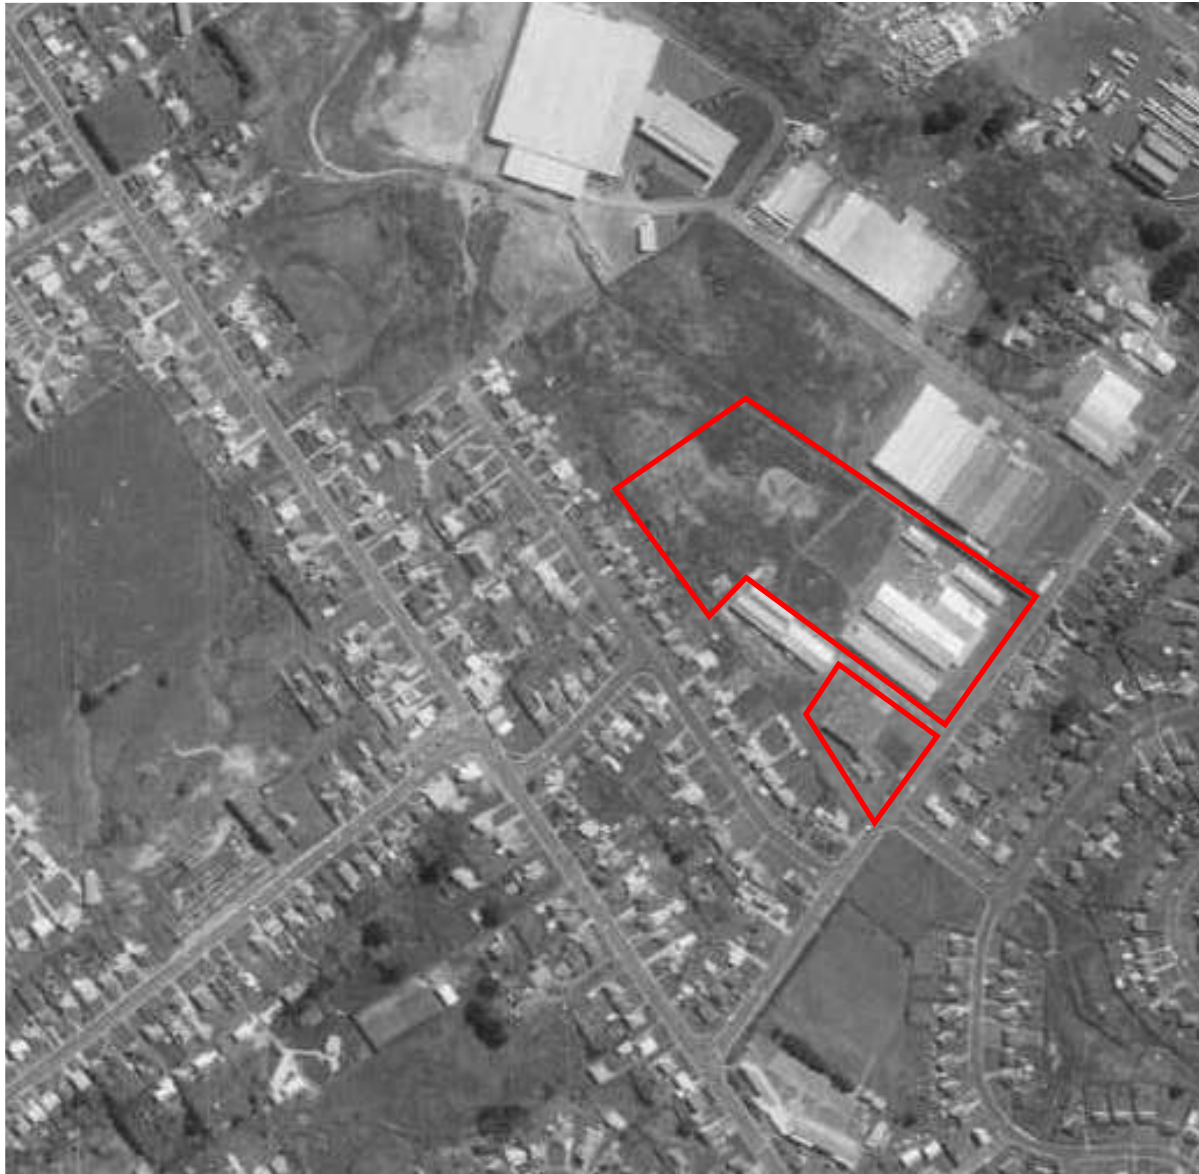
Year	On-Site	Surrounding Area
1968	<ul style="list-style-type: none"> 105 May Road appears to be predominantly vegetated with what appears to be an unvegetated area in the north-west that connects to the eastern development by a path/ track. The building structures noted in the 1959 aerial in the east of 105A-109A May Road have been removed/ redeveloped and several new large warehouses constructed (these appear to be the same structures that remain today based on shape/ size). No significant changes observed in 119 May Road. 	<ul style="list-style-type: none"> A large warehouse structure was present adjacent to the north-eastern boundary of 105A-109A May Road. The structure present to the south of 105A-109A May Road and west of 119 May Road has been extended along the southern boundary of 105A-109A May Road. Further commercial/ industrial development has occurred to the north, and residential development to the south, west and east.

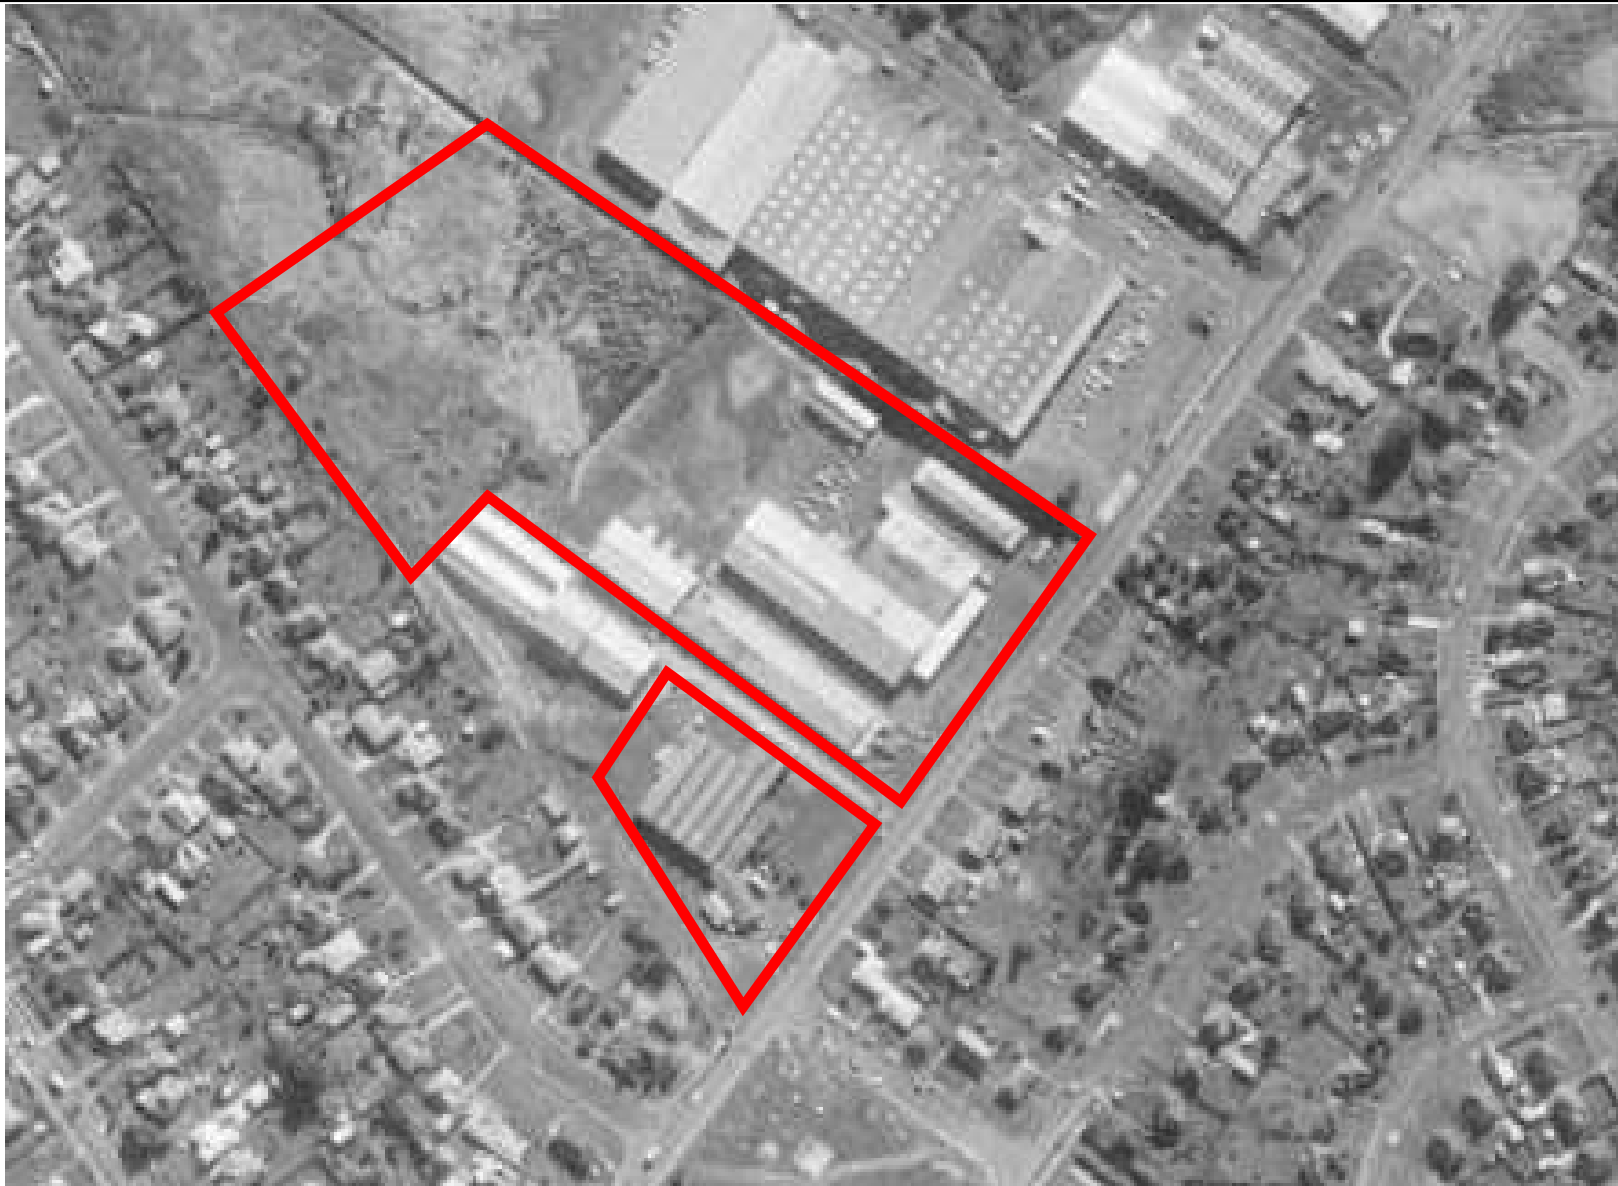
1975	<ul style="list-style-type: none"> The buildings in the south-western portion of 105 May Road are no longer present. No other significant changes observed. 	<ul style="list-style-type: none"> The structure adjacent to the north-eastern boundary of 105 May Road has been extended. No other significant changes observed.
1988	<ul style="list-style-type: none"> The vegetation in the northern portion of 105 May Road appears to have been removed and a track extends from this clearing in 105 May Road off-site to the north-west. The building along the south-western boundary of the eastern portion of 105A-109A May Road has possibly extended west. No other significant changes observed. 	<ul style="list-style-type: none"> Further commercial/ industrial development has occurred to the north, and residential development to the south, west and east.
1996	<ul style="list-style-type: none"> First colour photograph reviewed. The clearing in the northern portion of 105 May Road remains and a track now extends east towards the structures in the 105A-109A May Road. There appears to be a bridge over the watercourse to connect the two areas. No other significant changes observed. 	<ul style="list-style-type: none"> No significant changes observed.

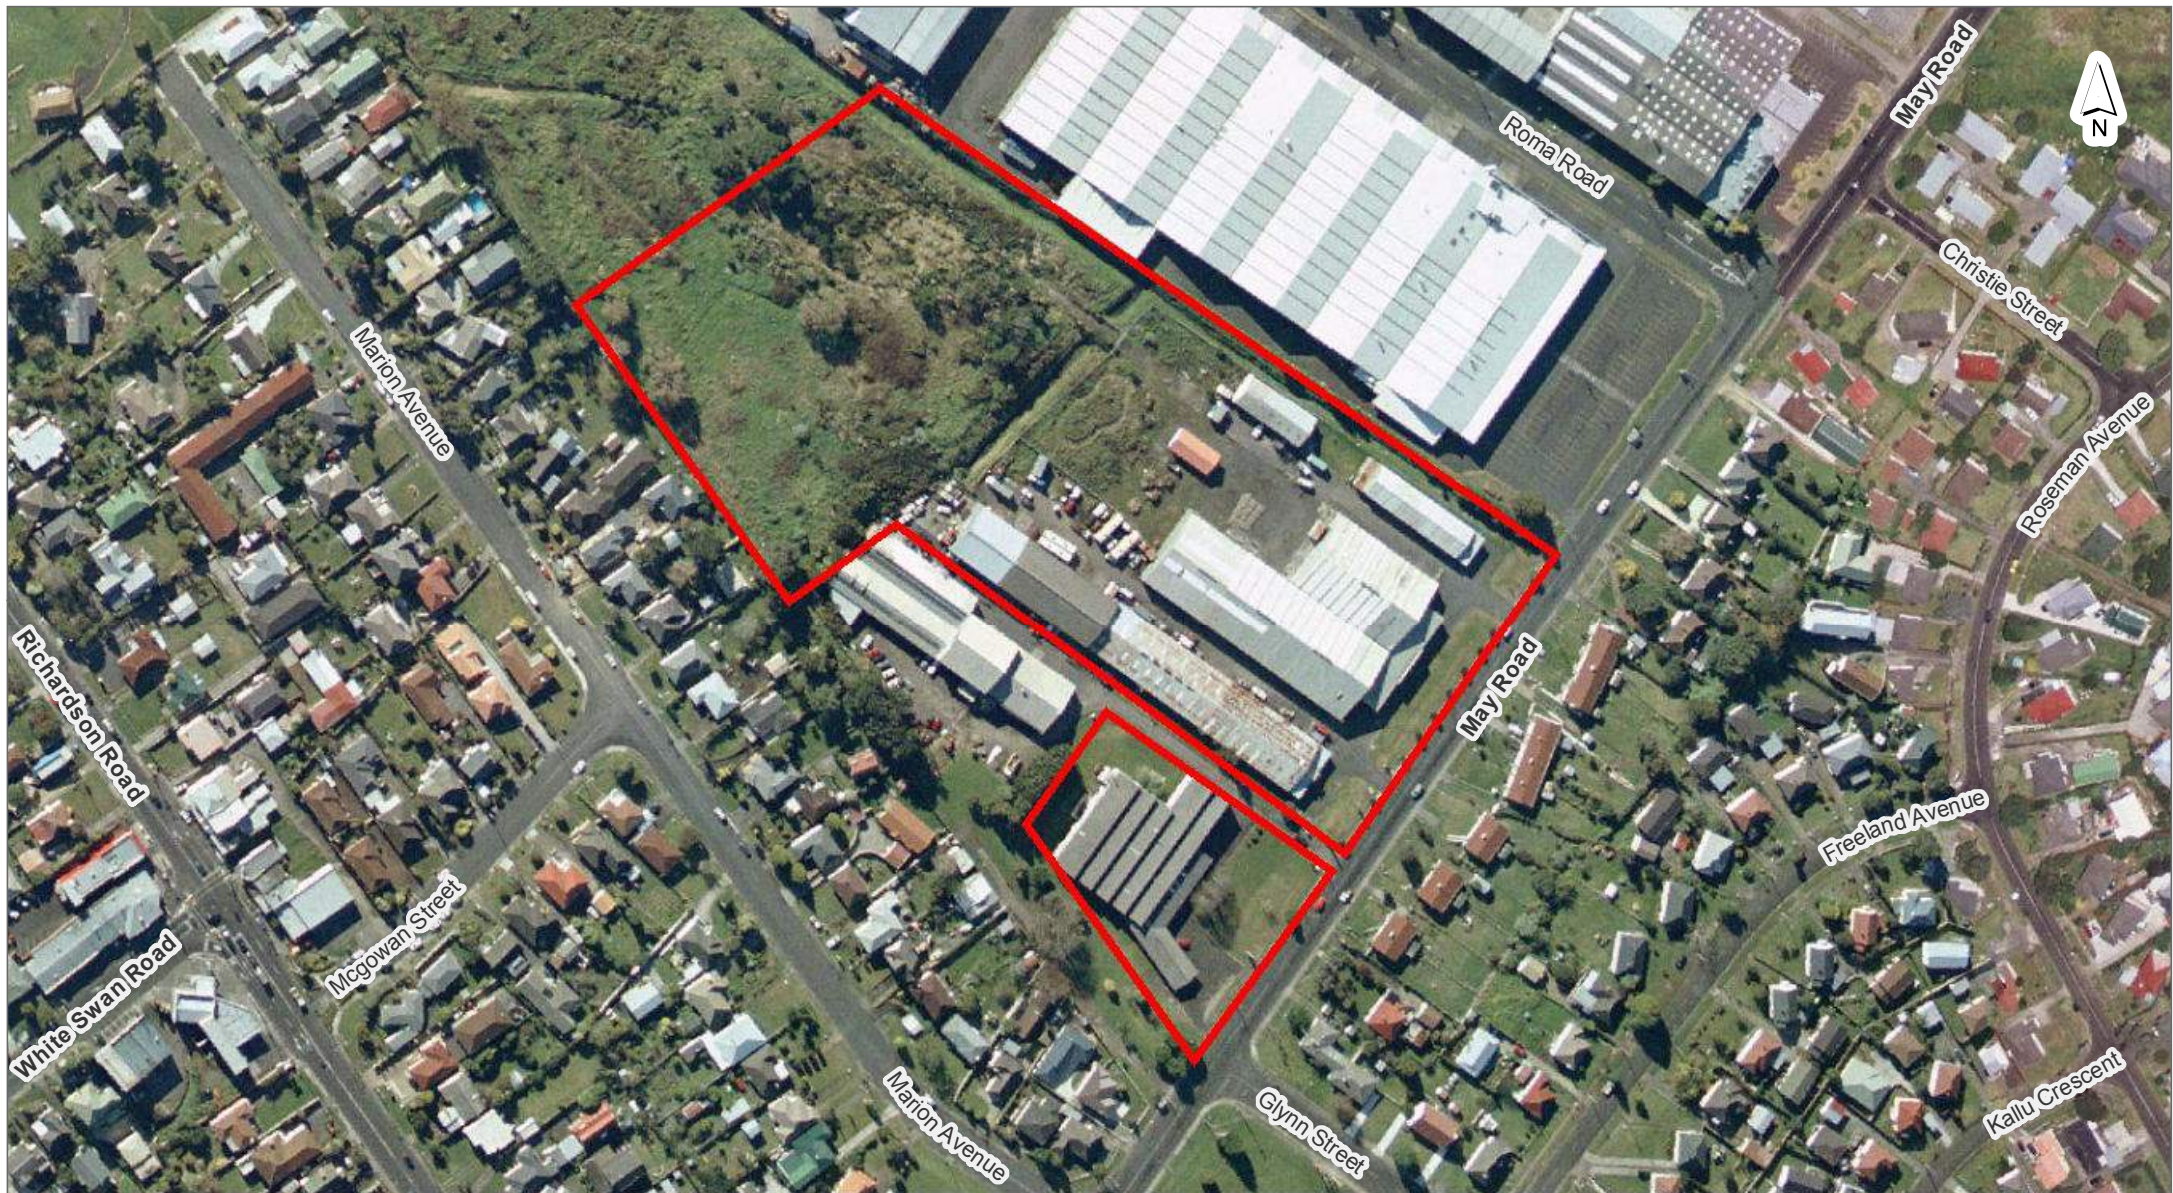
2001	<ul style="list-style-type: none"> The cleared area in the northern portion 105 May Road has been vegetated. The bridge over the watercourse between the vegetated area in 105 May Road and buildings in 105A-109A May Road still remains although the location of the track is not clear. A new structure with a red roof is visible on the central portion of 105A-109A May Road. A number of vehicles are present in the central southern portion of 105A-109A May Road. No significant changes were observed in 119 May Road. 	<ul style="list-style-type: none"> No other significant changes observed.

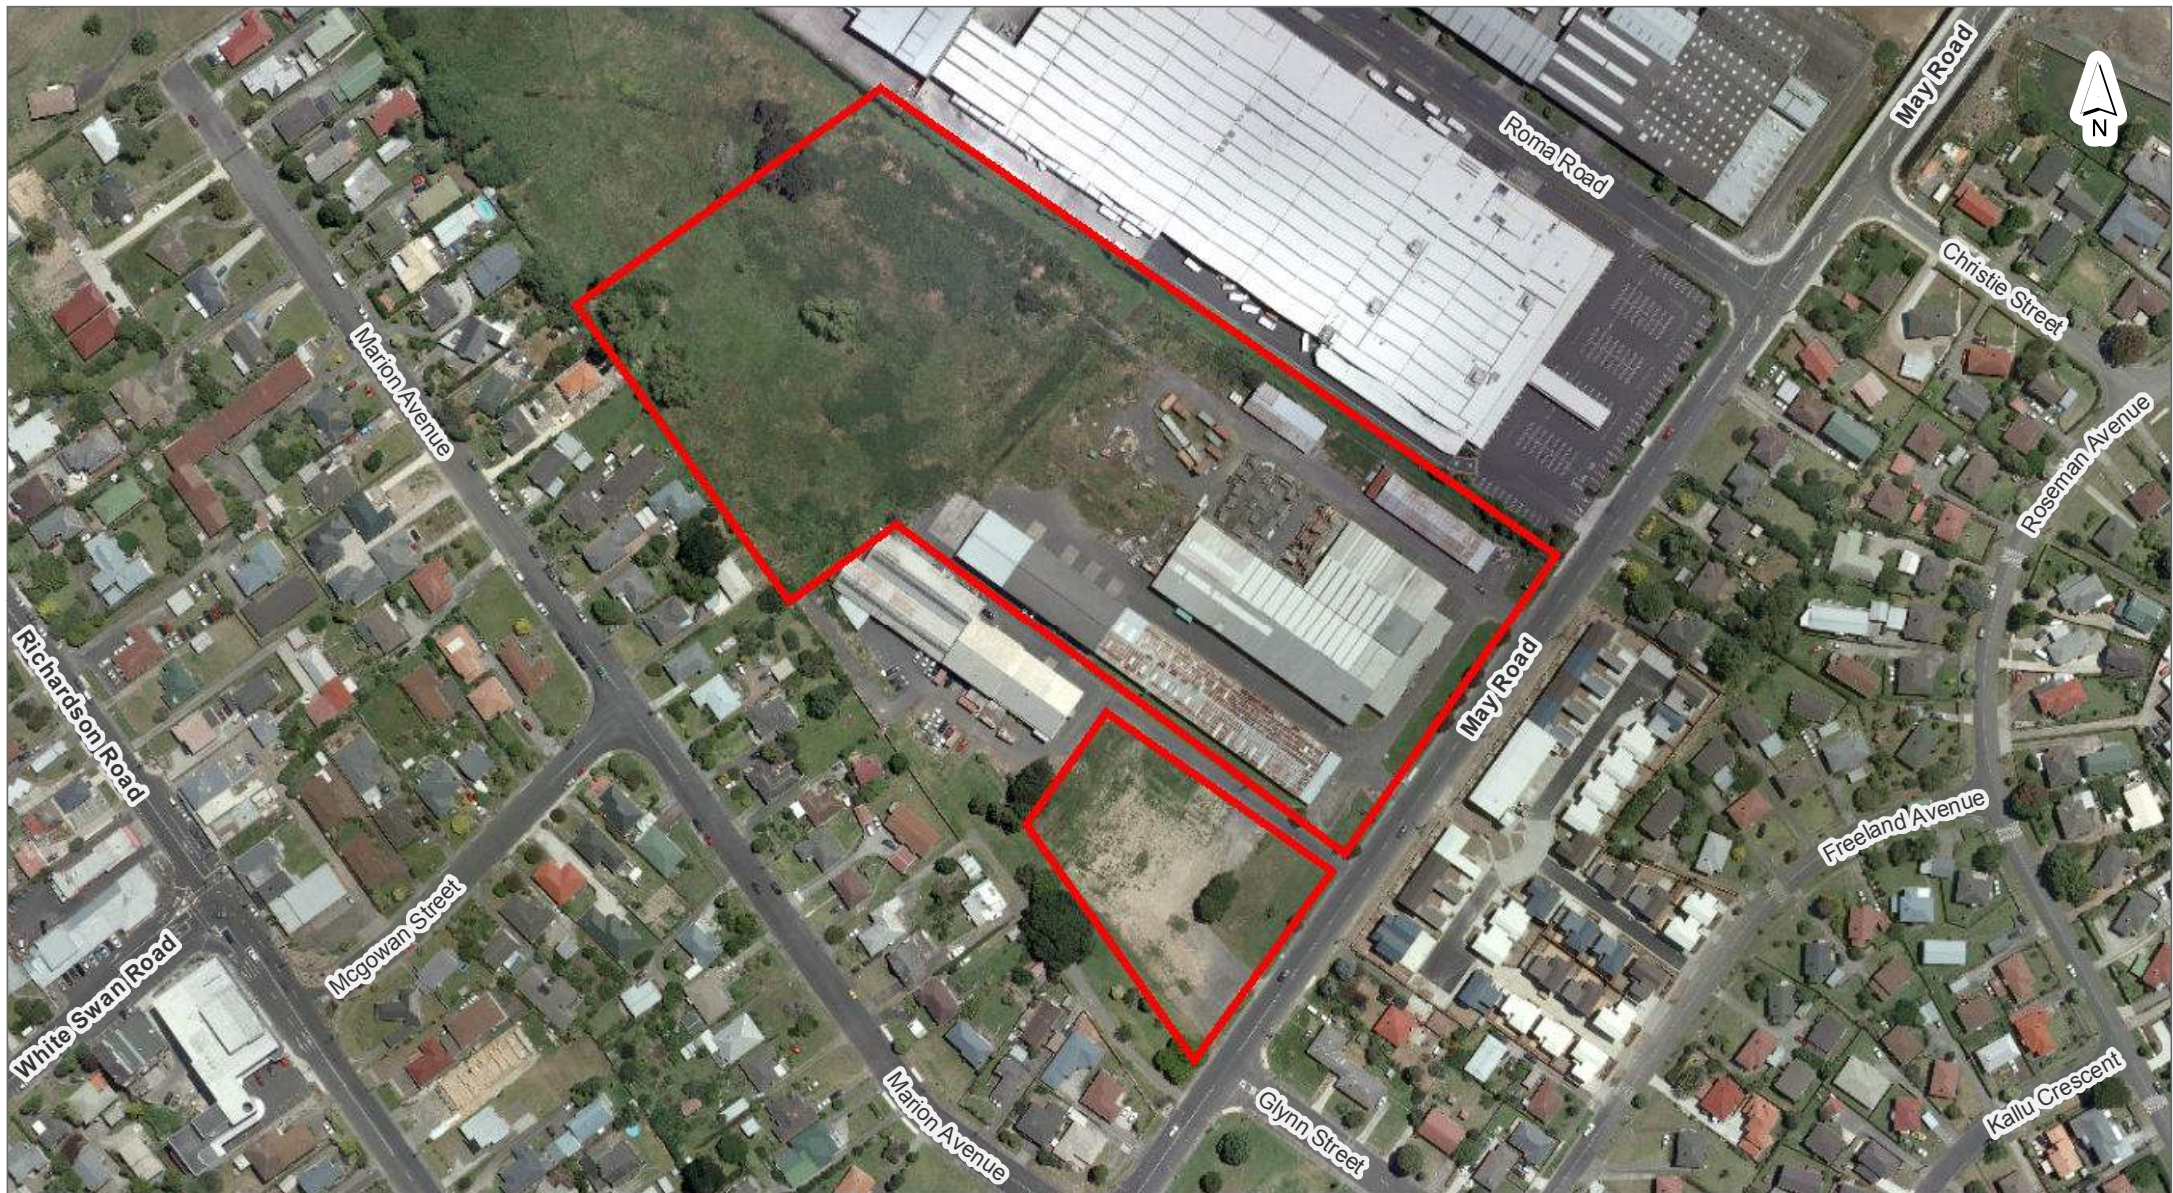
Year	On-Site	Surrounding Area
2008	<ul style="list-style-type: none"> 105 May Road remains vegetated and the bridge and watercourse appears to be overgrown. The structure with the red roof in 105A-109A May Road appeared to have been removed and there are shipping containers stored in this location. To the south-east of the shipping containers there appears to be piles of wood / timber / pallets. All vehicles previously observed at the Site has been cleared from 105A-109A May Road. The warehouses previously located on 119 May Road have been removed and the Site appears to be cleared and vegetated except for a sealed portion in the location of the historical warehouse parking lot. 	<ul style="list-style-type: none"> Additional developments appeared to have been undertaken on the properties on the south eastern border of the Site. No other significant changes were observed.
2015/16	<ul style="list-style-type: none"> There is a dark grey, gravelly laydown area located in the central portion of 105 May Road. The road and bridge over the watercourse towards 105A-109A May Road also appears to be covered in the same grey gravel material. A lighter grey gravel road connects and extends from the laydown area in a north-westerly direction from 105 May Road. There is a stockpile of the lighter grey gravels located in the northern area of 105A-109A May Road. The shipping containers previously observed in 105A-109A May Road have been removed and replaced with what appears to be wooden pallets or boxes. The eastern portion of the building located along the south-western boundary of 105A-109A May Road had been demolished and only concrete slab remains. No other significant changes were observed in 119 May Road. 	<ul style="list-style-type: none"> A gravel road and what appears to be stockpiles of uncontrolled rubble were observed to the west of 105 May Road. Some demolition works appeared to have been undertaken at a property directly south of 119 May Road.

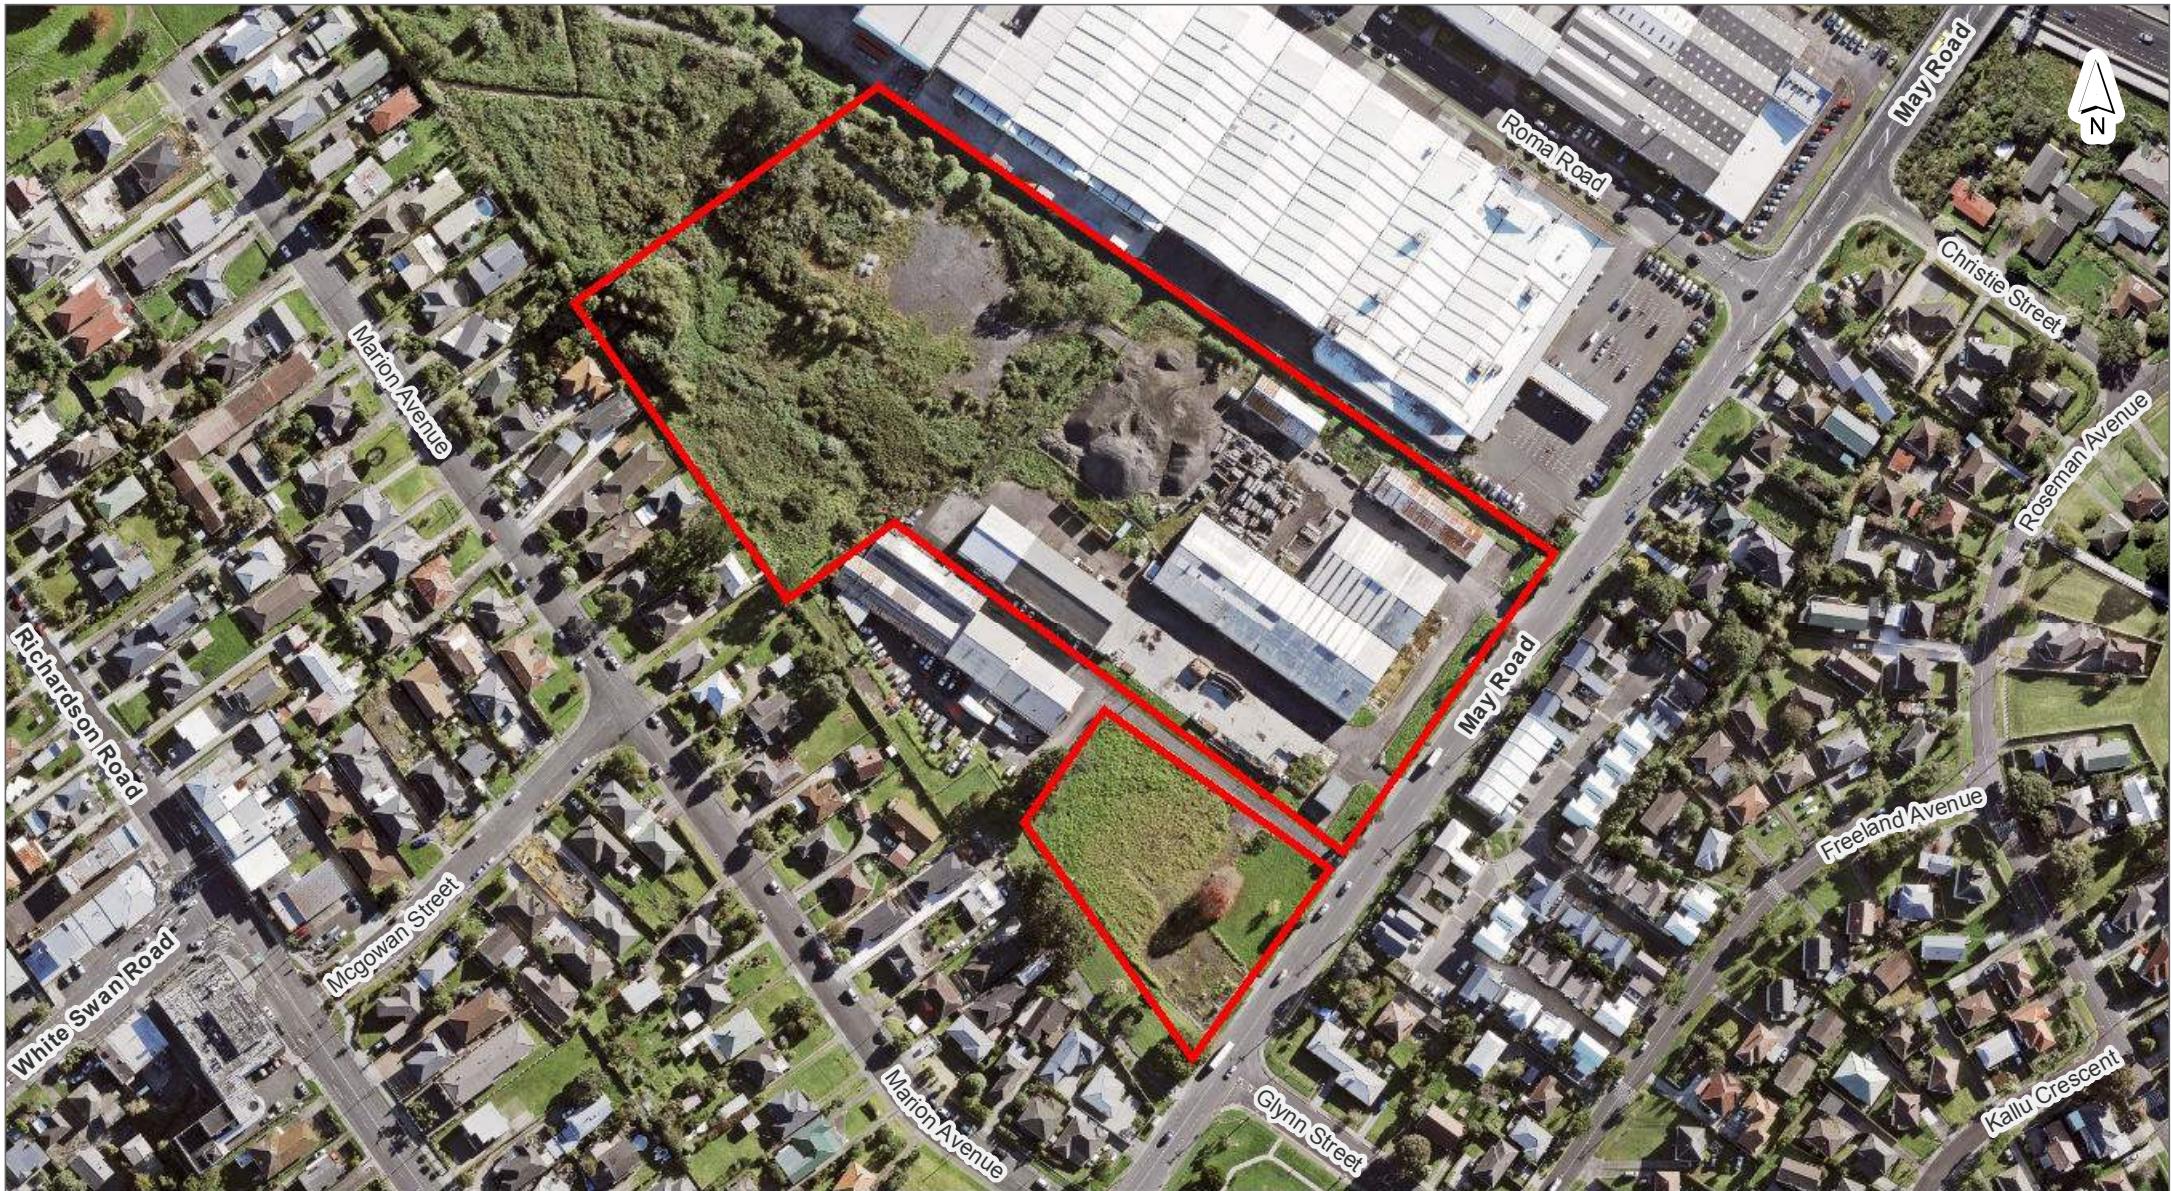
2017	<ul style="list-style-type: none"> No other significant changes were observed in 105 May Road. No significant changes were observed in 119 May Road. 	<ul style="list-style-type: none"> No other significant changes observed.
2020	<ul style="list-style-type: none"> A construction compound has been developed in 105 May Road. There are a number of Site cabins and parking areas in the northern portion and stockpiles of material and storage shipping containers to the central/ southern portions. 	<ul style="list-style-type: none"> No other significant changes observed.

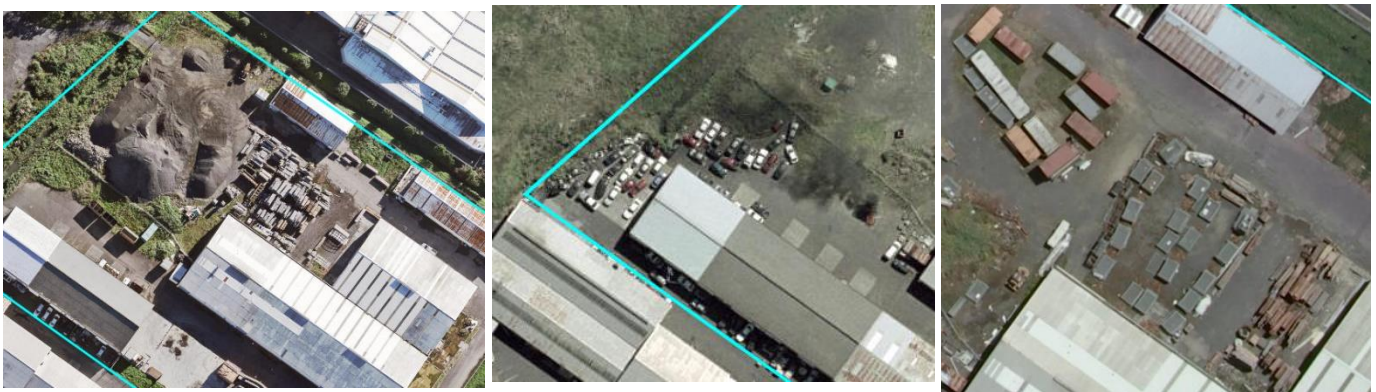
Records indicate the site 105A – 109A May Road, Mount Roskill, has a permit for an underground tank on site issued in 1956. Additionally, aerial records indicate the site has been utilised for the stockpiling of a number of materials over the years, including vehicles, seen in aerial images below:
