Geotechnical Factual Report

May Road Development

Prepared for May 1 Limited

Prepared by Beca Limited

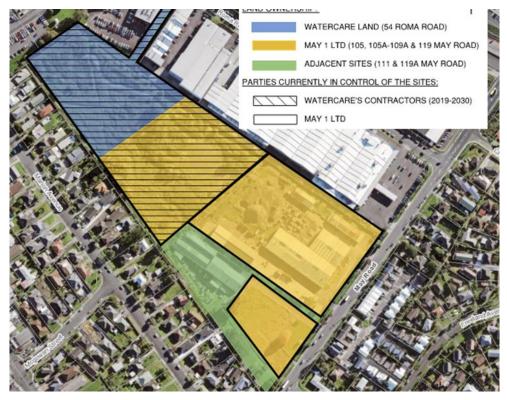
Figure 1: Site Plan

Beca Limited (Beca) has been commissioned by May 1 Limited to undertake a geotechnical investigation at their May Road properties in Mount Roskill (the Site). The Site is located on May Road in the suburb of Mount Roskill and encompasses the properties of 105, 105a-109a, and 119 May Road. The land at 54 Roma Road directly northwest of the Site will host a shaft site for Watercare Services Limited (Watercare)'s Central Interceptor tunnel and 105 May Road is currently being leased to facilitate construction activities. Figure 1 shows the Site, Watercare's land and adjacent lots.

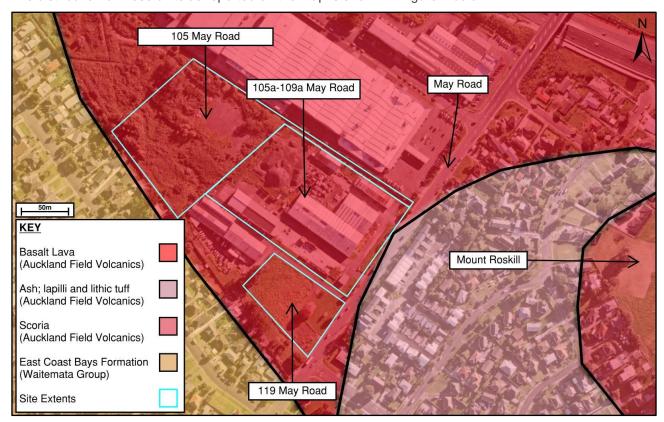
Figure 2: Mapped Geology of the Site (Edbrooke, 2001).

The relevant published geological map - Geology of the Auckland area 1:250,000 (Edbrooke, 2001), shows the Site to be underlain by basalt lava flows consisting of dense, fine grained basalt rock, with the alternating sandstone and siltstone beds of the East Coast Bays Formation forming the ridgeline to the immediate west. The distribution of these units as reported on the map is shown in Figure 2 below.

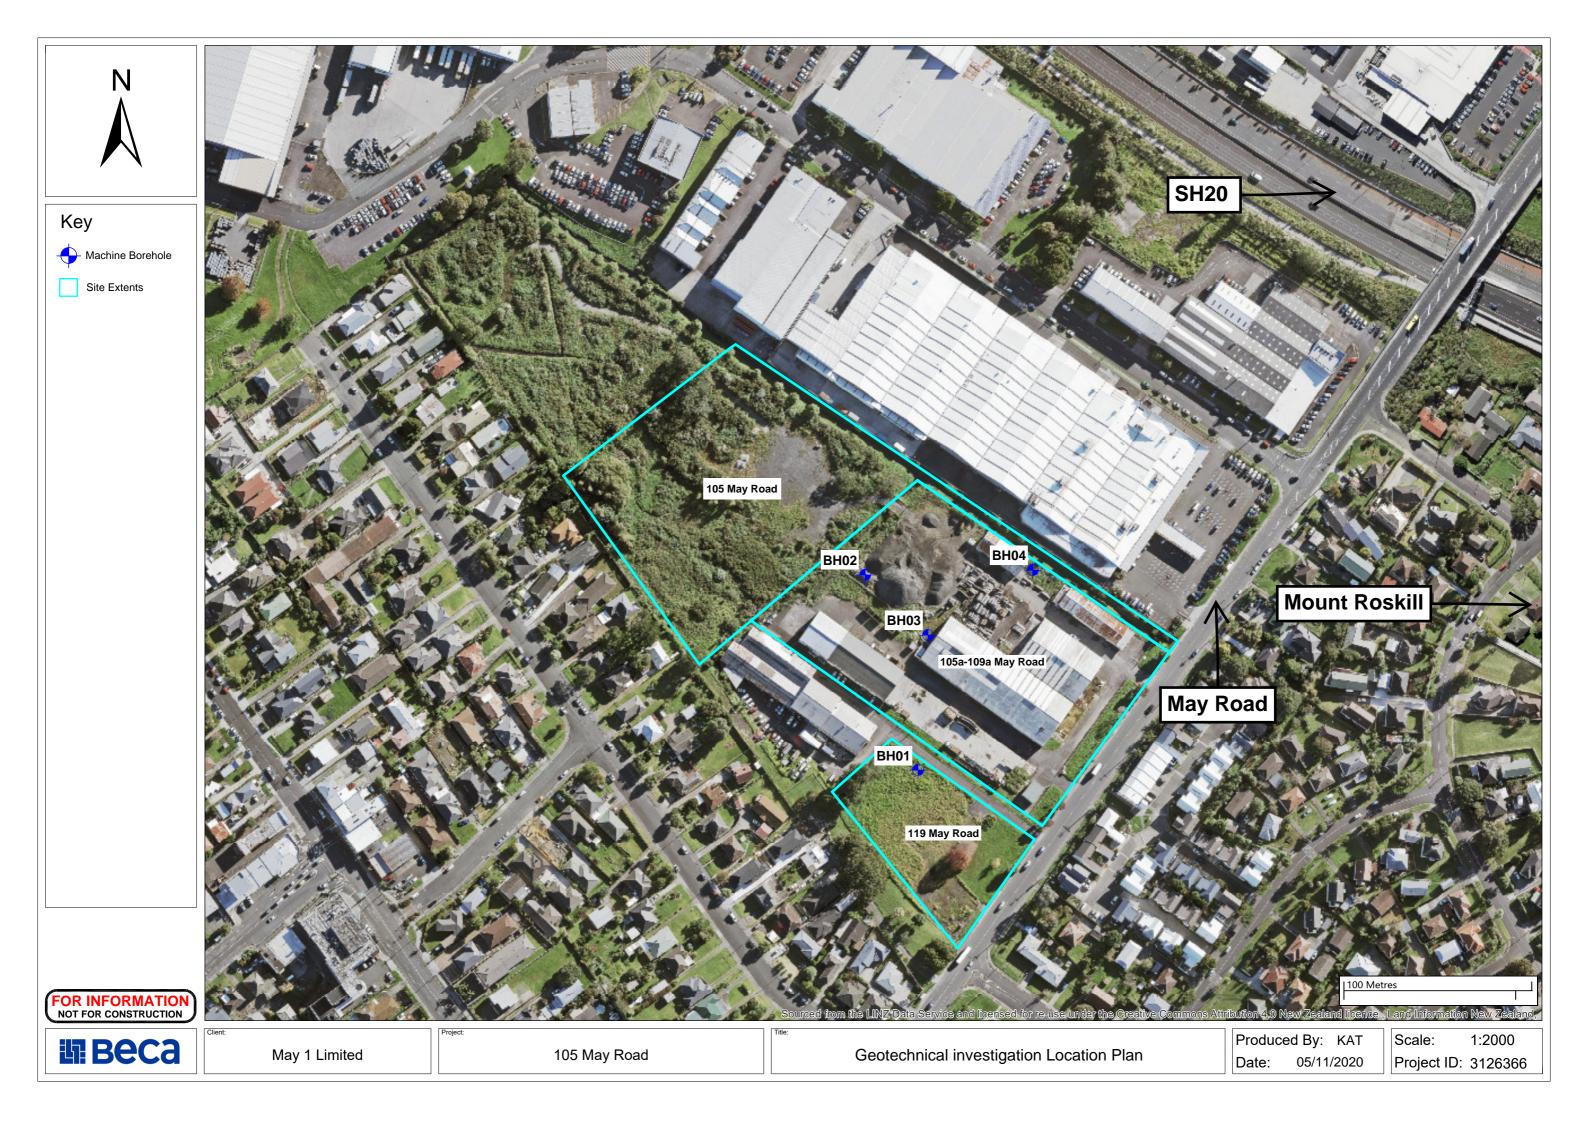
Appendix A – Site Investigation Location Plan

The locations of the completed investigations were proposed in an attempt to define the extent of basalt lava flows present on the site. A site plan of investigations is shown in Appendix A.

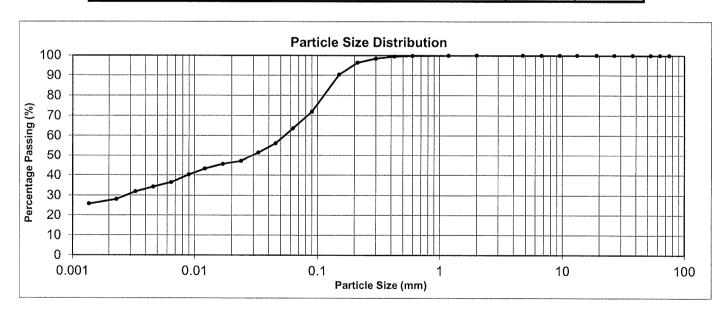
Test Standard: NZS4402: 1986, Test 2.8.4 Dispersion: Sodium hexametaphosphate, pH = 9

% Clay	% Silt	% Sand	% Gravel	Max. size:
27	37	36	0	0.425um

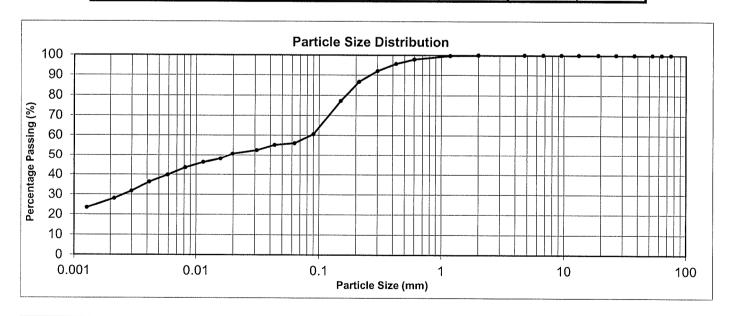
Test Standard: NZS4402: 1986, Test 2.8.4 **Dispersion:** Sodium hexametaphosphate, pH = 9

% Clay	% Silt	% Sand	% Gravel	Max. size:
27	29	44	0	0.600µm

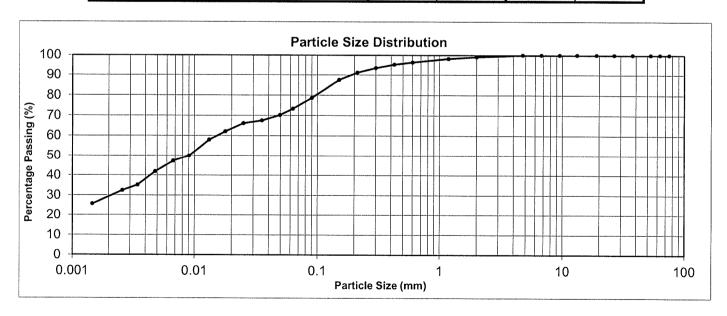
Test Standard: NZS4402: 1986, Test 2.8.4 **Dispersion:** Sodium hexametaphosphate, pH = 9

% Clay	% Silt	% Sand	% Gravel	Max. size:
1	29	44	26	1	6.75mm

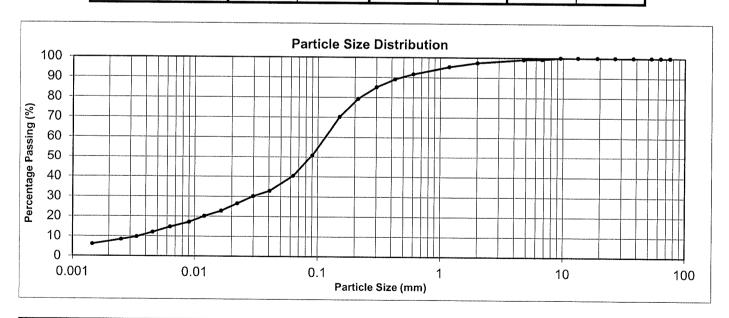
Test Standard: NZS4402: 1986, Test 2.8.4 **Dispersion:** Sodium hexametaphosphate, pH = 9

% Clay	% Silt	% Sand	% Gravel	Max. size:
7	33	57	3	6.75mm

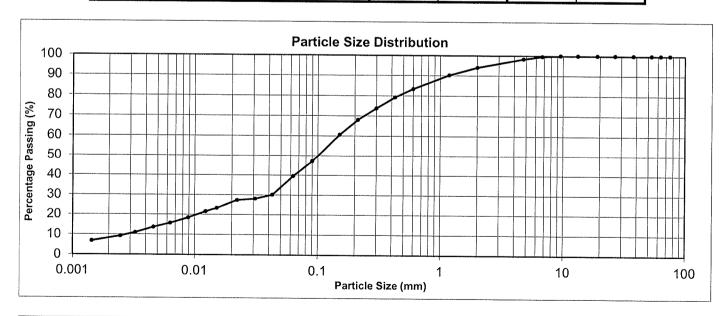
Test Standard: NZS4402: 1986, Test 2.8.4 **Dispersion:** Sodium hexametaphosphate, pH = 9

% Clay	% Silt	% Sand	% Gravel	Max. size:
8	31	54	6	4.75mm

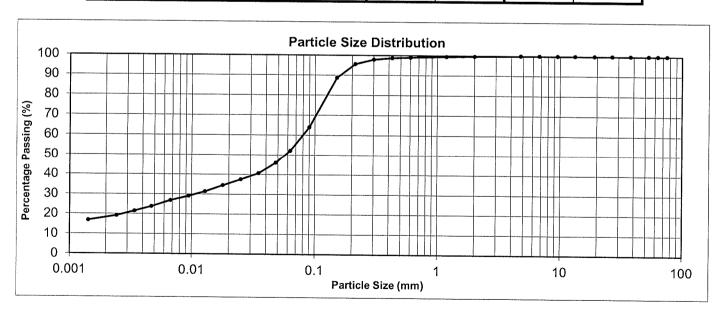
Test Standard: NZS4402: 1986, Test 2.8.4 **Dispersion:** Sodium hexametaphosphate. pH = 9

0/ 4:				
% Clay	% Silt	% Sand	% Gravel	Max. size:
18	34	Δ7	0	0.600
		- T /		TO BUUUUM I

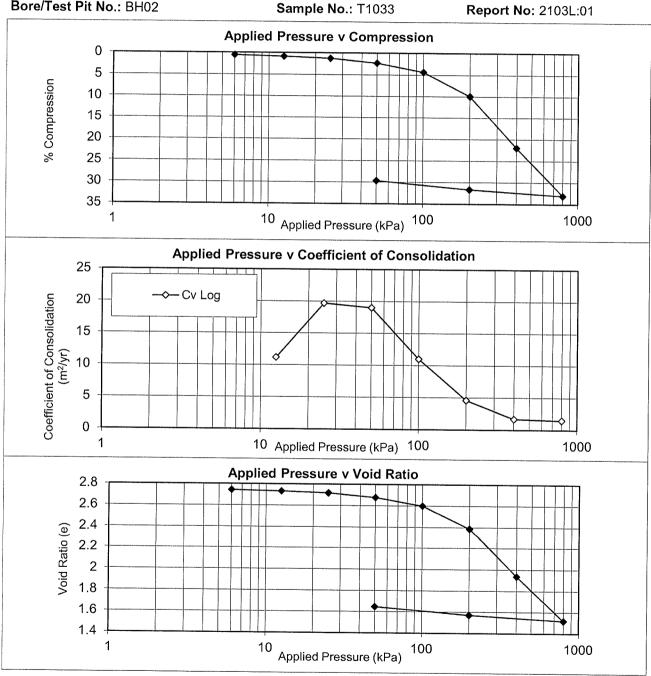
Bore/Test Pit No.: BH02

Test Condition: Inundated at 1 minute interval on initial load sequence

Depth (m): 4.50-5.00

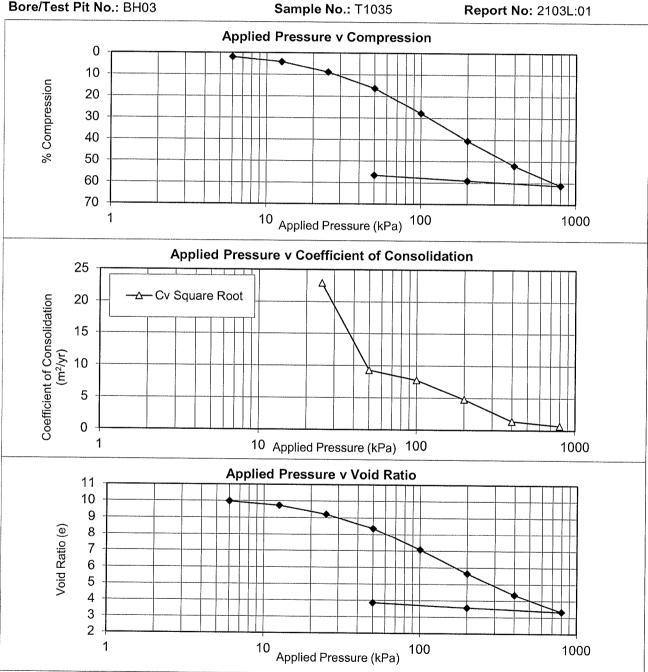
Bore/Test Pit No.: BH03

Test Condition: Inundated at 1 minute interval on initial load sequence

Depth (m): 3.00-3.50

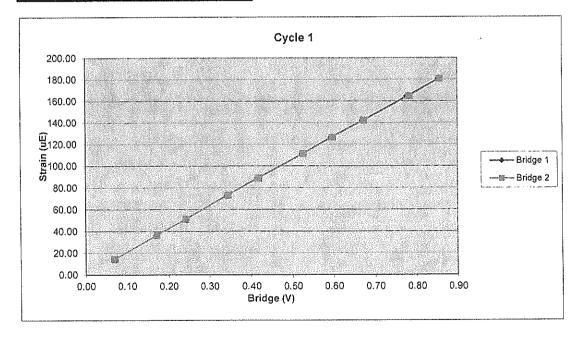
468BW	C	ycle 1		
Sample	Force (lb)	Strain (µE)	Bridge 1 (V)	Bridge 2 (V)
1	0.00	0.00	0.00	0.00
2	782.94	14.25	0.07	0.07
3	1946.02	36.44	0.17	0.17
, 4	2764.49	51.27	0.24	0.24
5	3936.16	73.24	0.34	0.35
6	4754.05	88.74	0.42	0.42
7	6000.50	111.15	0.52	0.53
8	6807.06	126.47	0.59	0.60
9	7671.22	142.02	0.67	0.67
10	8917.48	164.67	0.78	0.78
11	9779.69	180.59	0.85	0.86

Bridge 1		Bridge 2	
Force Calibration (lb/V)	11462.56	Force Calibration (lb/V)	11424.53
Offset	-11.05	Offset	-13.80
Correlation	0.999998	Correlation	0.999998
Strain Calibration (µE/V)	211.61	Strain Calibration (µE/V)	210.90
Offset	0.18	Offset	0.12
Correlation	0.999980	Correlation	0.999979

Force Strain Calibration	
EA (Kips)	54167.22
Offset	-20.34
Correlation	0.999979

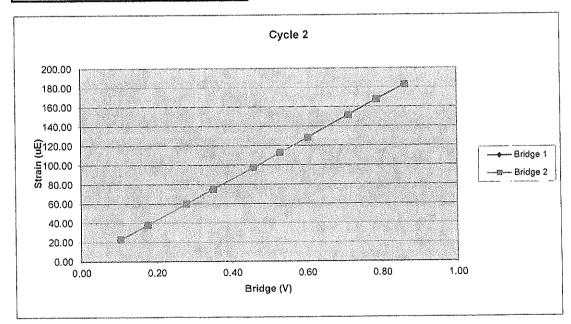
468BW	Су	cle 2		
Sample	Force (lb)	Strain (µE)	Bridge 1 (V)	Bridge 2 (V)
1	0.00	0.00	0.00	0.00
2	1183.58	22.91	0.10	0.10
3	1997.95	37,74	0.18	0.18
4	3167.48	59.66	0.28	0.28
5	3990.05	74.82	0.35	0.35
6	5219.91	97.20	0.46	0.46
7	6026.27	112.64	0.53	0.53
8	6879.11	128.25	0.60	0.60
9	8120.29	151.22	0.71	0.71
10	8983.67	167.28	0.79	0.79
11	9849.19	182.73	0.86	0.86

Bridge 1		Bridge 2	
Force Calibration (lb/V)	11433,10	Force Calibration (lb/V)	11420.68
Offset	-9.50	Offset	-13.99
Correlation	0.999997	Correlation	0.999997
Strain Calibration (µE/V)	211.36	Strain Calibration (µE/V)	211.13
Offset	0.82	Offset	0.74
Correlation	0.999989	Correlation	0.999994

Force Strain Calibration	
EA (Kips)	54092.14
Offset	-53.77
Correlation	0.999993

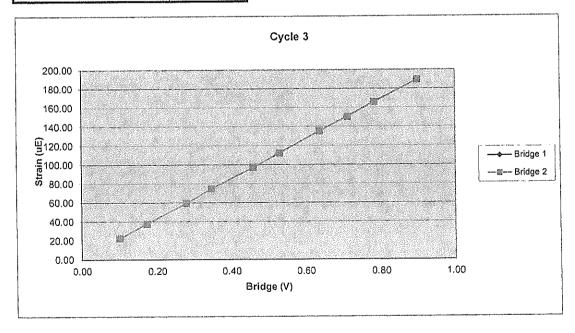
468BW	Cy	cle 3		
Sample	Force (lb)	Strain (μΕ)	Bridge 1 (V)	Bridge 2 (V)
1	0.00	0.00	0.00	0.00
2	1164.45	22,45	0.10	0.10
3	1968.67	37.63	0.17	0.17
4	3174.51	59.55	0.28	0.28
5	3952.56	74,53	0.35	0.35
6	5203.31	97.35	0.46	0.46
7	6009.09	112.15	0.53	0.53
8	7260.23	135.29	0.64	0.64
9	8112.87	150,35	0.71	0.71
10	8925.09	165.78	0.78	0.78
11	10236,76	189.35	0.90	0.90

Bridge 1		Bridge 2	
Force Calibration (lb/V)	11388.71	Force Calibration (lb/V)	11364.29
Offset	-8.01	Offset	-0.35
Correlation	0.999997	Correlation	0.999998
Strain Calibration (µE/V)	209.54	Strain Calibration (µE/V)	209.09
Offset	1.25	Offset	1.39
Correlation	0.999988	Correlation	0.999990

Force Strain Calibration	
EA (Kips)	54349.04
Offset	-75.61
Correlation	0.999985
