PS 23 Assessment of Ecological Effects

Prepared for Watercare Services Limited Prepared by Tonkin & Taylor Ltd Date October 2022 Job Number 1015172.1600 v1

Watercare Services Ltd (Watercare) proposes to undertake ecological enhancement works at Pump Station 23 (PS 23) as part of the Central Interceptor (CI) project.

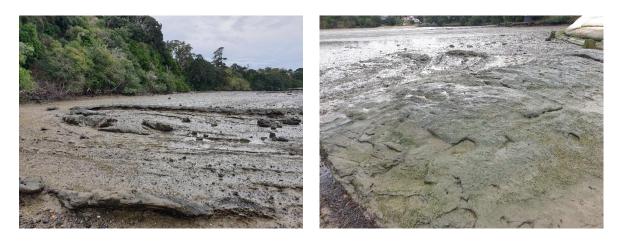
Photograph 5.1: Photos showing the sandstone reef present in the area surrounding PS 23 footprint.

Approximately 4,500 m² of sandstone reef was estimated within the 100 m radius around PS 23, bordering the Mean High Water Springs (MHWS) to the North and South of the PS 23 (Appendix A Figure.1). The eastern transect surveyed in the 2011 field assessment by BML was located within the sandstone reef habitat (Appendix C). Sandstone reefs generally support a diverse species assemblage including sea snails, seaweeds, sponges, crabs and shrimps, bivalves, polychaete worms, amphipods, chitons, echinoderms, sea squirts, barnacles, anemones and fish.

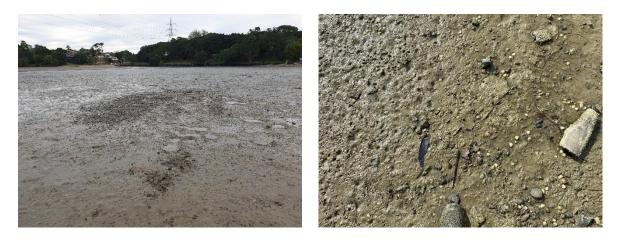
Photograph 5.2: Photos showing the firm muddy fine sand flats present in the area surrounding PS 23 footprint.

Firm muddy fine sand flats dominated the CMA adjacent to the site footprint, approximately 8,400 m² was estimated within the 100 m radius around PS 23 (Appendix A). These sandflats transitioned to soft gloopy mud further seaward. The western and central transects surveyed in the 2011 field assessment by BML were located with the area of firm muddy fine sand flat habitat (Appendix C). Firm muddy fine sand flats are common in the Auckland region and are highly productive (TP127, 1999). Sand flats support high diversity of intertidal organisms dependent on tidal level, including bivalves (i.e. shellfish), gastropods and polychaete worms (TP127, 1999).

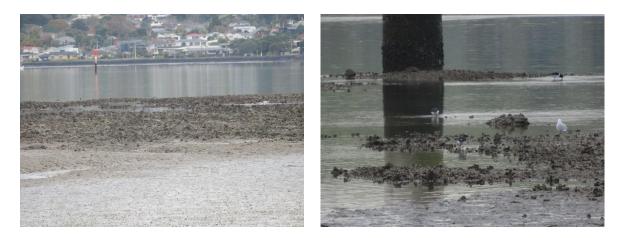
Photograph 5.3: Pacific oyster beds present in the area surrounding PS 23 footprint.

Approximately 131 m² of encrusting pacific oysters were estimated within the 100 m radius around PS 23 (Appendix A). Pacific oysters were located offshore adjacent to soft gloopy mud habitat (Photograph 5.3). Pacific oysters are commonly observed encrusting onto dead or live shells and can cover the substrate in places. Pacific oysters are not native to New Zealand but are now considered to be 'introduced and naturalised'.
