Title: Tawariki Shafts Groundwater and Settlement Effects Assessment					
Date	Version	Description	Prepared by:	Reviewed by:	Authorised by:
11/11/22	1	Final Issue	EDMA	SVP	KLB

1 Introduction

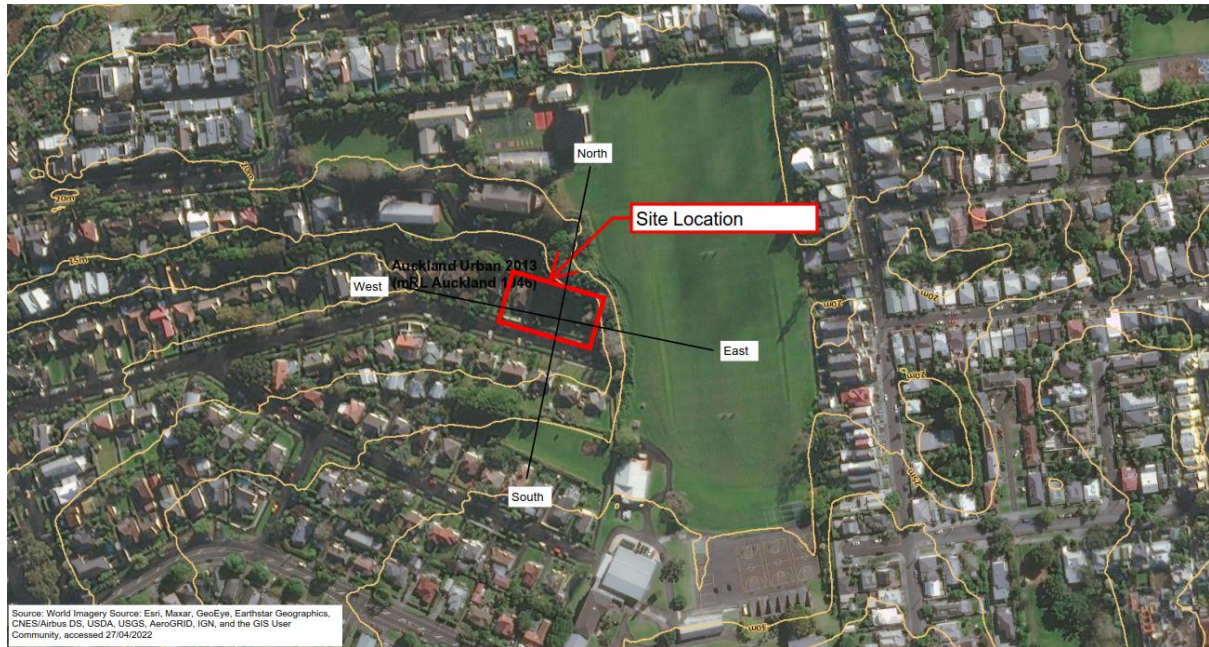
Figure 4.1. Site location

As shown on Figure 4.1, the topography of the site is variable. The site is located within a regional gully feature with ground levels to the north and south rising from approximately 12 m RL to 45 m RL to the north, and 35 m RL to the south.

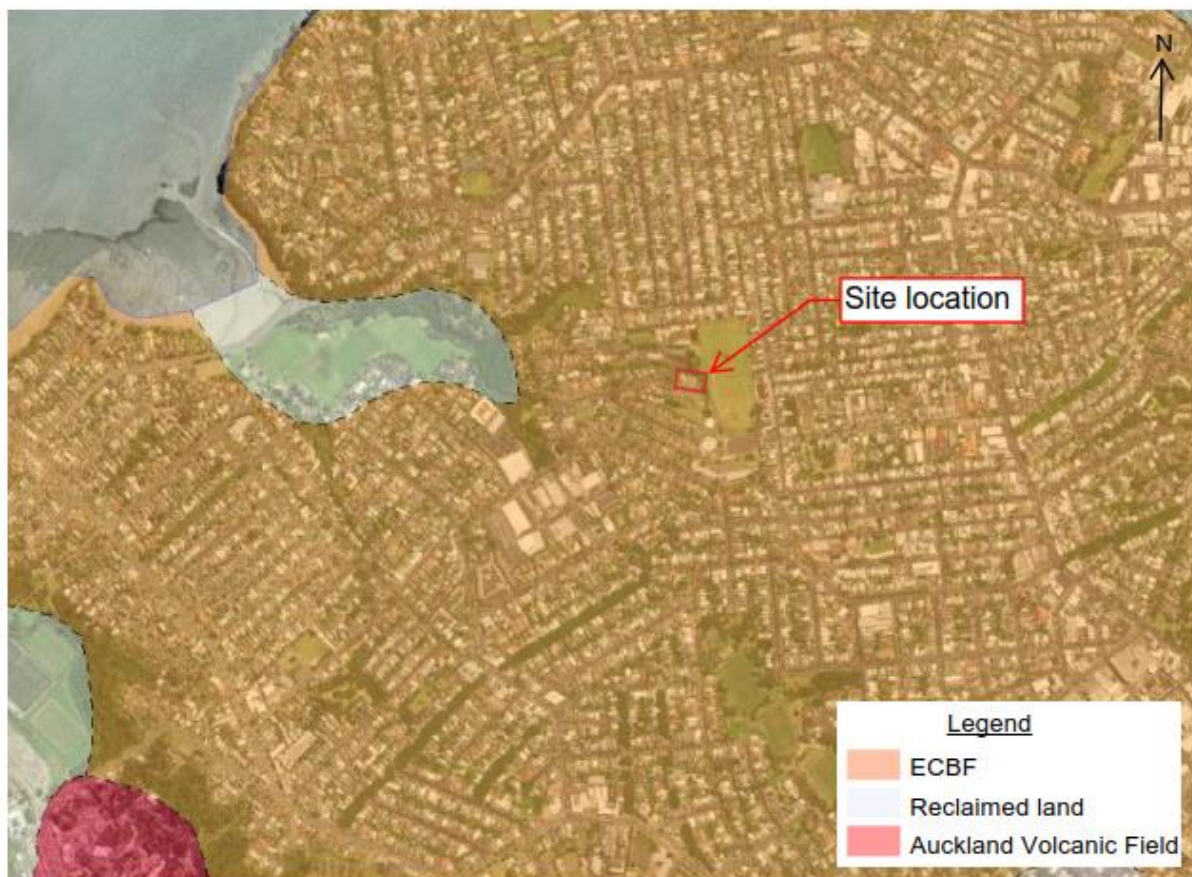
Figure 6.1: Geological map of the area. Image retrieved from T+T Mapviewer derived from Edbrooke, 2001, on 13 April 2022.

The ECBF deposits are indicated in orange on Figure 6.1 and were deposit in large submarine fan environments during the Miocene period. Cycles of erosion, along with sea level rise and fall have varied the material type from siltstone to sandstone. Intermittent volcanism within the area deposited volcanic grit within sediments.

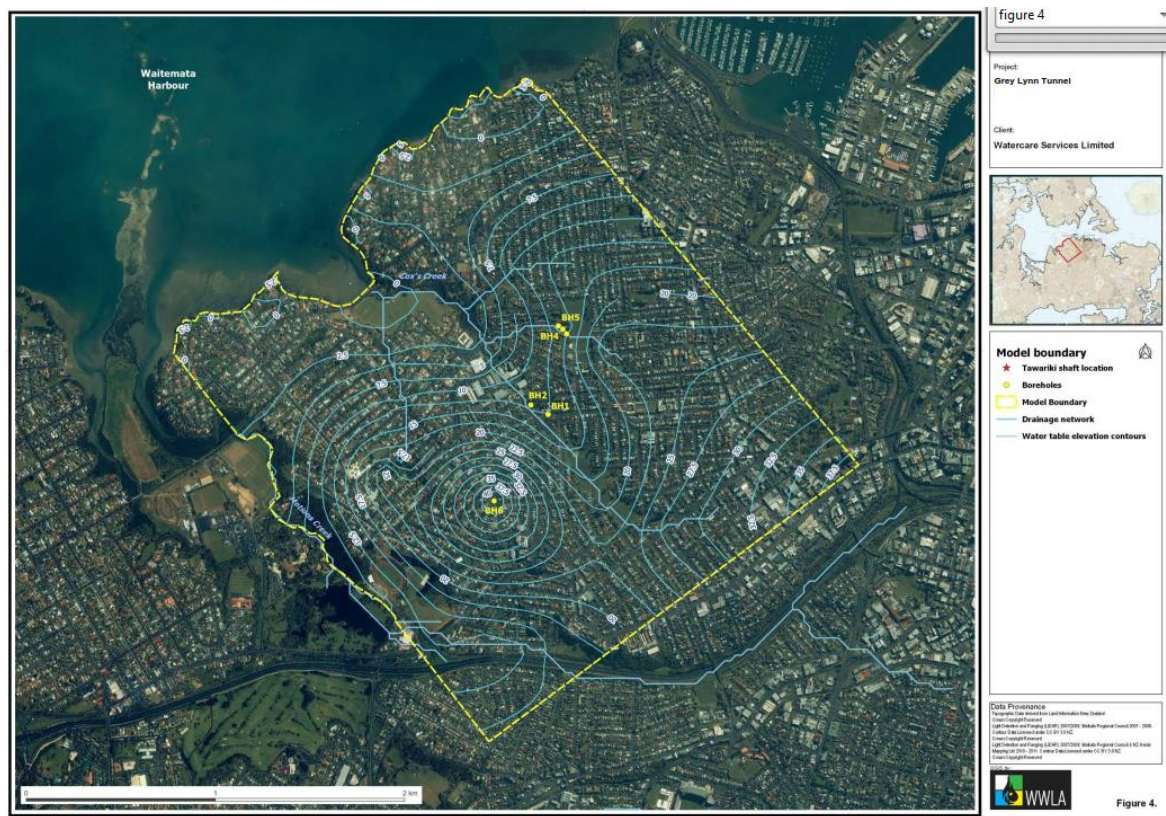
Figure 6.2: An extract of the hydraulic head distribution representative of initial (pre-construction dewatering) conditions from the previous groundwater assessment undertaken¹¹

T+T completed a visual review of the hydraulic head contours which indicates the direction of groundwater flow in the immediate vicinity of the site (i.e. 200 m radius) is relatively uniform and is generally from east to west. The hydraulic gradient is also relatively uniform. The change in head between 200 m upgradient of the site and 200 m downgradient of the site is approximately 10 m, resulting in a hydraulic gradient of approximately 0.025 (or 2.5%).

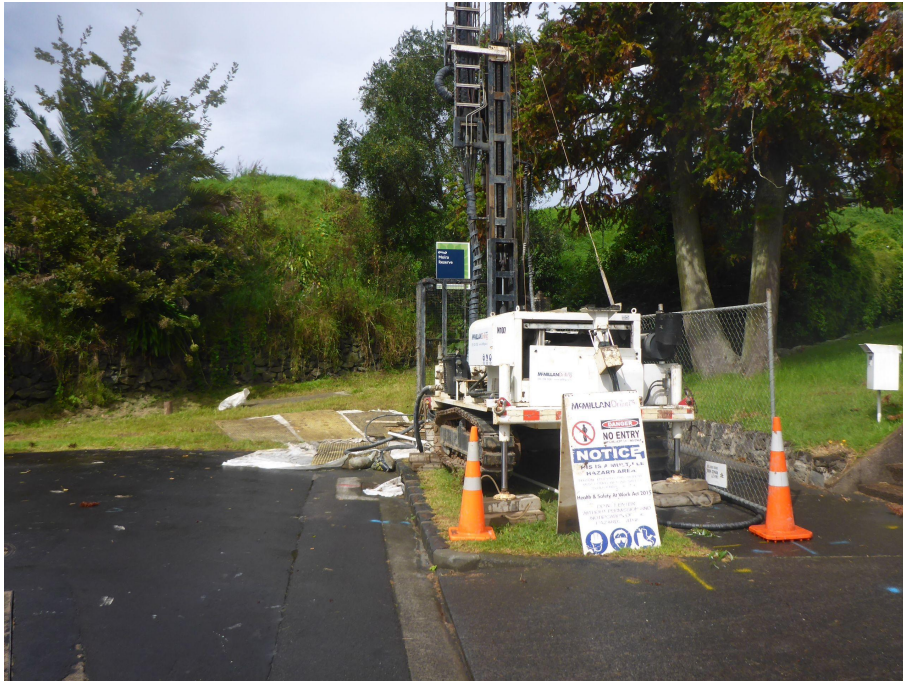
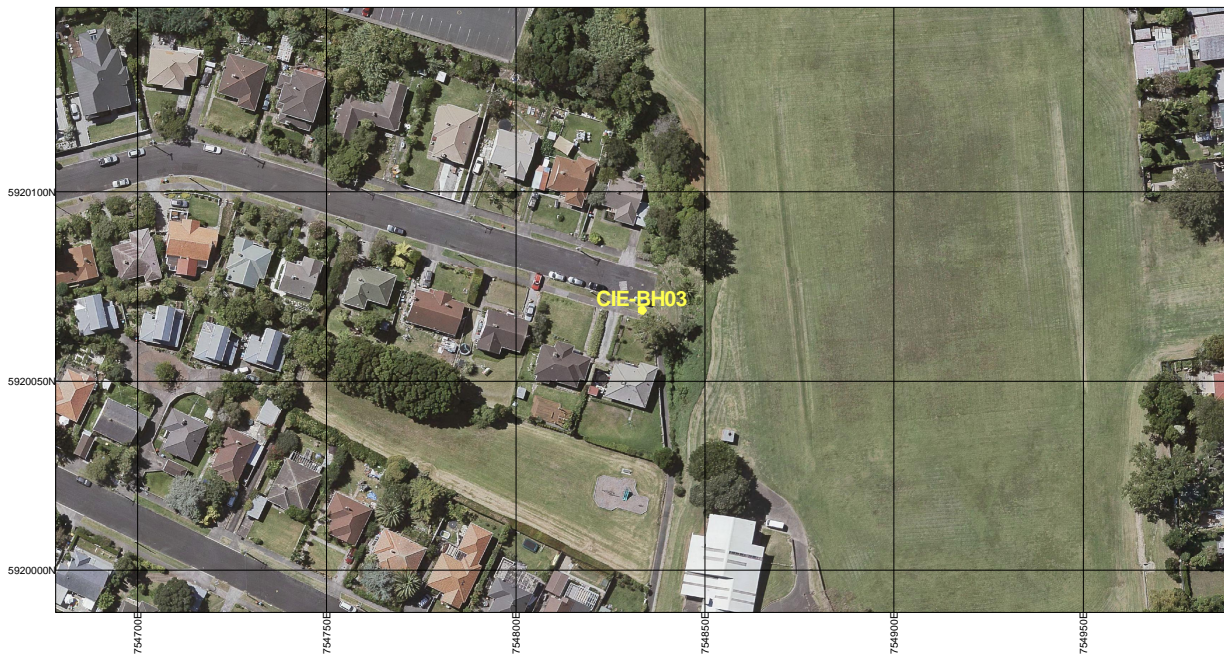
Started: 23/03/2018
Finished: 27/03/2018
Driller: McMillan
Plant: Rig N101 (McMillan)
Logged: A. Coutts
Checked: CS

Remarks
Packer Test at 20.00-24.50 m
Artesian piezometer, low pressure gauge installed..
Pressure reading on 25/05/2018 was 21 kPa.
Hole location determined by Survey.

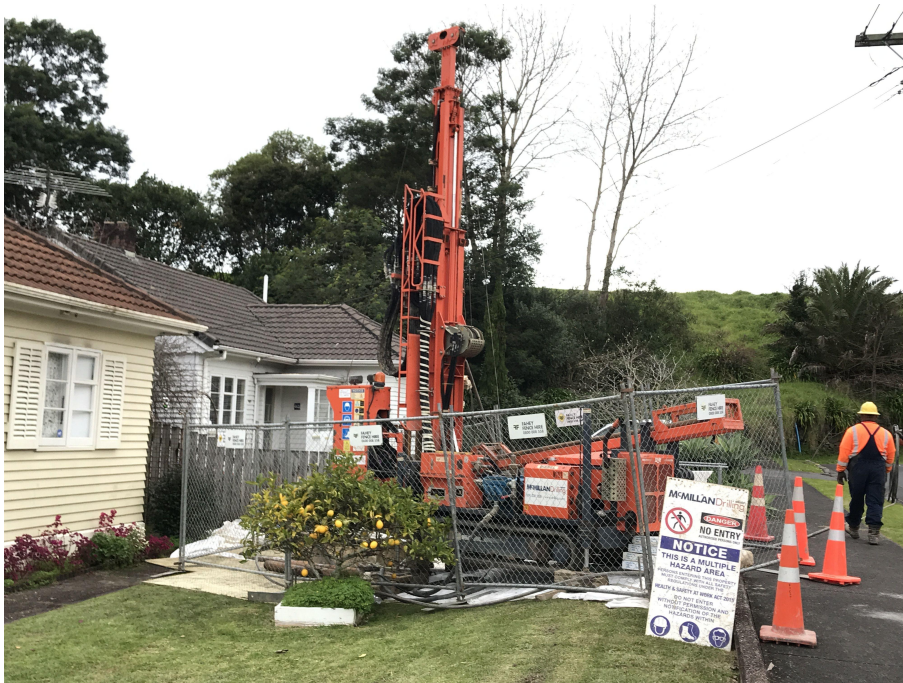
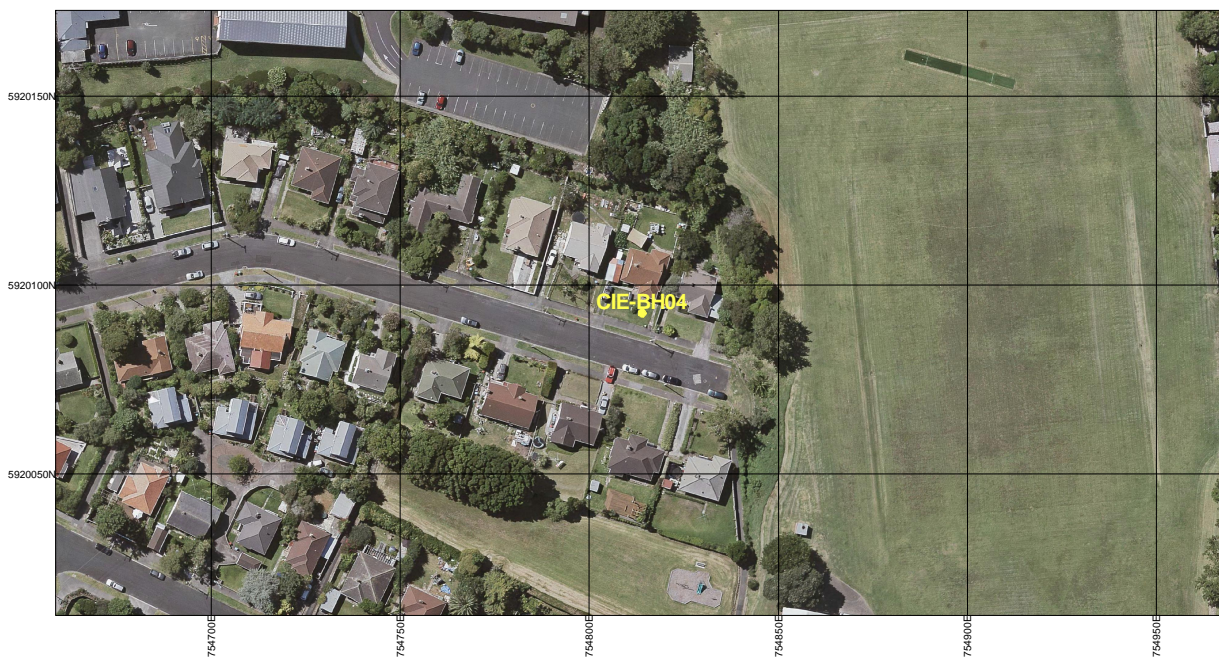
Started: 5/07/2018
Finished: 10/07/2018
Driller: McMillan
Plant: Rig N111 (McMillan)
Logged: S. Burgess
Checked: LD

Remarks
Packer Test 1 at 9.75-12.00 m, Packer Test 2 at 19.25-22.50 m, Packer Test 3 at 28.50-31.50 m. Vibrating wire piezometer installed with sensor at 26.0m. Water level = 16.1 m RL.
Joint angles are relative to the core axis. If a borehole is true vertical; horizontal=90, vertical=0.
Hole location is in NZTM projection. Elevation is relative to Auckland Vertical Datum 1946
Hole location determined by Survey.

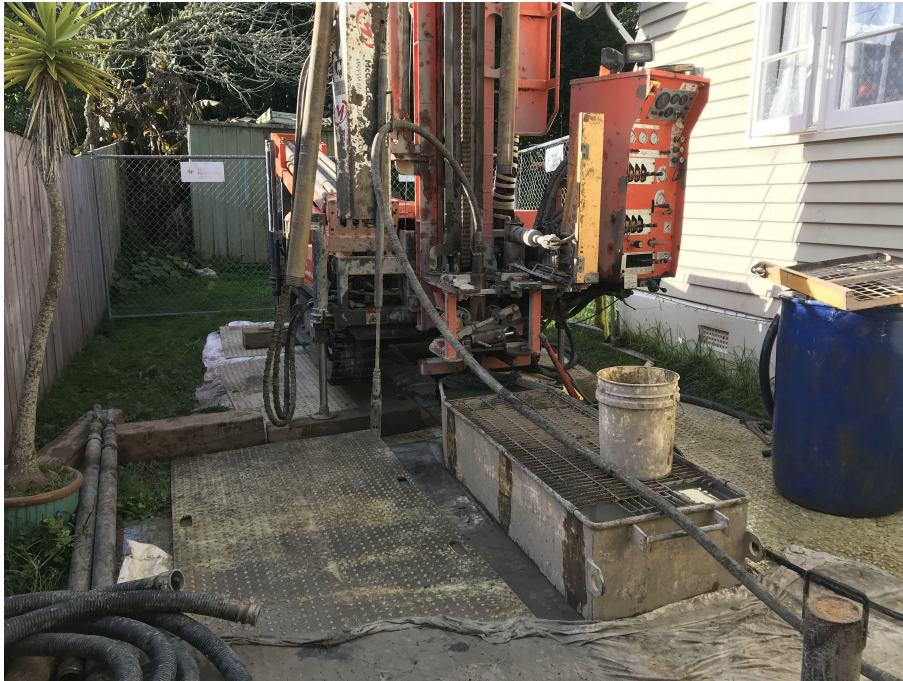
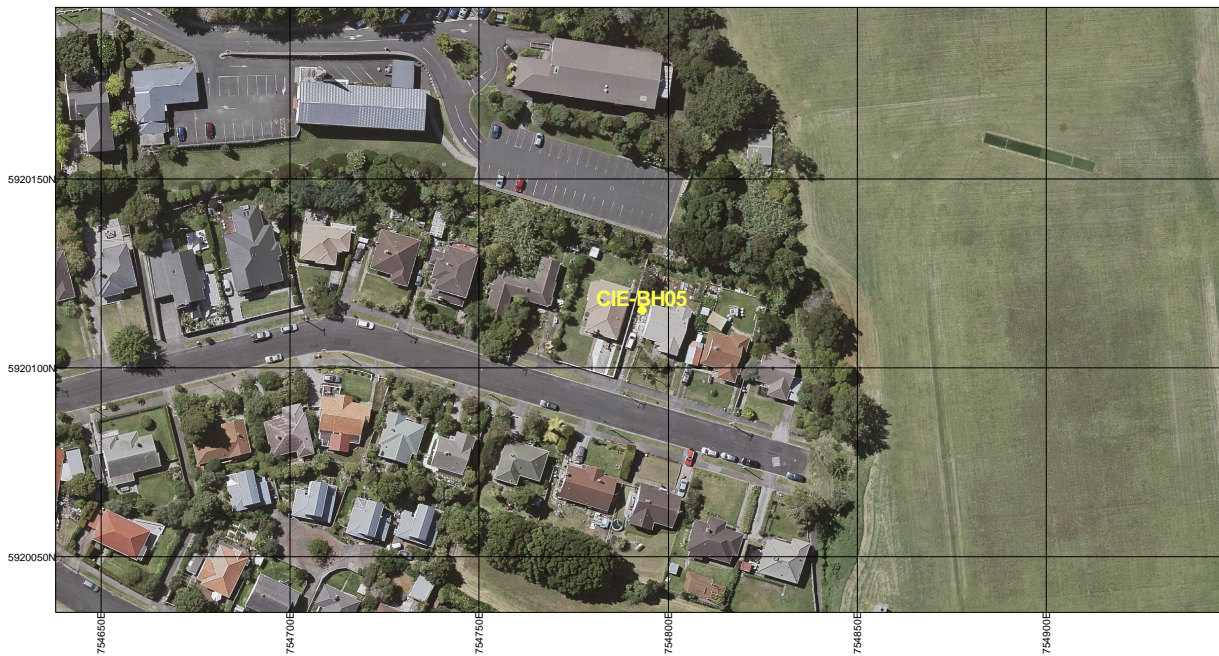
Started: 11/07/2018
Finished: 13/07/2018
Driller: McMillan
Plant: Rig N111 (McMillan)
Logged: S. Burgess
Checked: LD

Remarks
Packer Test 1: 11.00 - 13.50 m, Packer Test 2: 19.00 - 21.00 m, Packer Test 3: 28.50 - 31.50 m. Vibrating wire piezometer installed with sensor at 26.0m. Water level = 16.0 m. Joint angles are relative to the core axis. If a borehole is true vertical; horizontal=90, vertical=0. Hole location is in NZTM projection. Elevation is relative to Auckland Vertical Datum 1946 Hole location determined by Survey.
