Arborist Tree Protection Management Plan – Batch 3

Appendix L11 to the Construction Management Plan
(GAJV-PLN-00017)

CENTRAL INTERCEPTOR TREE PROTECTION MANAGEMENT PLAN

For:	Ghella Abergeldie JV (GA-JV)
Subject:	Tree Protection Management Plan for construction phase of Central Interceptor – Batch 3 sites
Prepared by:	Leon Saxon – Senior Consultant 0274 957 221 leon@arborlab.co.nz
Reviewed by:	Jon Redfern – Principle Consultant
Date:	November 2019

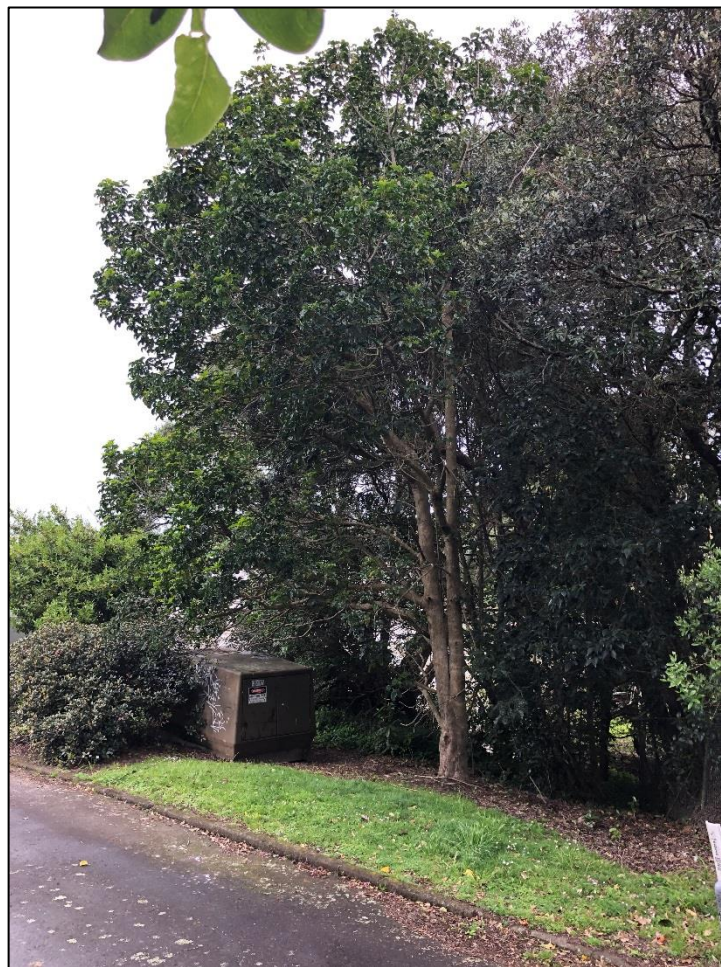
Figure 9 – Tree 6 which will likely require pruning over the access-way.

A group of four trees, two Puriri and two pōhutukawa (Trees 6, 9, 10 & 11) are located in a position at the western aspect of the work area within the designation, and are likely to be sufficiently isolated that they may be able to be retained. As construction space is limited on this site, it is likely that the area within the dripline and rootzone of trees 6, 10 & 11 will be required to be utilised for storage of equipment or laydown. Protection measures including pruning, by way of crown lift and lateral reduction, will provide sufficient clearance to truck movements and temporary surfacing will protect the root zones to allow for any potential storage buildings located beneath the trees. Where possible these trees will be attempted to be protected, but if they get damaged by construction works then they may require removal.

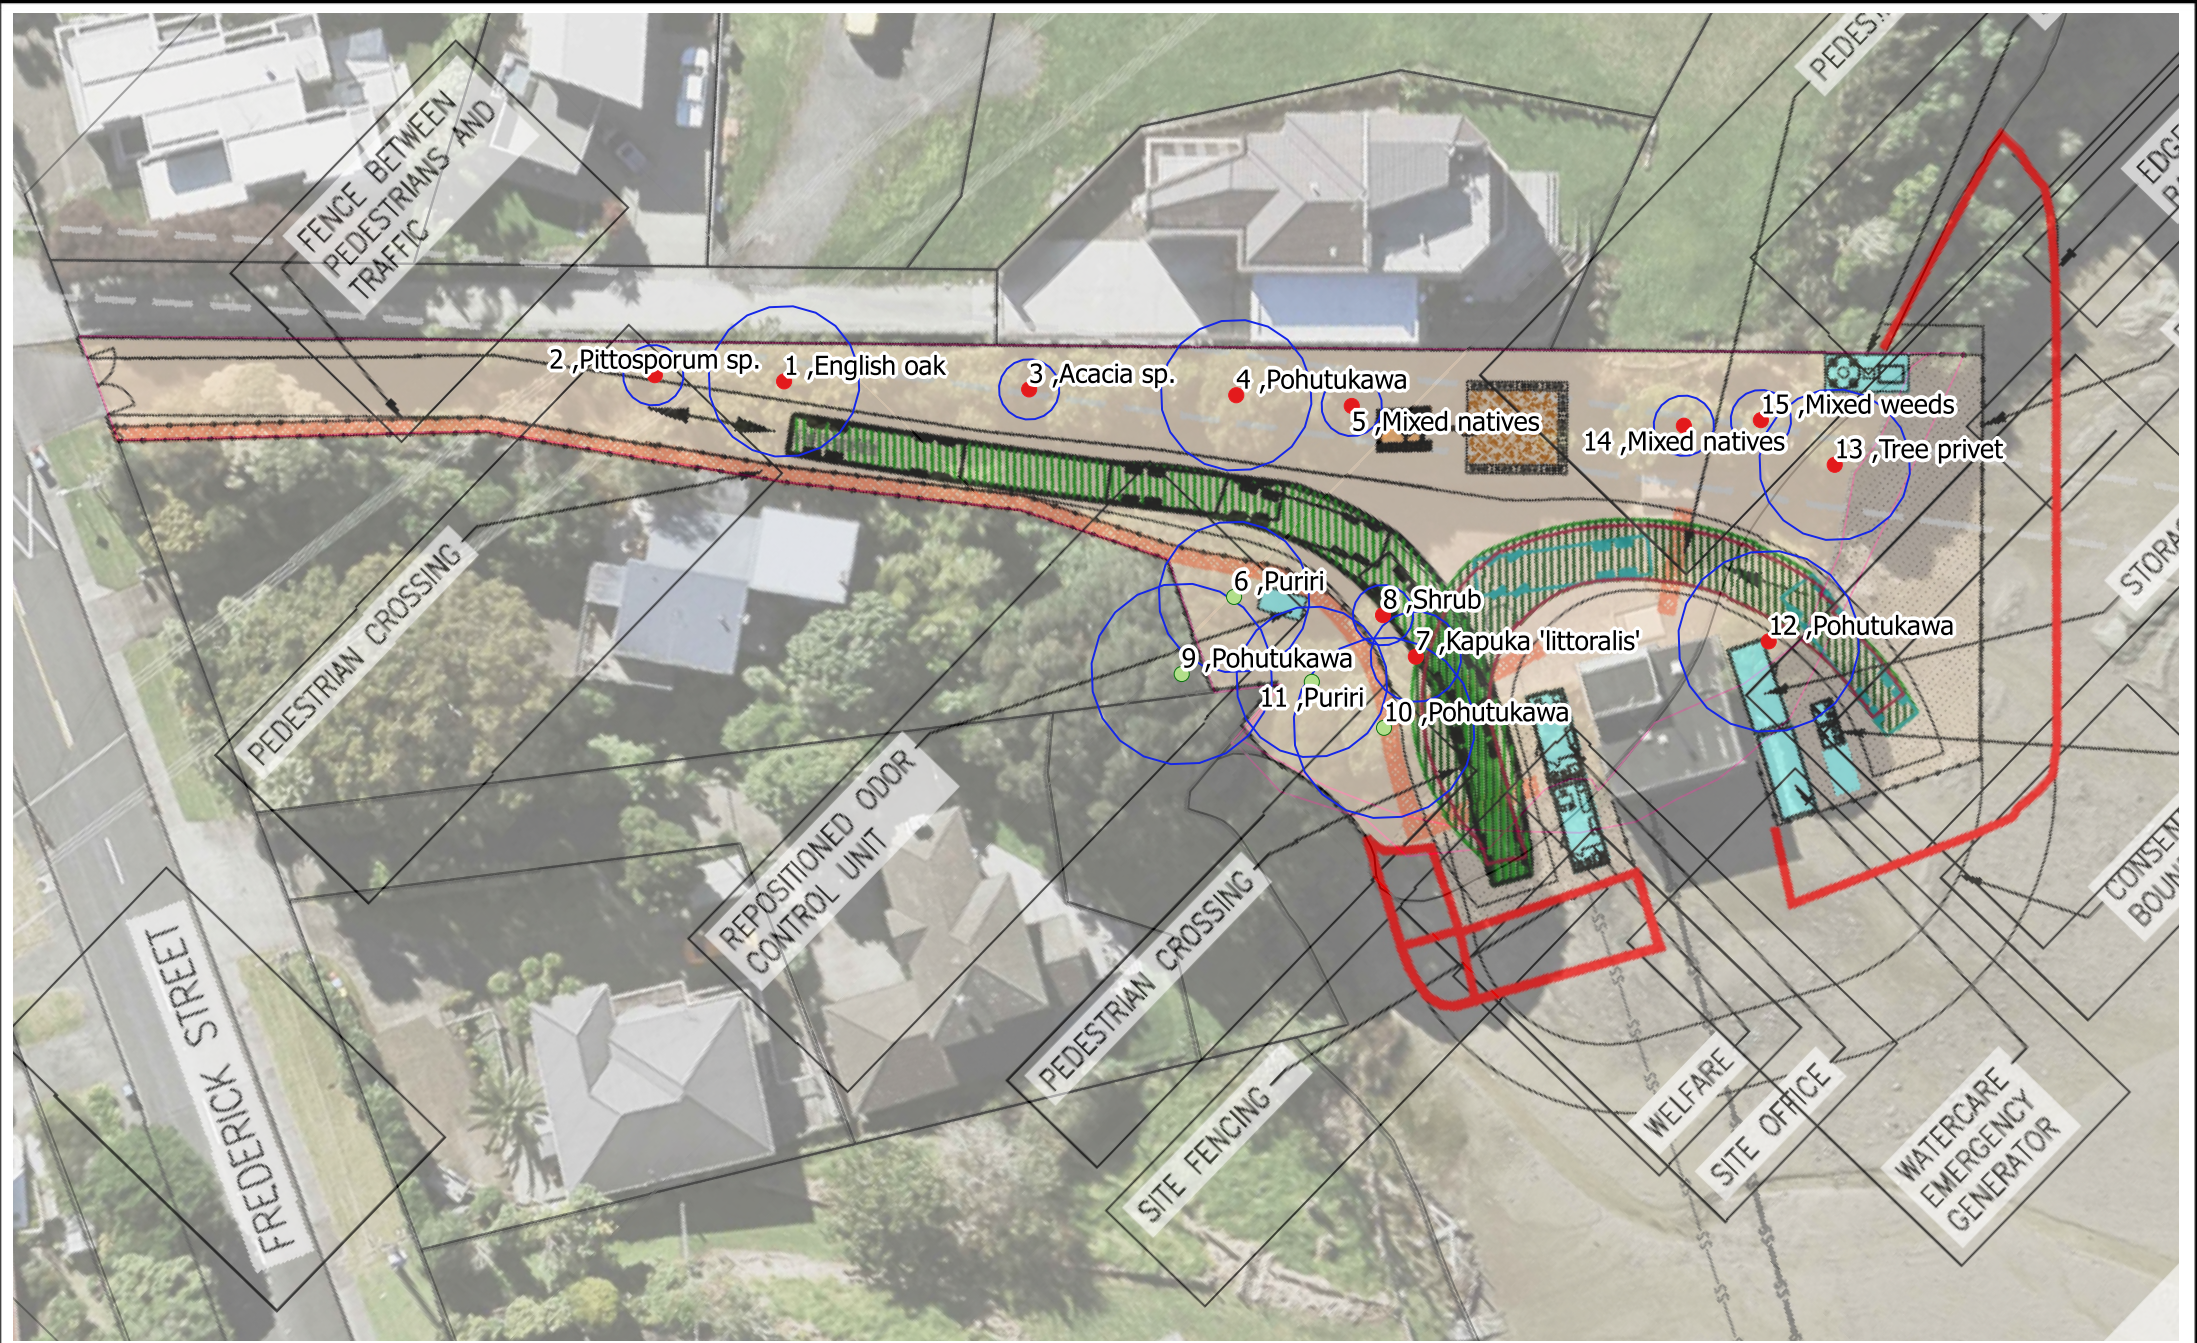
TREE LOCATION PLAN

Central Interceptor
Frederick Street (PS23)

The site at PS23, located at 39 Frederick Street, is an existing Watercare pump-station. It is accessed via an existing sealed driveway, with the land sloping up to the north from the driveway edge. Machinery access is required along this northern aspect of the site, and as such all of the vegetation within this area requires removal.

An established pōhutukawa tree and several weed species including tree privet (Trees 12, 13 & 15) will also require removal.

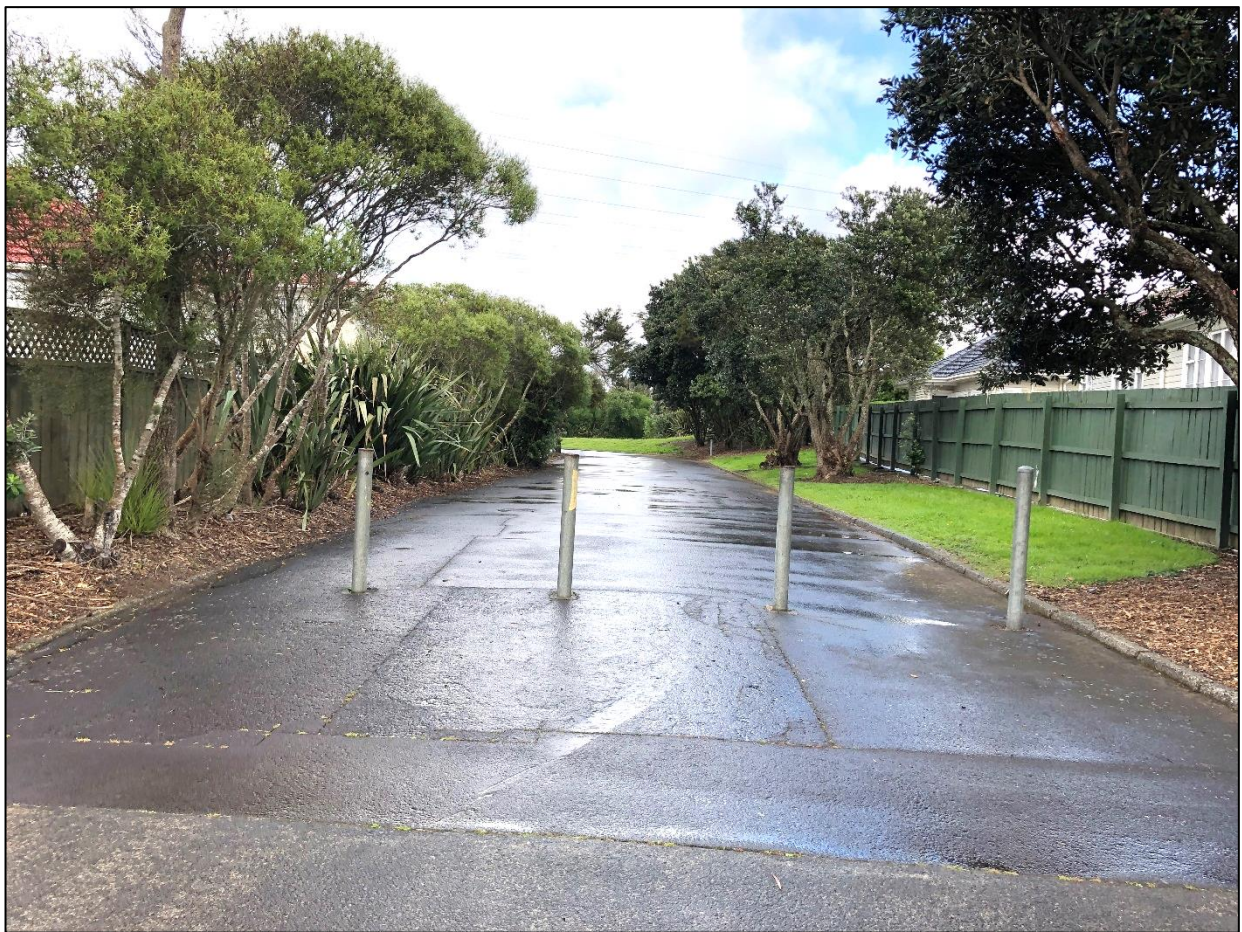
Figure 10 – Trees aligning access-way likely to require pruning.

The Pump Station 25 (PS25) site is accessed via a concrete driveway between No.32 and No.34 Miranda Street. The driveway has a selection of smaller growing mixed species on the left side and larger growing specimen trees (primarily pōhutukawa) growing on the right side. This vegetation will either require pruning, by way of crown-lifting, or removal, to provide sufficient clearance for truck movements.

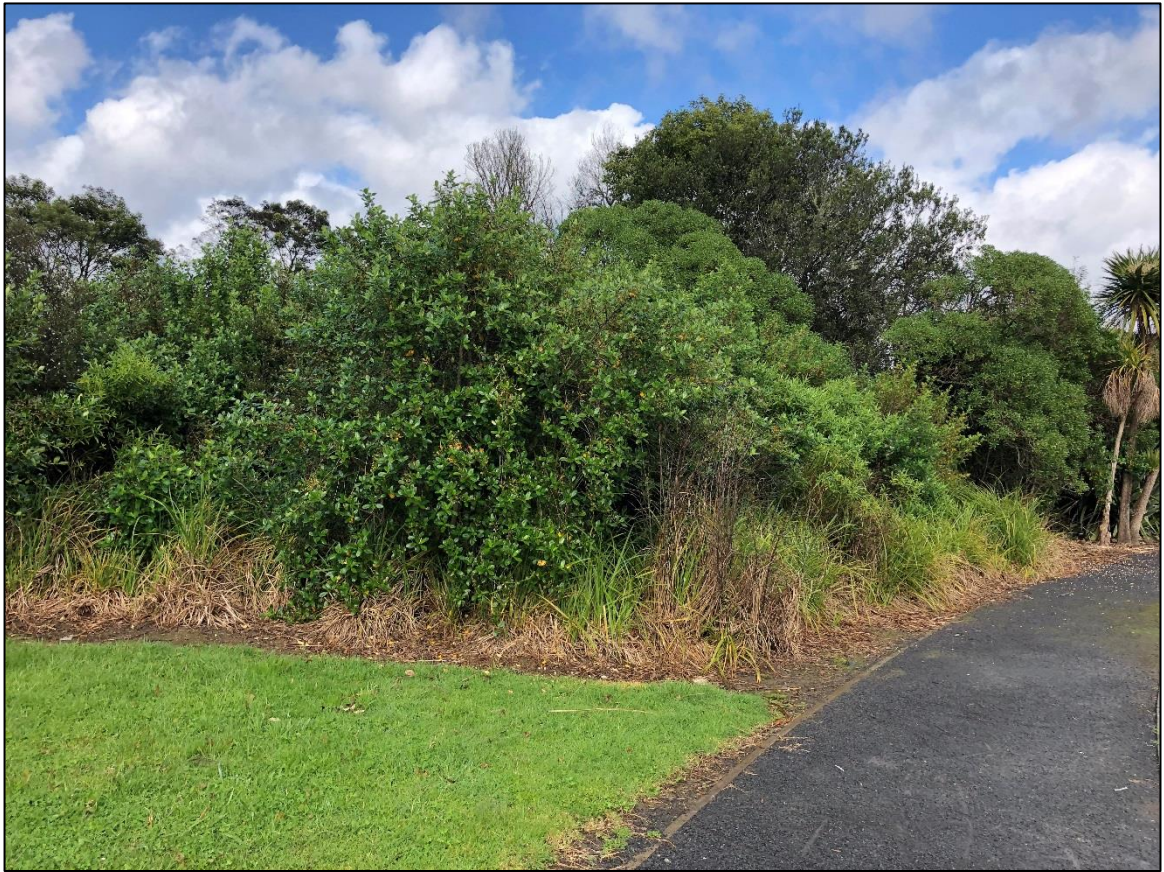
Figure 11 – Native vegetation (group 7) requiring removal.

Two small areas of native vegetation within the reserve conflict with the site layout and will require removal (Tree groups 6 and 7).

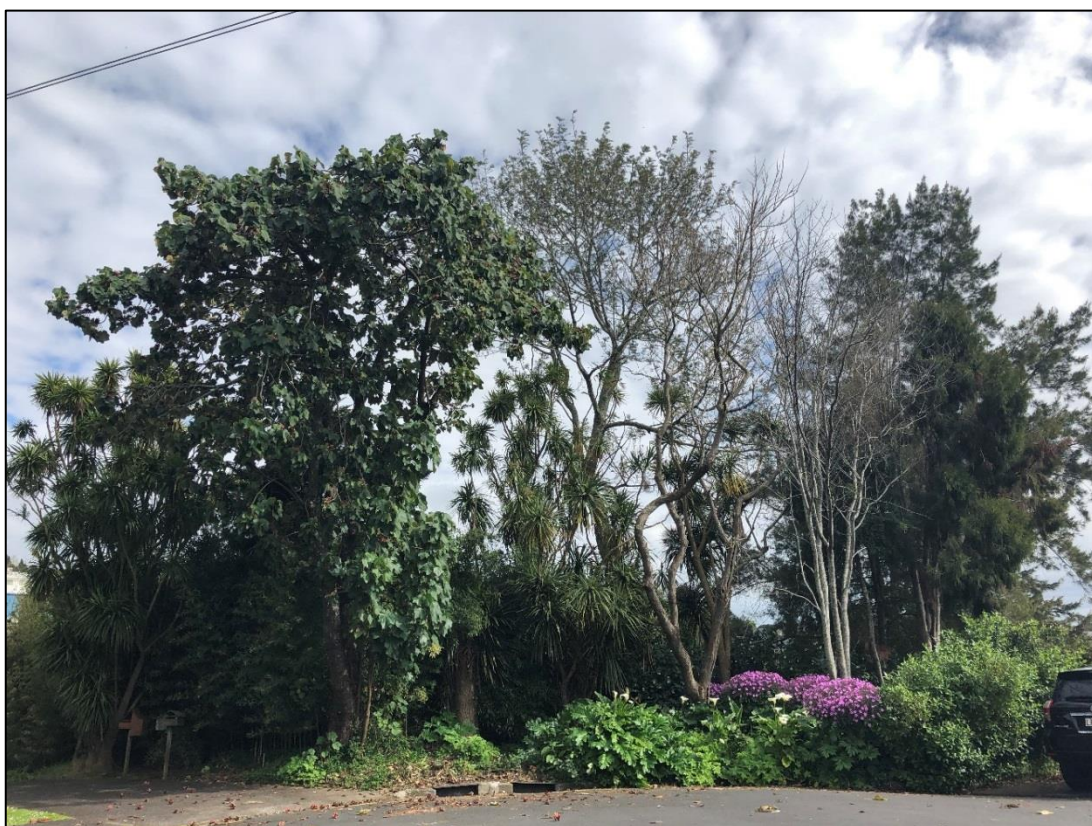
Figure 12 - Trees located at the end of Camden Road (Trees 5 – 9).

The road reserve at the end of Camden Road contains an assortment of mostly exotic, mature trees (Trees 5 – 9). One tree of particular botanical interest is a monkey hand tree (*Chiranthodendron pentadactylon*).

The plans indicate that the entry point from Camden Road is no longer to be utilised for vehicular access. This means that trees 5 – 7 are no longer affected by the proposed works.

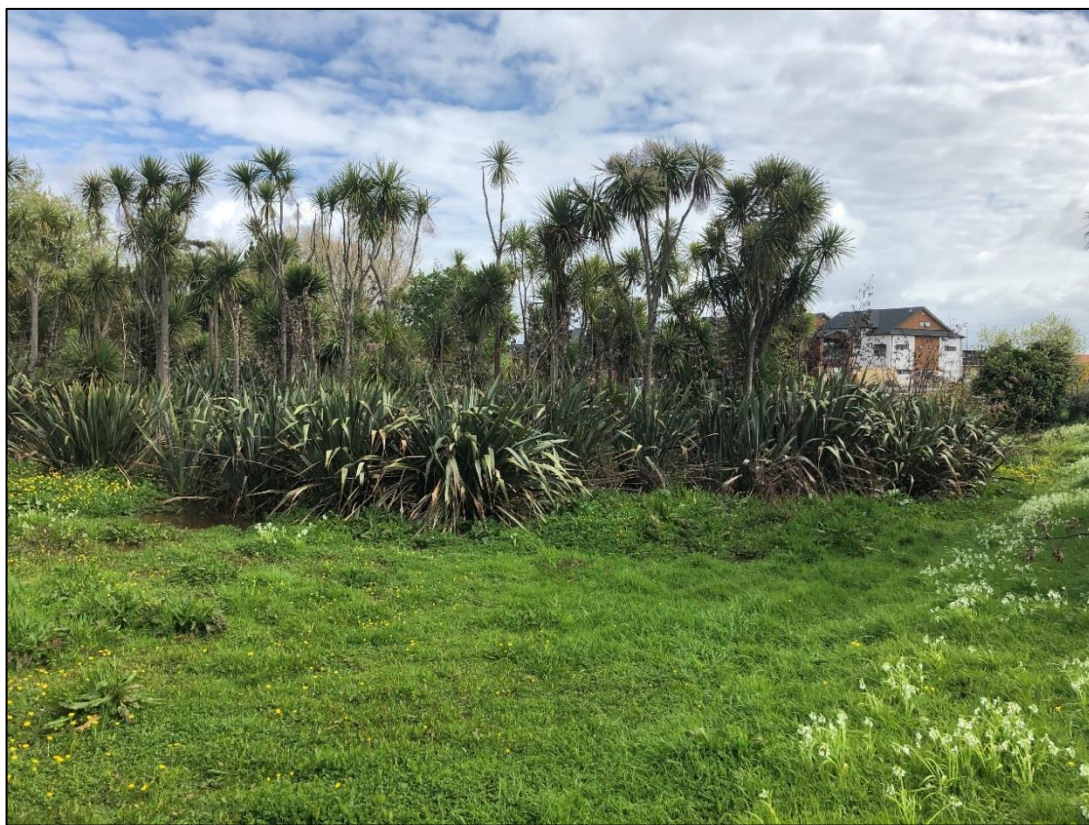
Figure 13 – Collection of Cabbage trees (Tree 4) on the Haverstock Road site.

Tree 4 is a group listing consisting of a collection of cabbage trees/ti kouka (*Cordyline australis*). It is understood that these trees were planted during the period when cabbage tree decline began to occur as a research crop. As such, the trees have a high value to the research teams that were/are studying them. The trees conflict with the current construction layout and based on that will need to be either removed or relocated as agreed with the landowner, Plant and Food. Further discussions are underway with Plant and Food to identify opportunities to retain as many of the cabbage trees as possible.

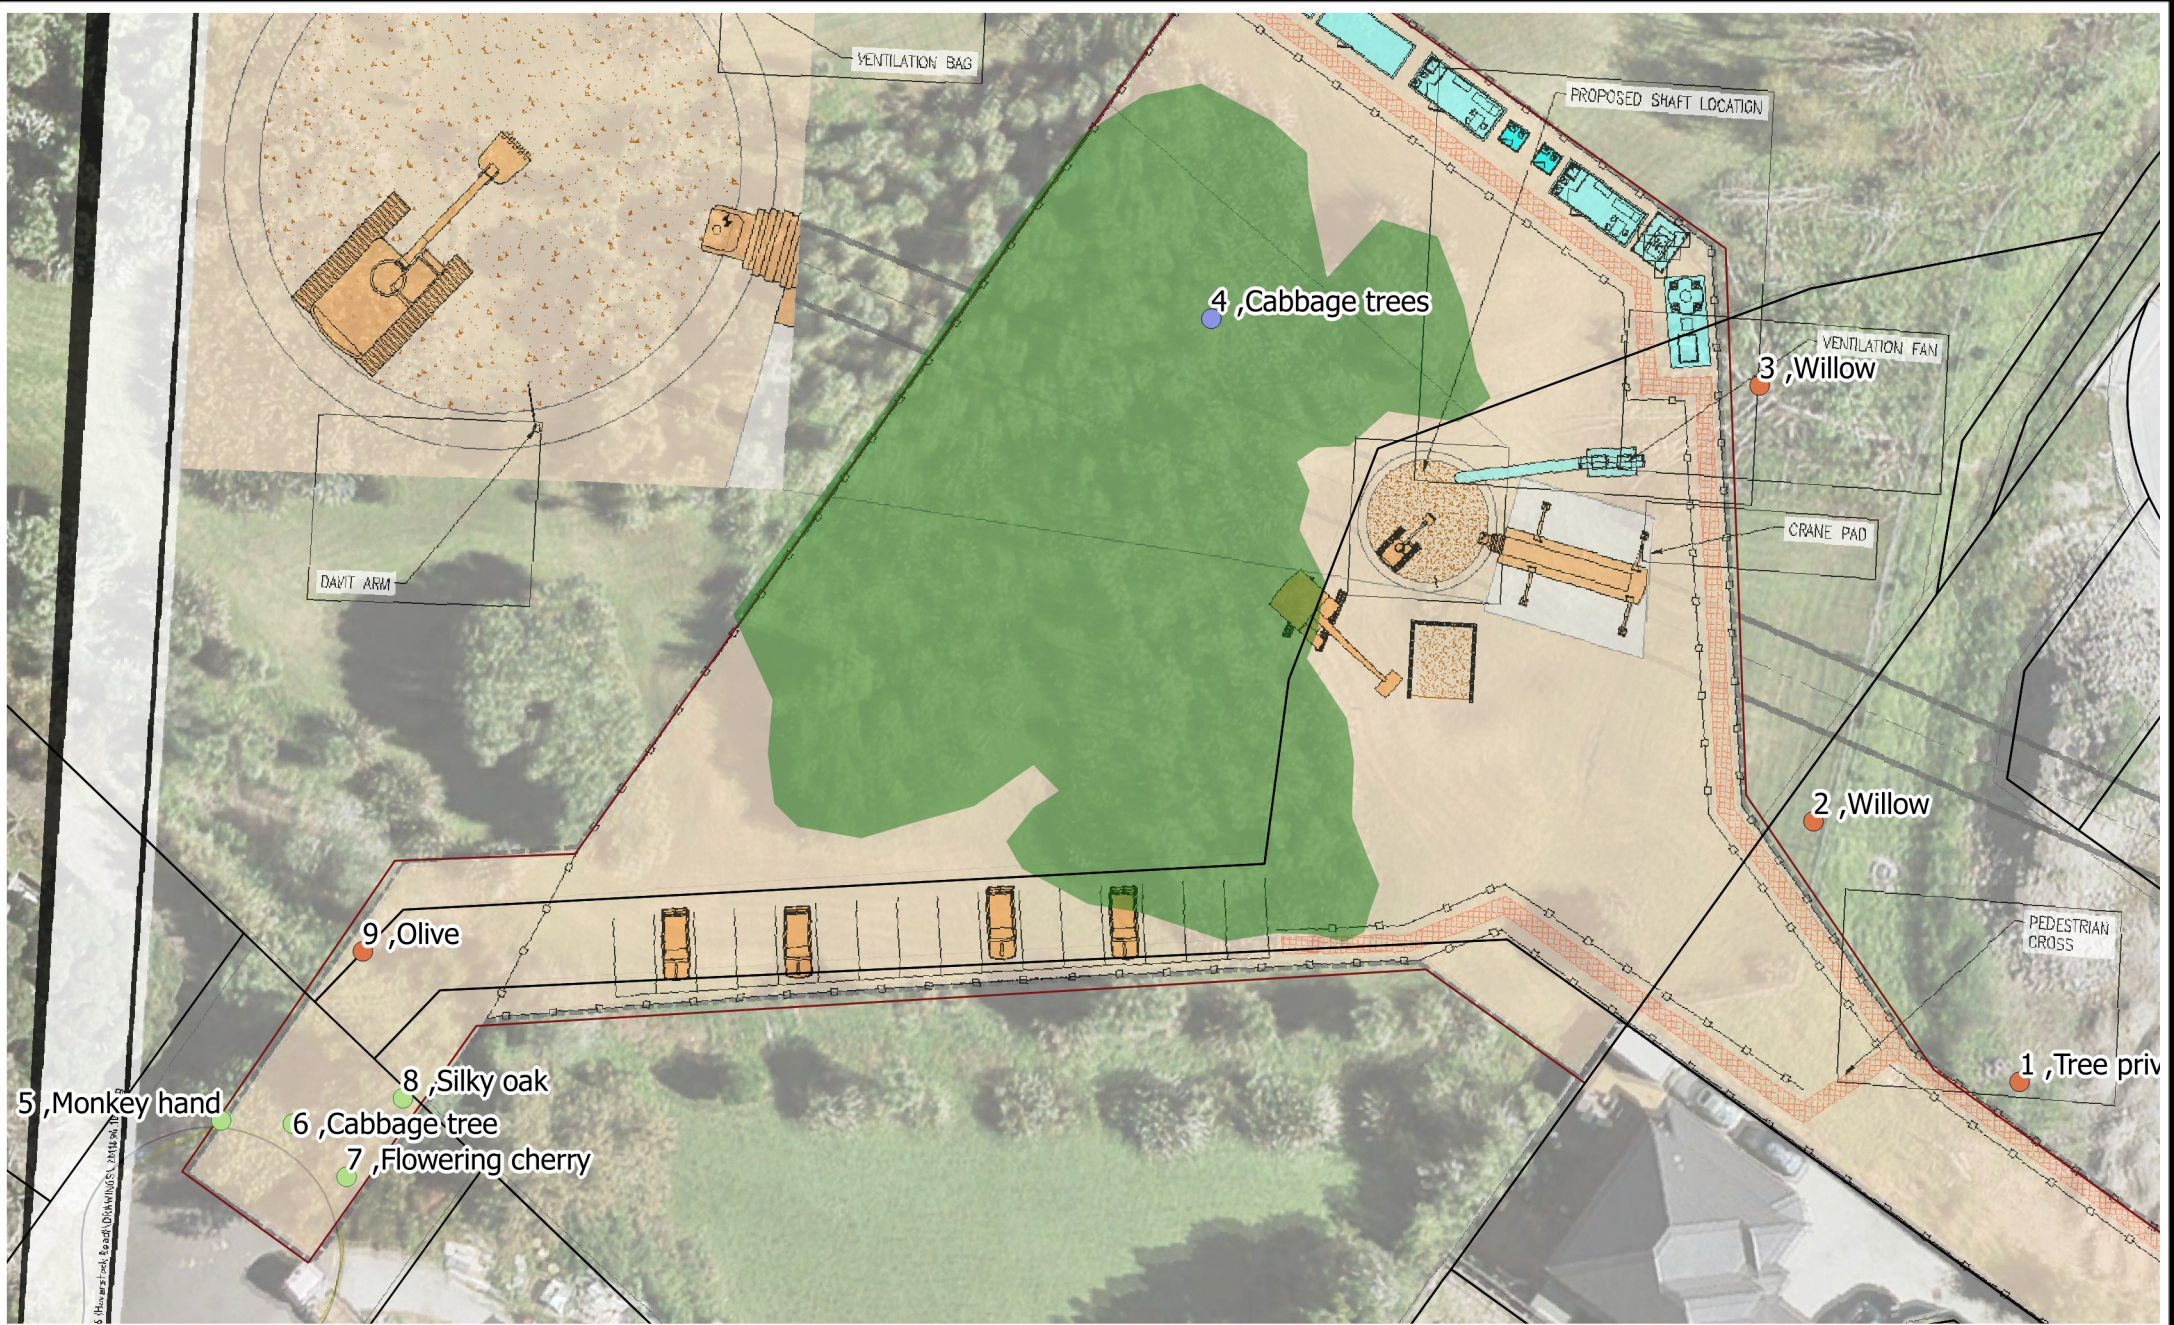
TREE LOCATION PLAN

Central Interceptor
Haverstock Road

The designation and resource consents allowed for access to the Haverstock Road site from two possible entry points. One from the end of Camden Road and the other from Haverstock Road (adjacent to 96 Haverstock Road).

Trees 1 – 3 consisted of two willows and one privet. Since the original Arborlab report in 2012, these trees have been removed by other parties.

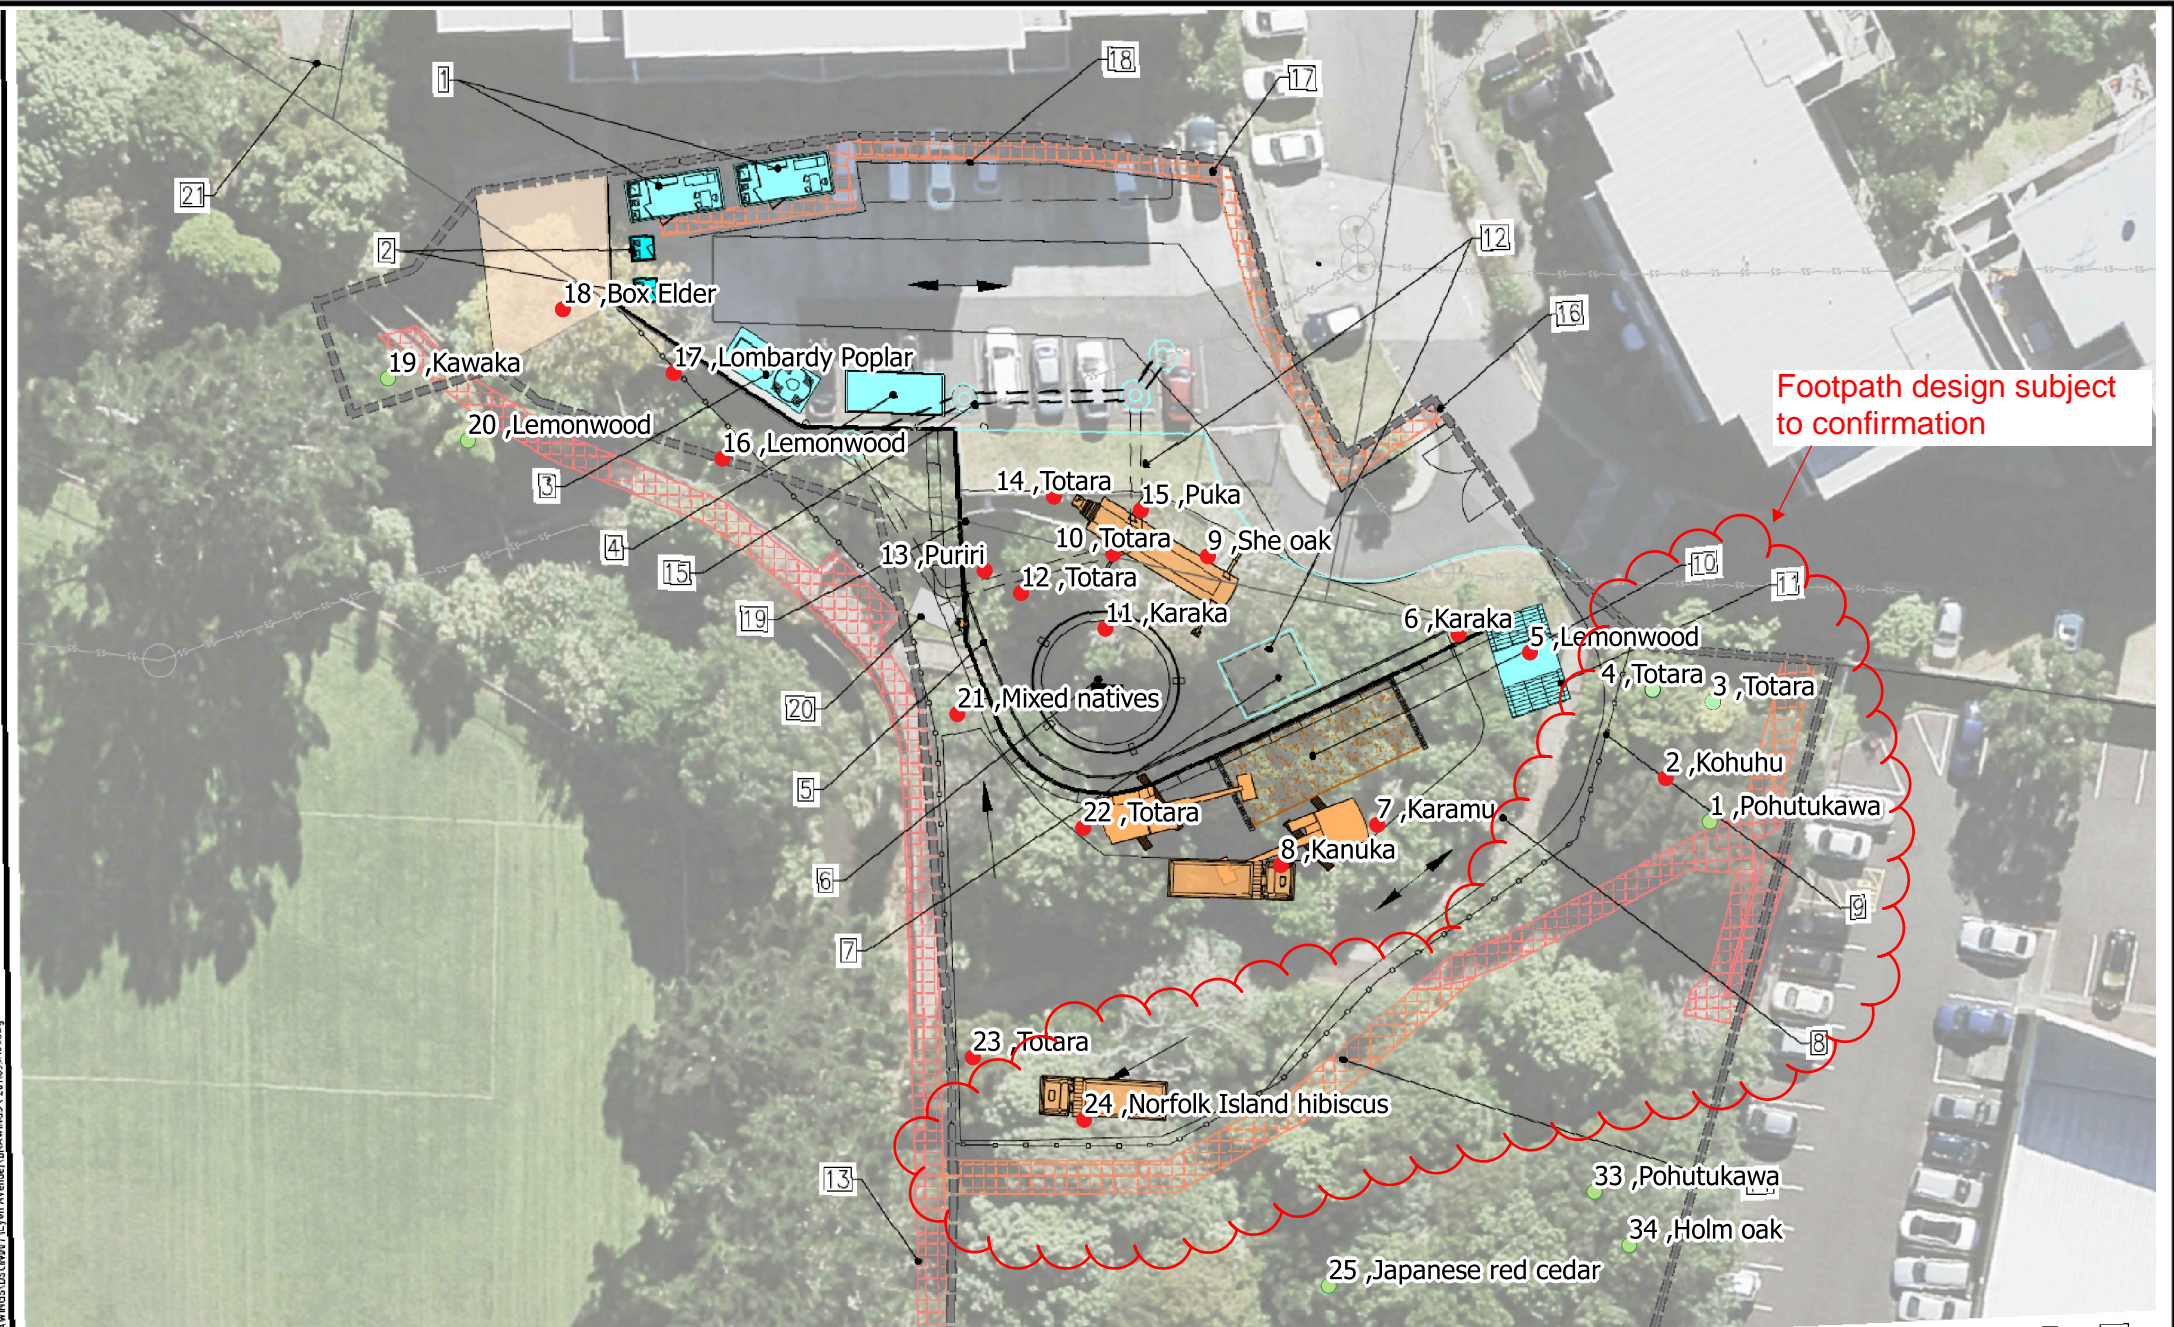
TREE LOCATION PLAN

Central Interceptor
Lyon Avenue

The Lyon Ave site is accessed via the end of Morning Star Place. All of the vegetation within the work site area will require removal other than one mature pōhutukawa (Tree 1). This vegetation is primarily comprised of young native vegetation but also includes a number of exotic trees.

Other vegetation, which is outside of the worksite but within the designation will be retained.

Tree 16 is a lemonwood tree located in the northern portion of the site. At this stage it is assumed to be within the designation, however confirmation of this is required by topographic survey. If the trunk of the tree is determined to be outside the designation then resource consent will be required to remove the tree.

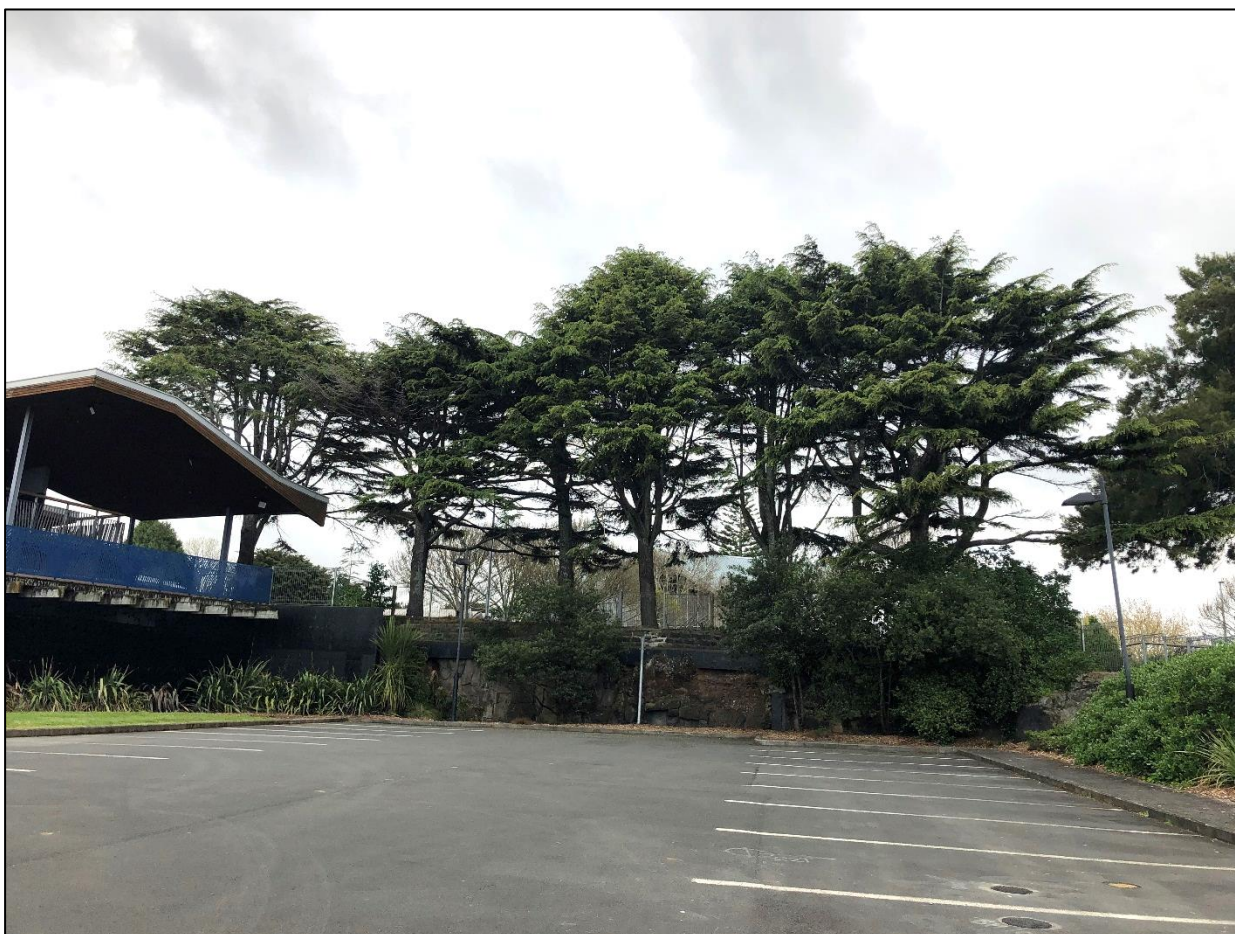
Figure 14 – Group of cedar trees (Trees 5 – 10).

A group of cedar trees (trees 5 – 10) growing to the south-east of the work site overhangs the site. The trees are located atop a retaining wall and no root activity is anticipated to be encountered. Minor pruning may be required to provide greater clearance to the site.

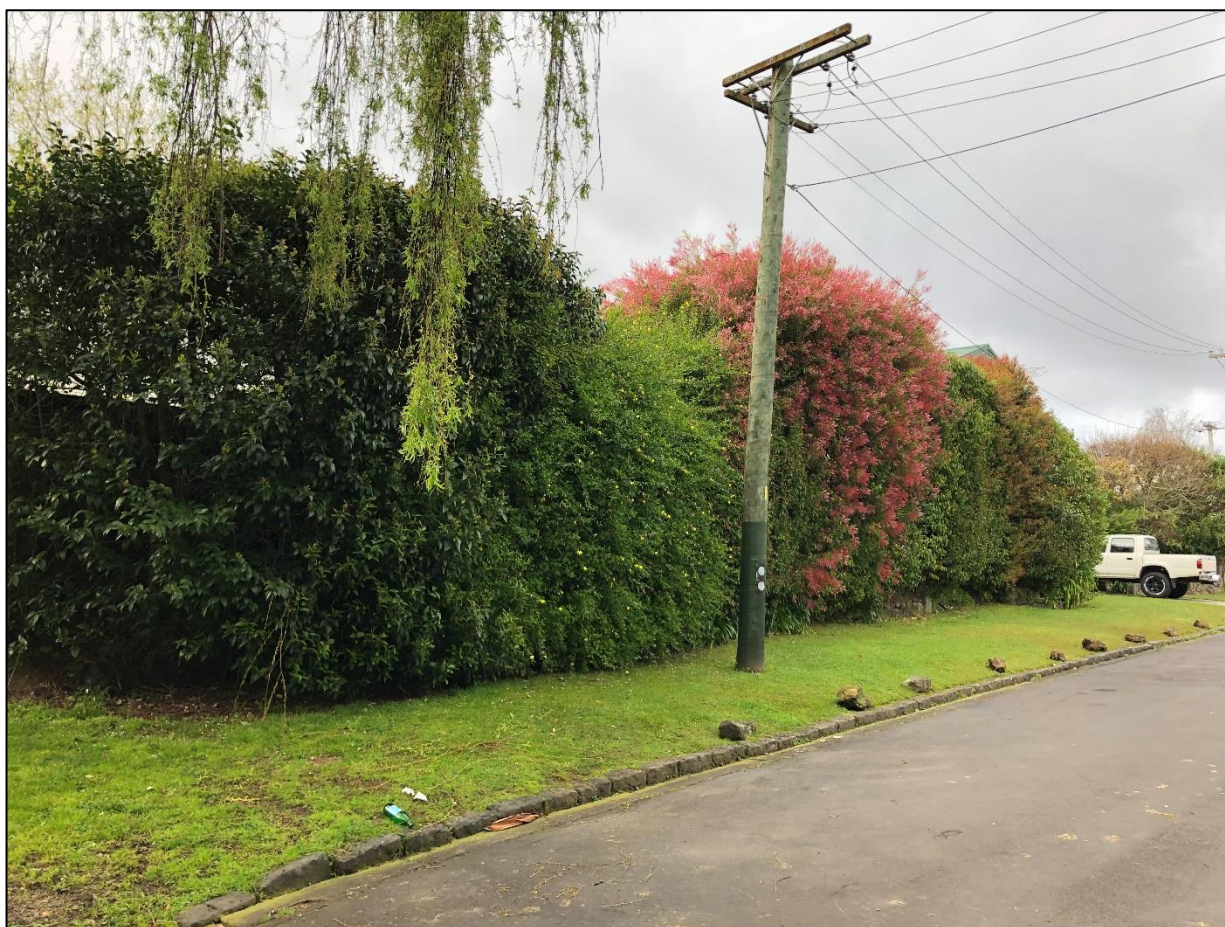
Figure 15 – Hedge of 27 Verona Avenue likely requiring trimming (Tree 7).

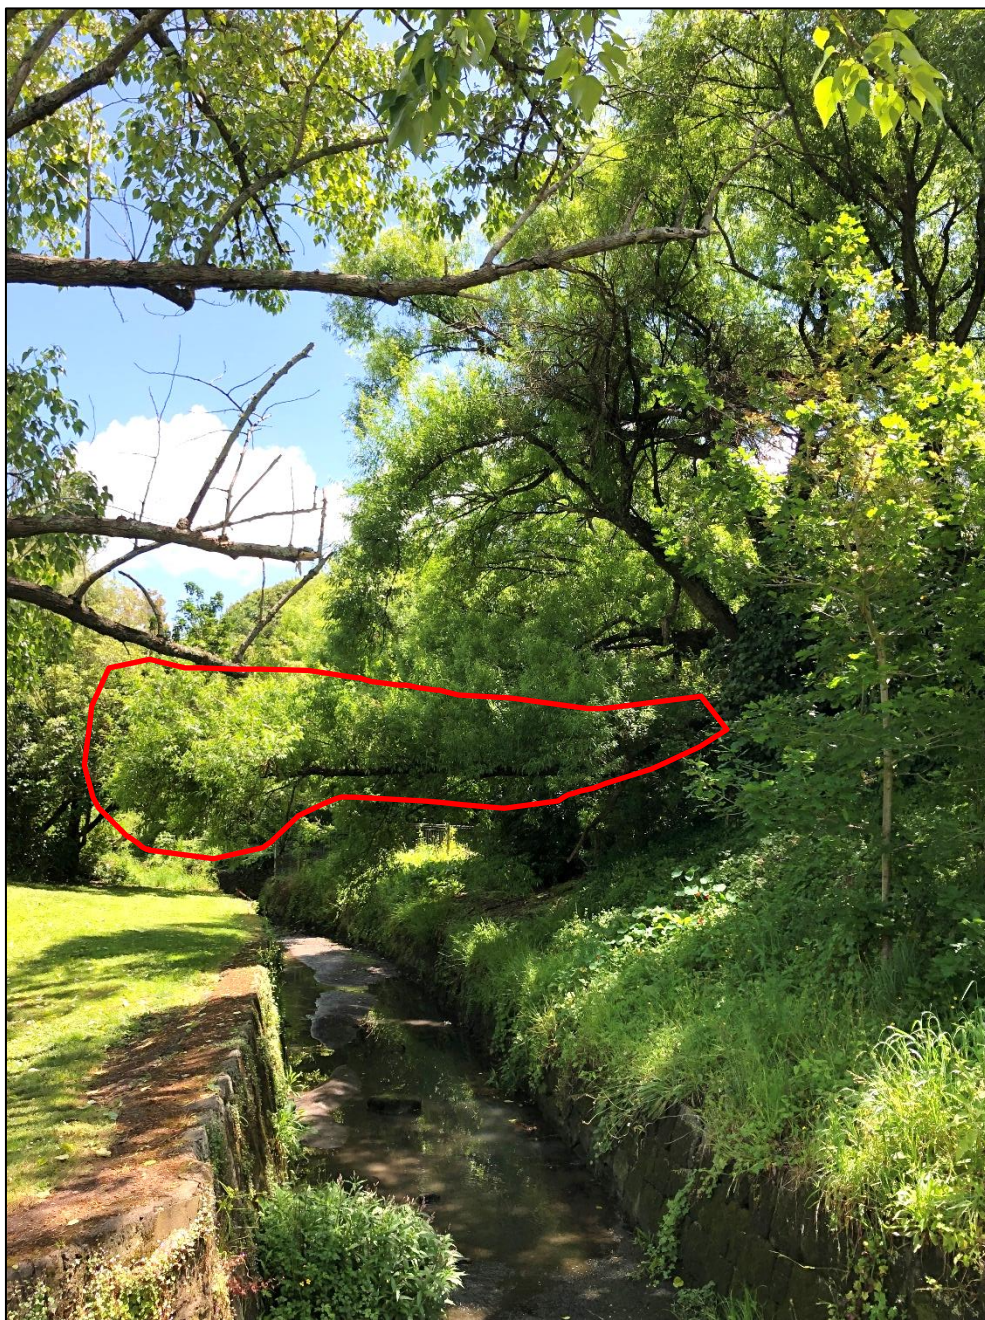
Figure 16 – The lowest stem on tree 23 will require removal as it conflicts with the site hoarding.

One willow within the reserve (Tree 23) will require crown lift pruning, involving the removal of a branch measuring approximately 150mm diameter as it will conflict with the site hoarding.

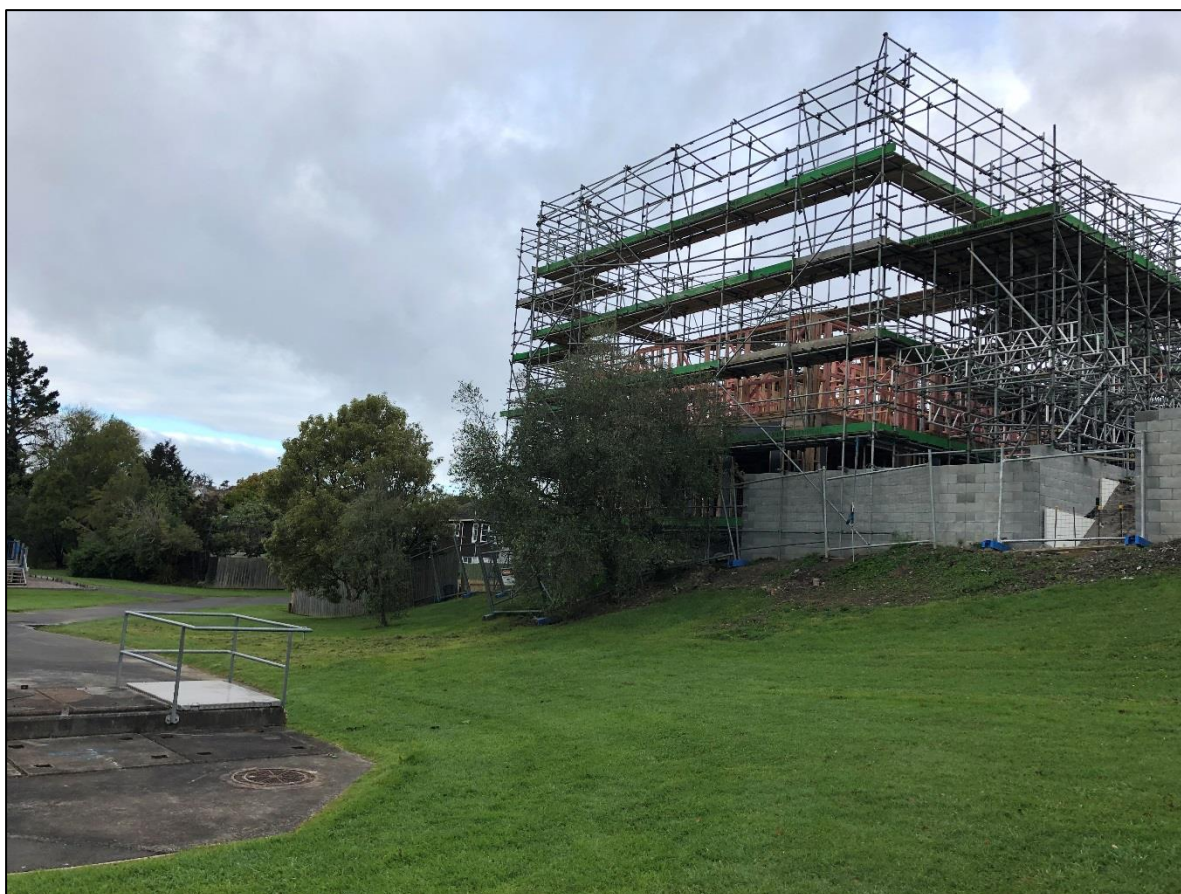
Figure 17 – Pittosporum and olive trees located at the edge of the work site able to be retained.

The site is generally open grass with young specimen tree planting. All of the trees within the work site will be removed other than one pittosporum and one olive (Trees 2 and 4).

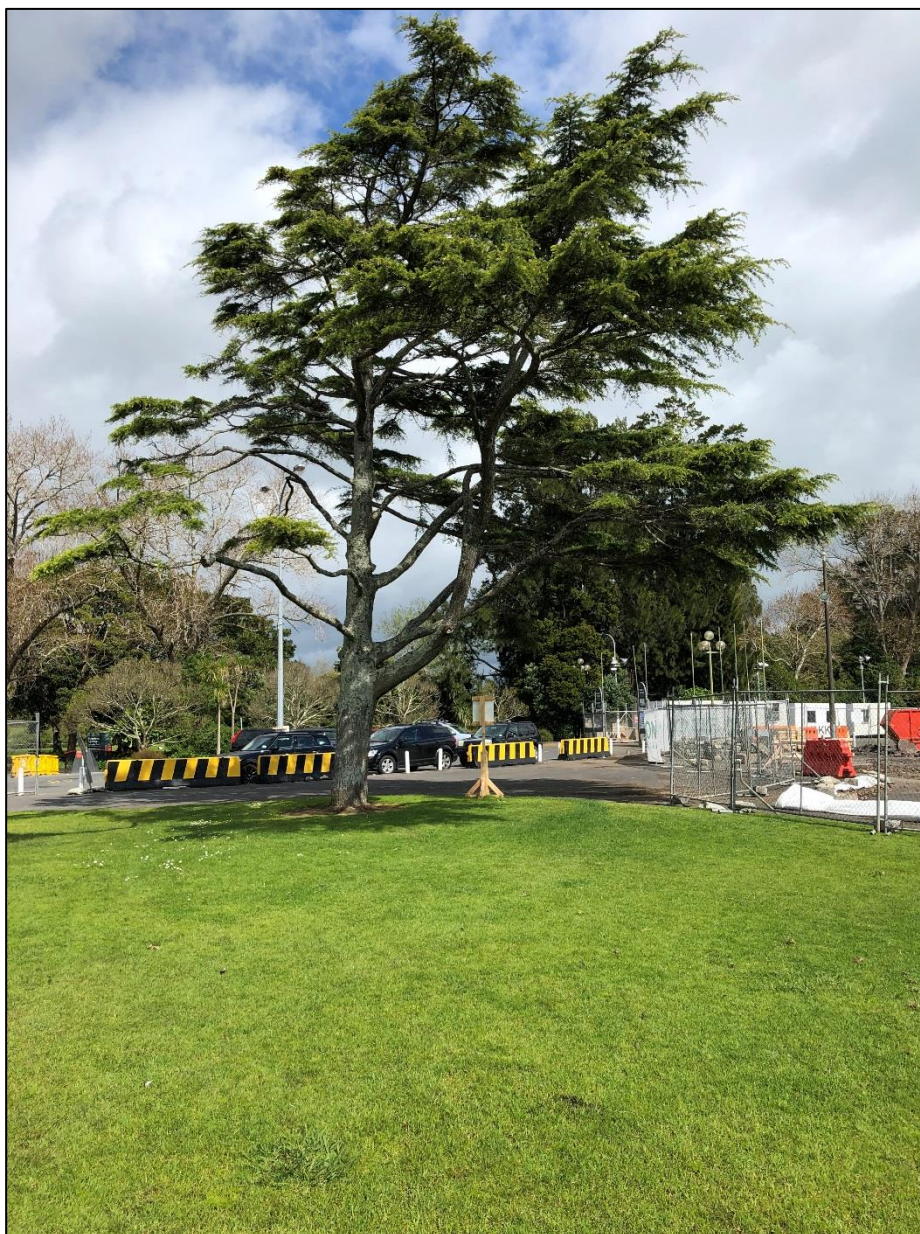
Figure 18 – The individual cedar tree likely requiring removal (Tree 11).

One of the cedar trees, which is isolated from the group, at its northern end, will require removal as it stands within the footprint of a significant excavation. This tree is outside of the designation and as such will only be removed once resource consent and landowner approval have been obtained.
