Preliminary Site Investigation

Replacement Huia Water Treatment Plant and Reservoirs

Prepared for
Watercare Services Limited

Prepared by
Tonkin & Taylor Ltd

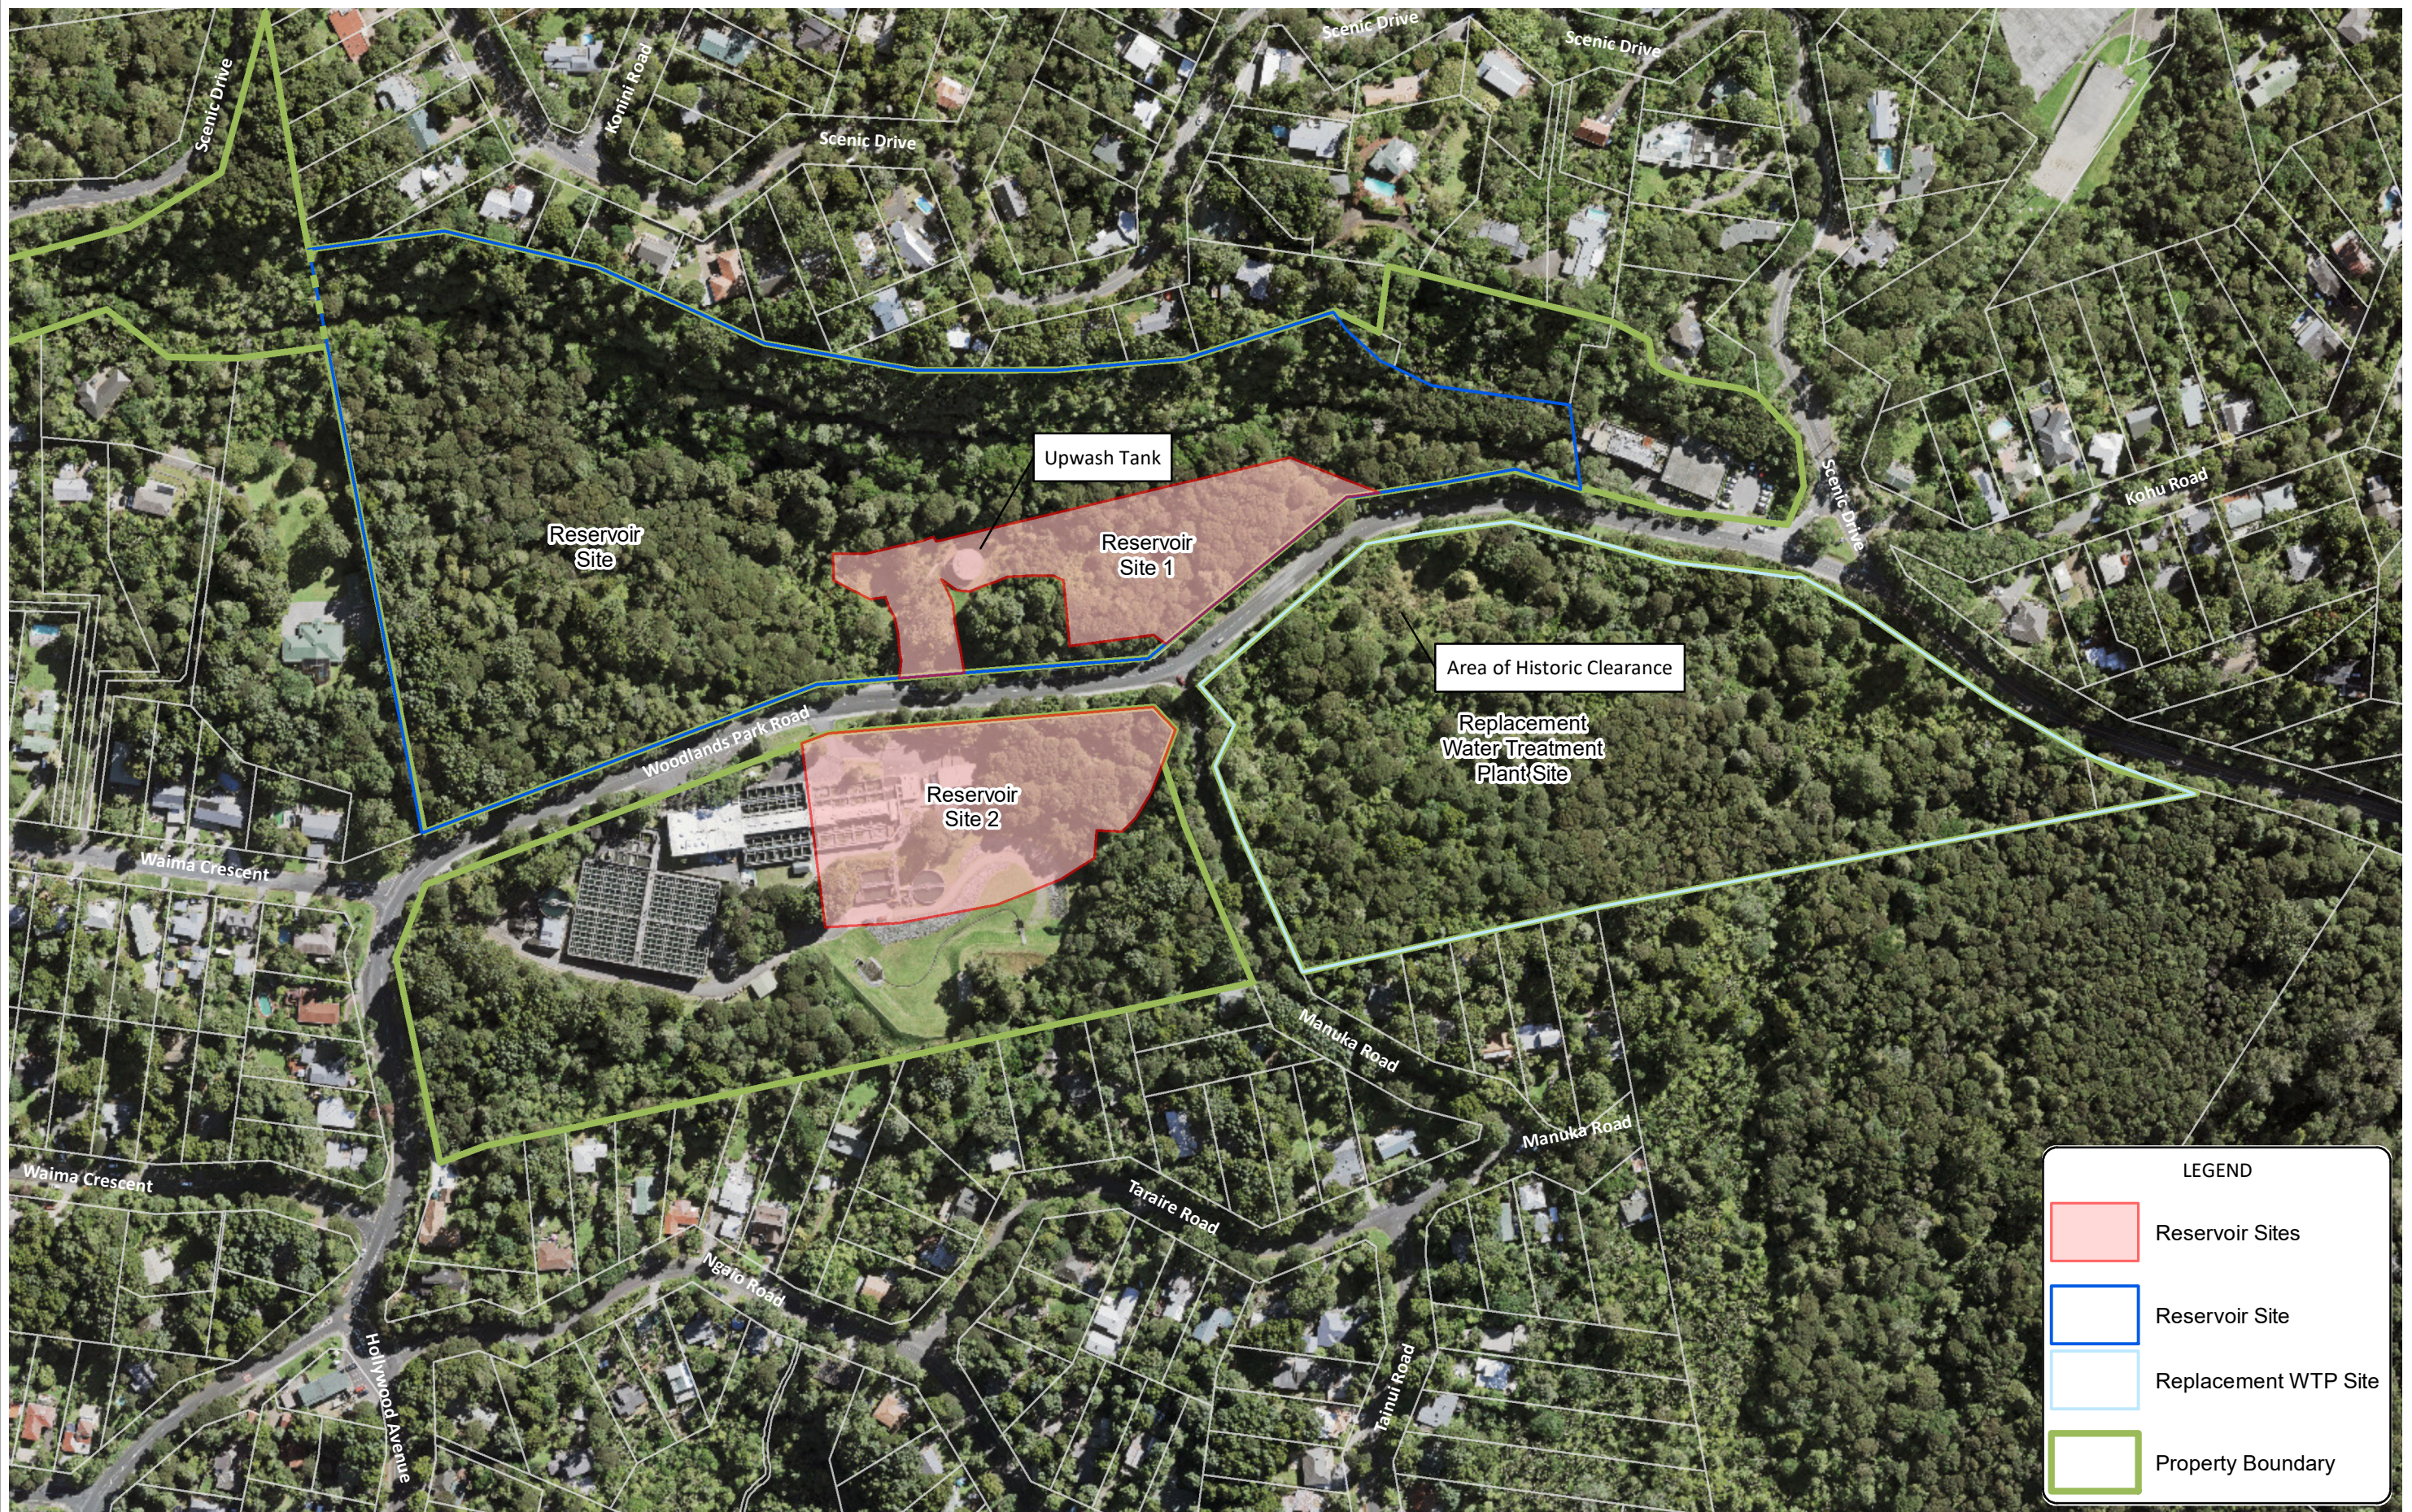
The proposed works are located within an area of land that encompasses three properties that are designated by Watercare for 'water supply purposes – water treatment plants and associated structures' as shown in Figure 1 outlined in green. The replacement WTP will be constructed on the corner of Manuka Road and Woodlands Park Road directly across from the existing Huia WTP site. The replacement WTP will have a treatment capacity of 140 mega-litres per day (MLD).

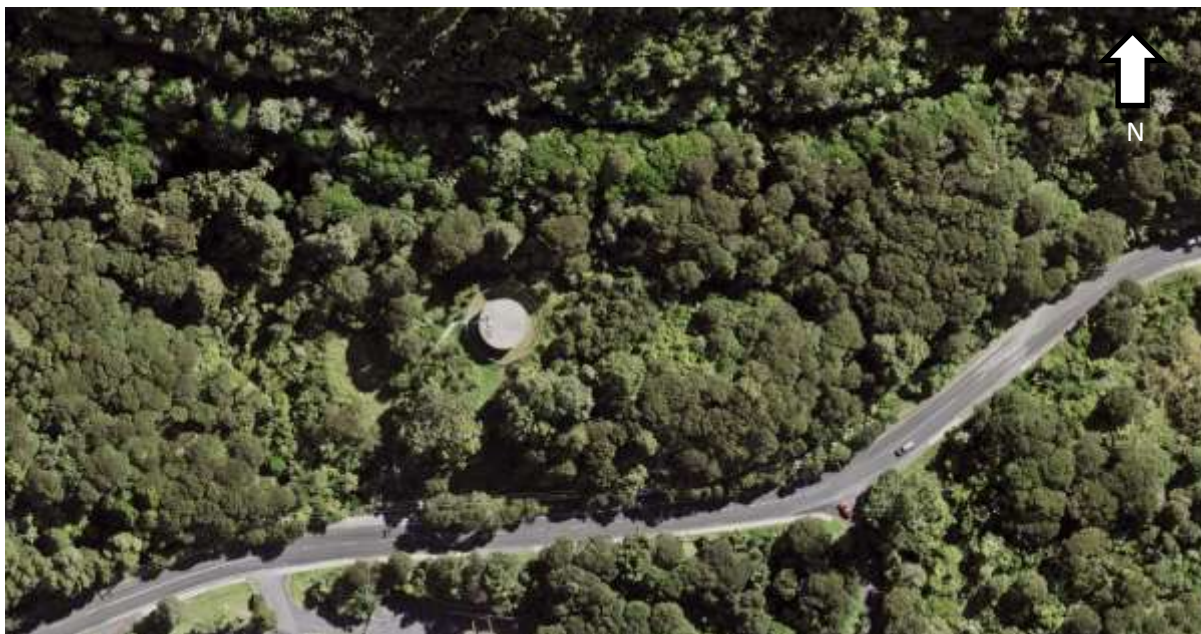
Figure 2.1: Upwash tank at Reservoir 1 site (Source: Google Maps)

The Reservoir 1 and replacement WTP sites are predominantly vegetated with the only notable structure apparent being a wash water tank on the Reservoir 1 site.

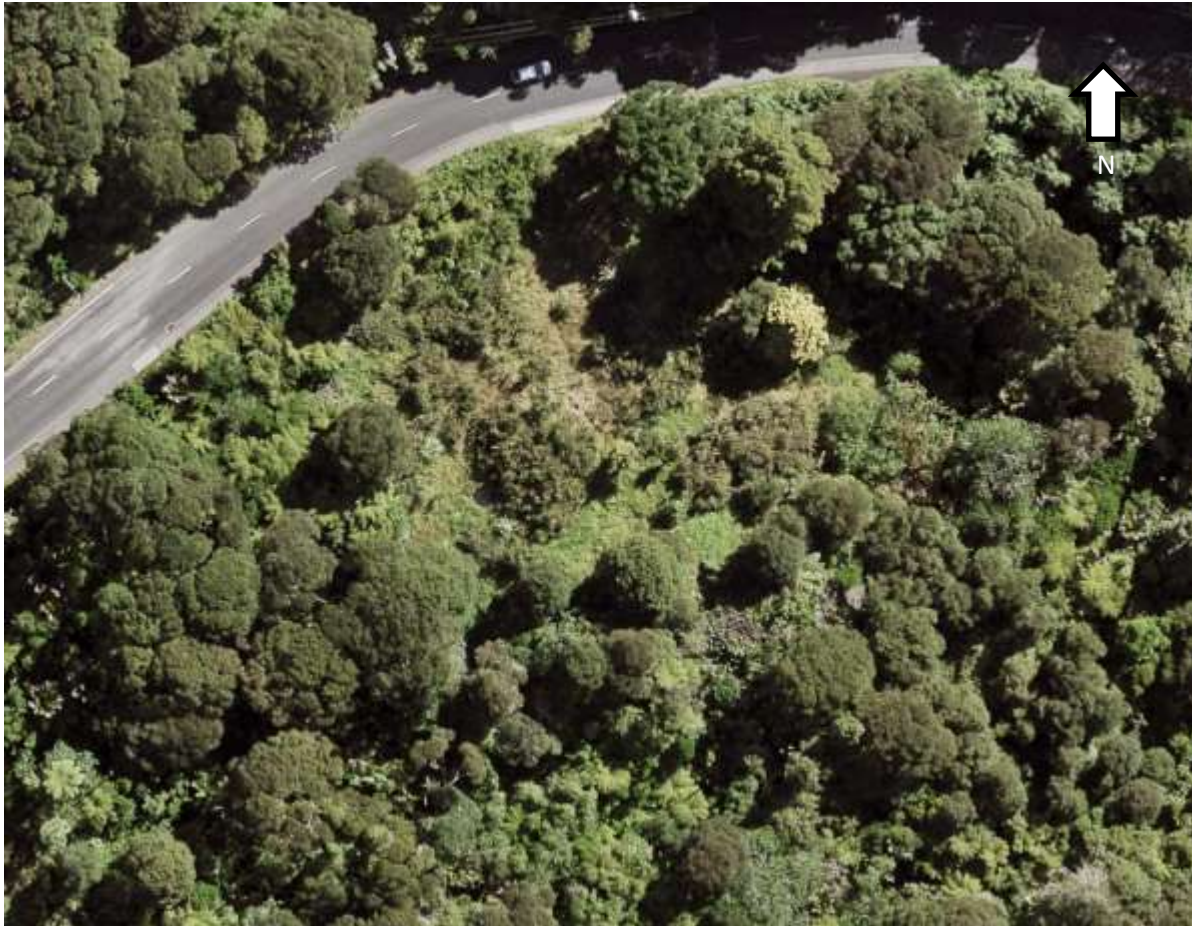
- On the replacement WTP site, a small area of clearance is evident in the current Google Maps aerial photograph (Figure 3) directly south of Woodlands Park Road. The potential origins of this cleared area is discussed in Section 3. This area was cleared in the 1940's aerial and has since been gradually reverting back into scrub. The removal of the houses has accelerated this transition.

Figure 2.2: 2017 Aerial Image showing the area of previous disturbance (source: Google Maps)

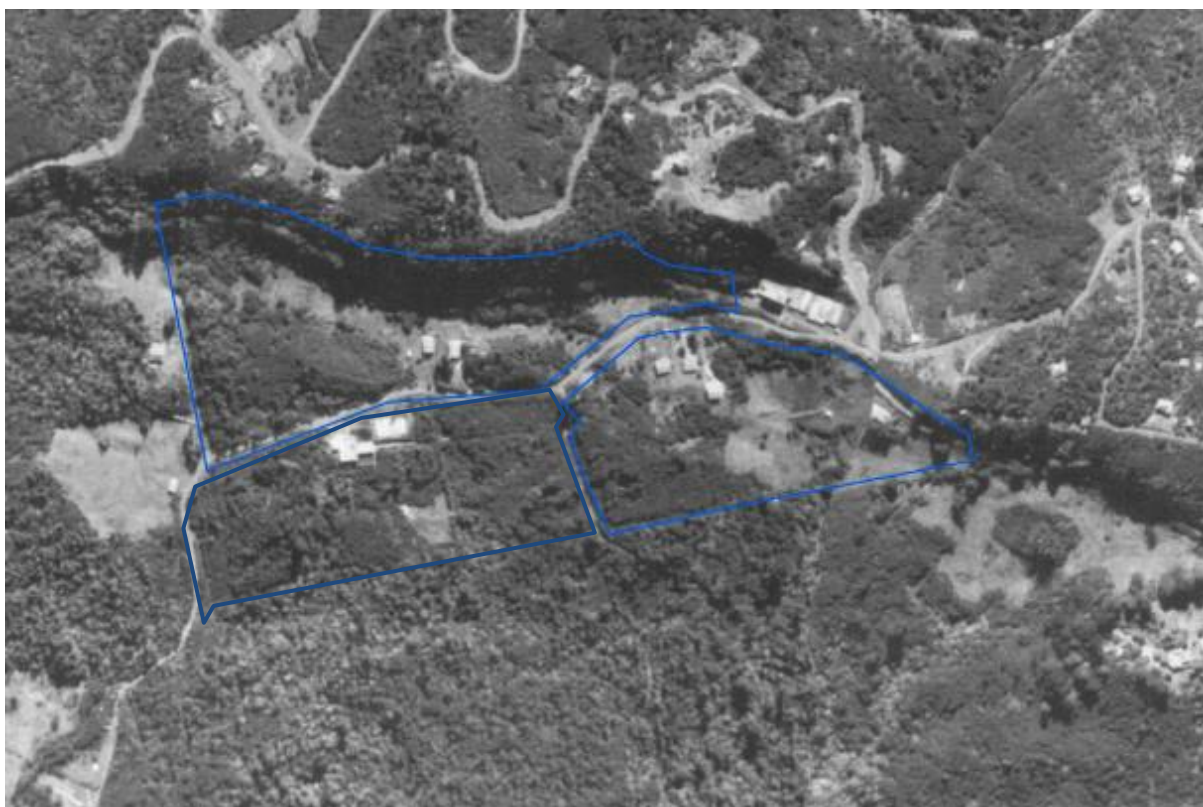
The earliest photo available (from 1940) shows that the site was predominantly covered in vegetation, however there are five dwellings; two on the Reservoir 1 site and three on the replacement WTP site. These dwellings are still visible in the 1988 photograph but none are visible in the 1996 photograph. Subsequent photographs show cleared areas where dwellings were formerly located.

Photograph Appendix C.1: 1940 Aerial Photograph (Source: Auckland GeoMaps)

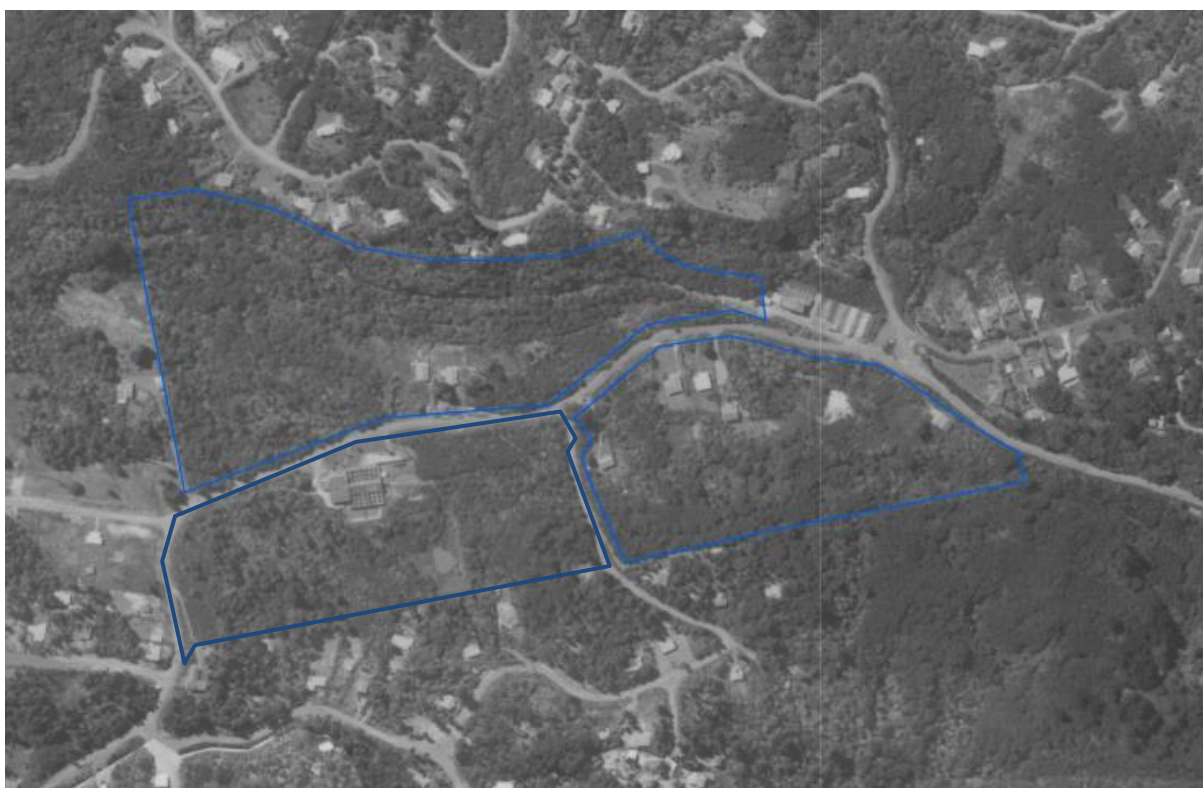
From 1959, there is a small clearance on the replacement WTP site in the centre of the vegetated area that is visible up until the 2000 aerial and disappears by 2001. There appears to have been some ground disturbance in this area, however it is unclear as to whether this has been caused by a natural activity (e.g. landslip) or human activity (e.g. cleared for construction activity, storage or disposal to land). There is no knowledge of any construction activity in this area and there are no pipes, etc – in the 1959 photo two concrete chambers are visible slightly to the north west and a pipe line going directly south of the concrete chambers. However, according to Watercare this pipeline has since been abandoned and is in disrepair.

Photograph Appendix C.2: 1959 Aerial Photograph (Source: Auckland GeoMaps)

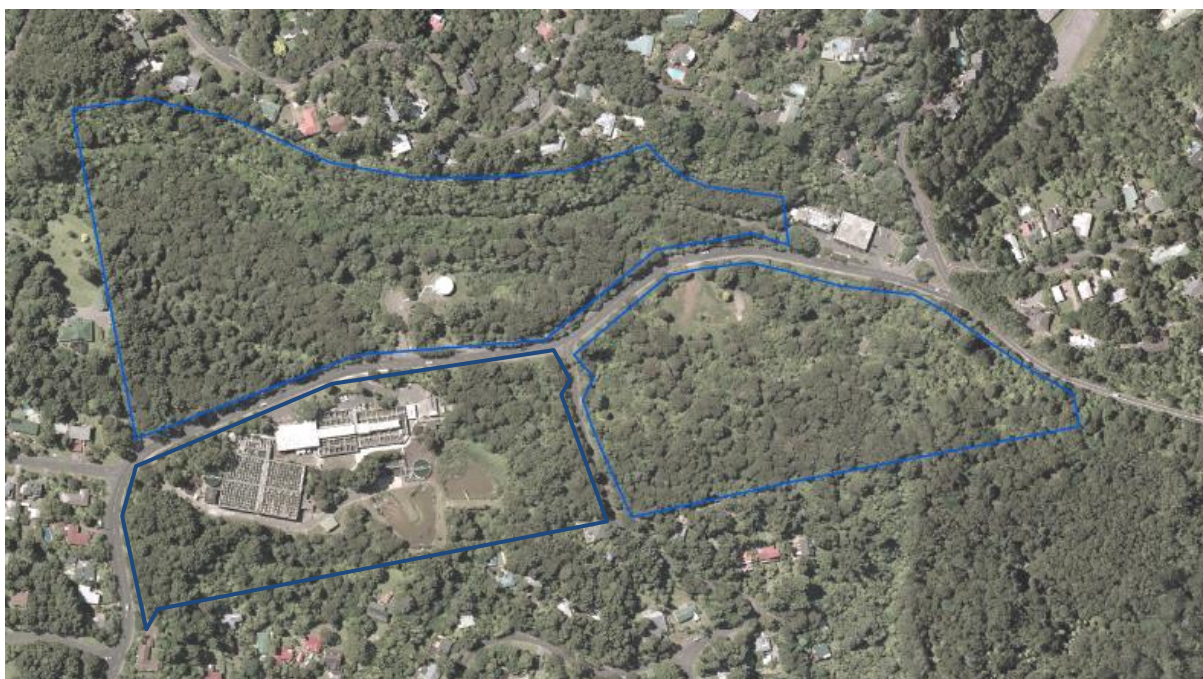
In 2006 the area of the historical houses on the replacement WTP site immediately south of Woodlands Park Road appears to be cleared of vegetation. The 2008 photograph shows what appears to be coarse material on the surface of the clearing, which could have been filling or temporary stockpiling since the area appears to have been partially revegetated by the 2010/2011 photographs. By 2010 these works appear finished in the photos and the area become partially revegetated by 2015/2016. Watercare has advised that the material visible in the clearing in the 2006 photograph is rocks used by a contractor in the enlargement of an attenuation pond – Watercare has also pointed out that these rocks are visible on the 2008 photograph, having been placed around the edges of the attenuation pond.

Photograph Appendix C.10: 2006 Aerial Photograph (Source: Auckland GeoMaps)

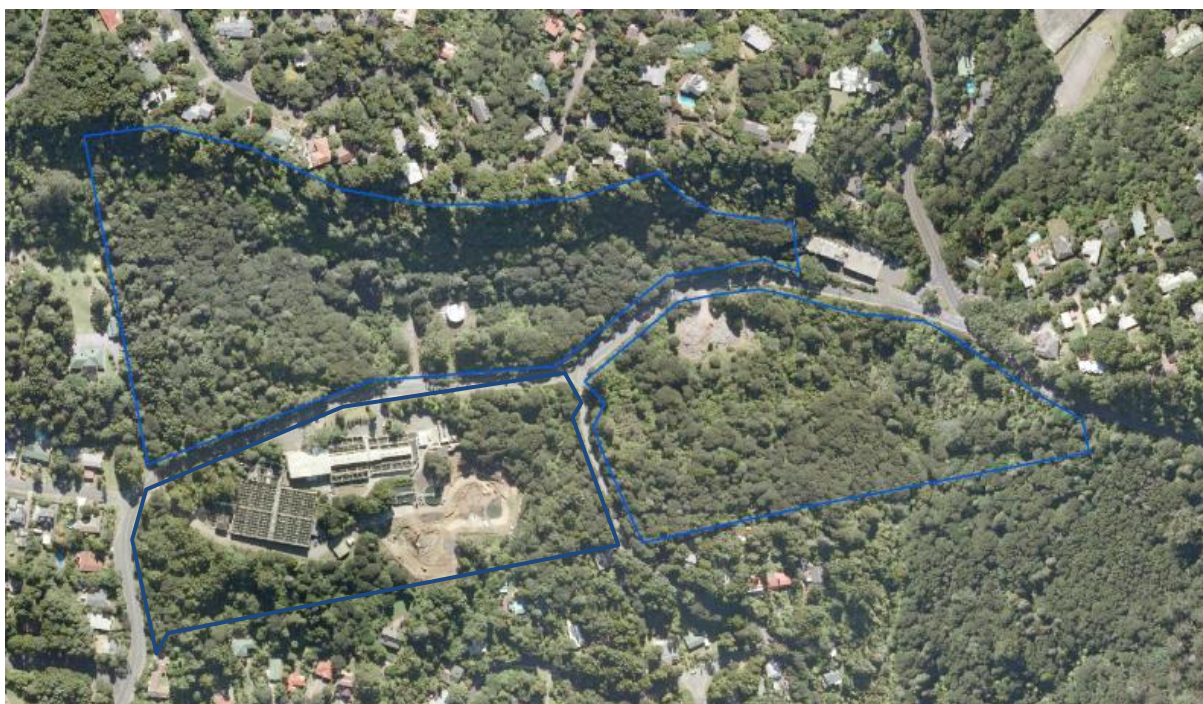
Photograph Appendix C.11: 2008 Aerial Photograph (Source: Auckland GeoMaps)

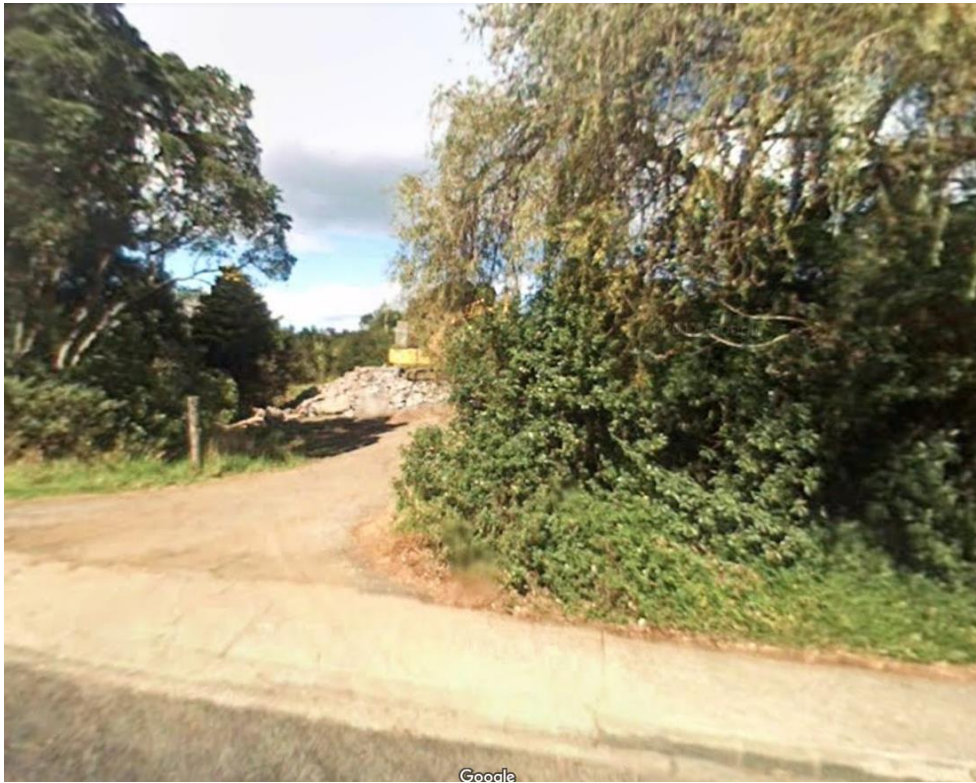
Google Maps street view images also identified these activities on the replacement WTP site. These are included in **Appendix H**. In 2008 a digger is shown on site in a Google street view image with material (rocks) which have been stockpiled here. This is no longer visible in the Google Street View 2009 images and the area appears to be flat with some material on site.

Google Maps street view images that were from 2008 and 2009. The 2008 image shows a digger on the southern site at the area of unknown clearance and unknown material stockpiled here. In 2009 the area appears clear with the entrance way blocked with a small stockpile of unknown material.

Photograph Appendix H.1: Google Street View of cleared section on Woodpark Road March 2008 (Source: Google Maps)

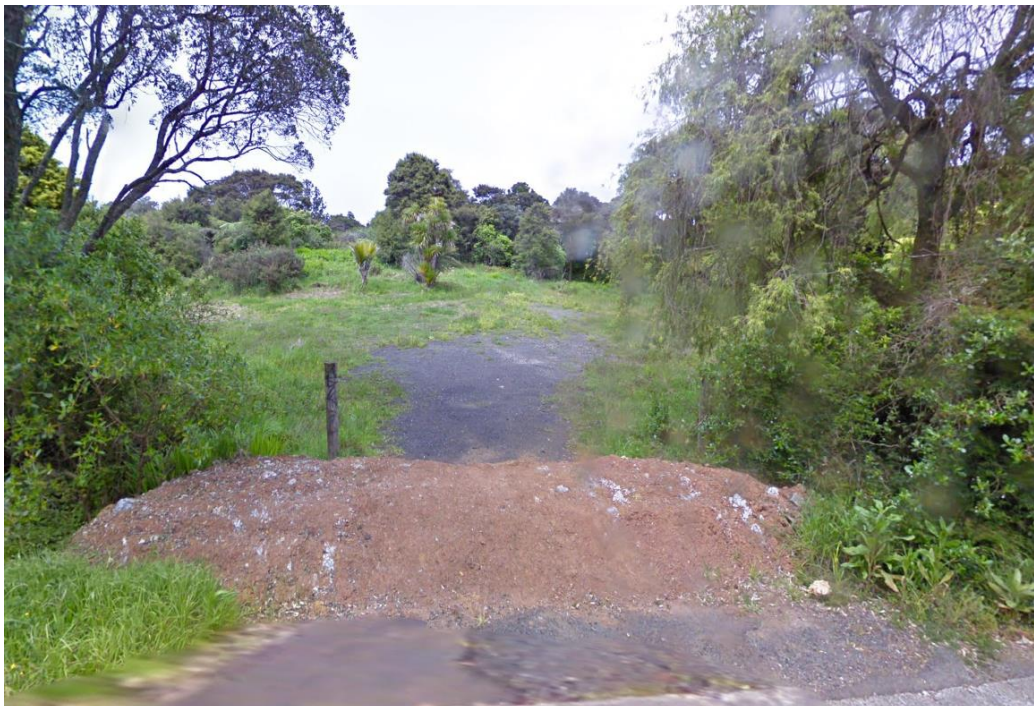
Photograph Appendix H.2: Figure Appendix H.1:Google Street View of cleared section on Woodpark Road November 2009
