# REPORT

## Northern Interceptor - Phase 1

Ground contamination assessment

Prepared for:  
Watercare Services Limited

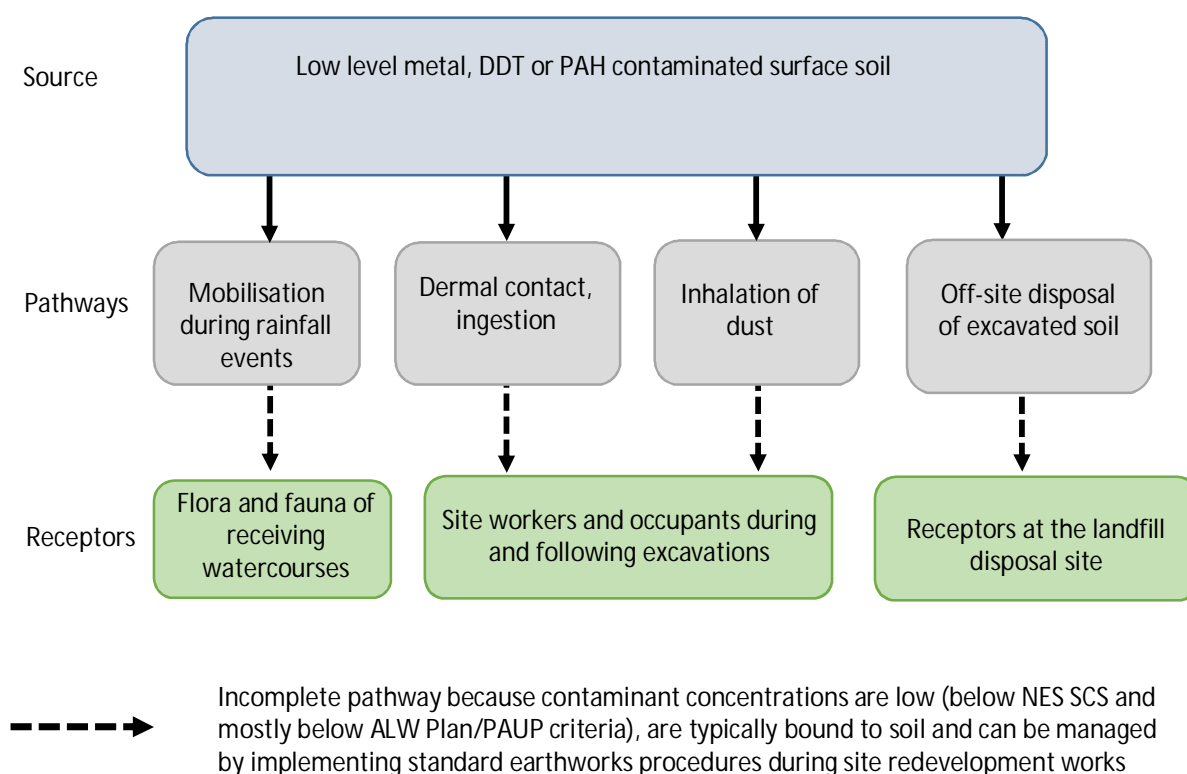
Diagram 1: Preliminary conceptual site model for project. All pathways are incomplete

A conceptual site model has been developed generally for the project, which takes into account the available information about the site, geological, hydrological and hydrogeological site conditions and our understanding of the potential effects on human health and the environment. The model is presented below.

The results of the testing indicate that contaminant concentrations are not at levels that would pose a human health risk to construction workers and the general public. In addition, the works can be managed using standard earthworks procedures to ensure that any environmental impacts will be less than minor. The procedures are provided in a Ground Contamination Site Management Plan which has been prepared for the project and is attached.

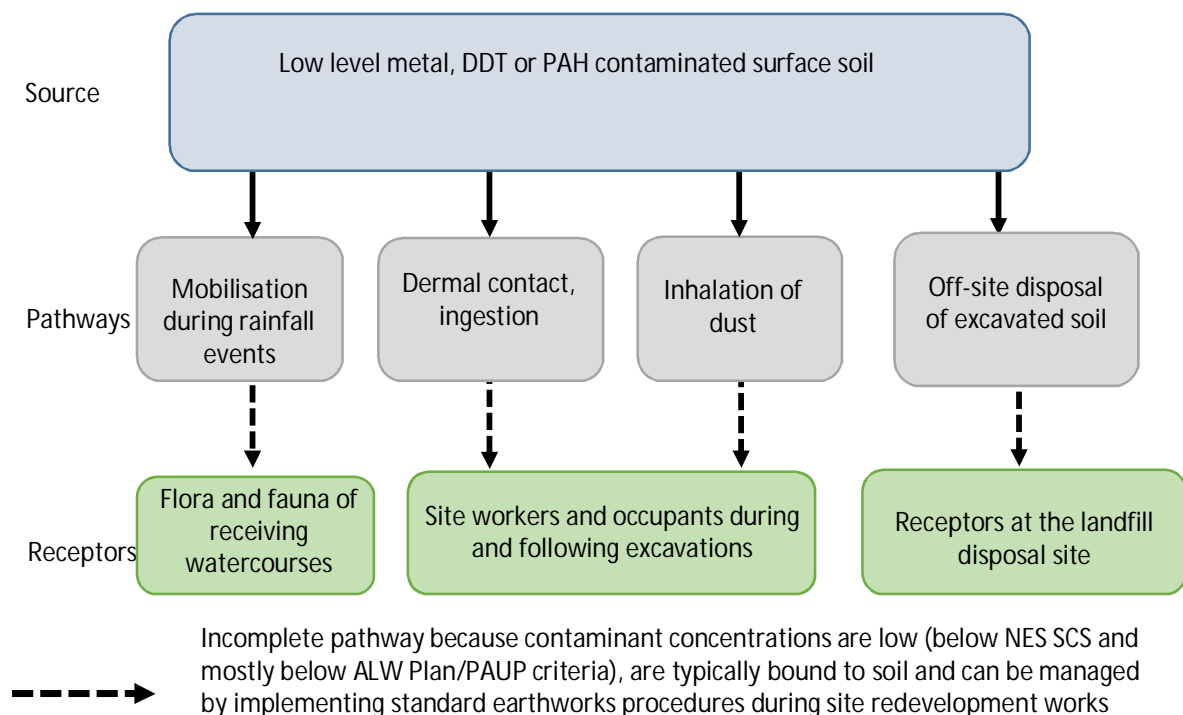
Diagram 1: Site conceptual Model

An assessment of effects of the proposed works based on the results of the testing is shown on the conceptual site model below.

The results of the testing indicate that contaminant concentrations are not at levels that would pose a human health risk to construction workers and the general public. However, the presence of low level contamination in near surface soils has implications for the work as set out in this document.

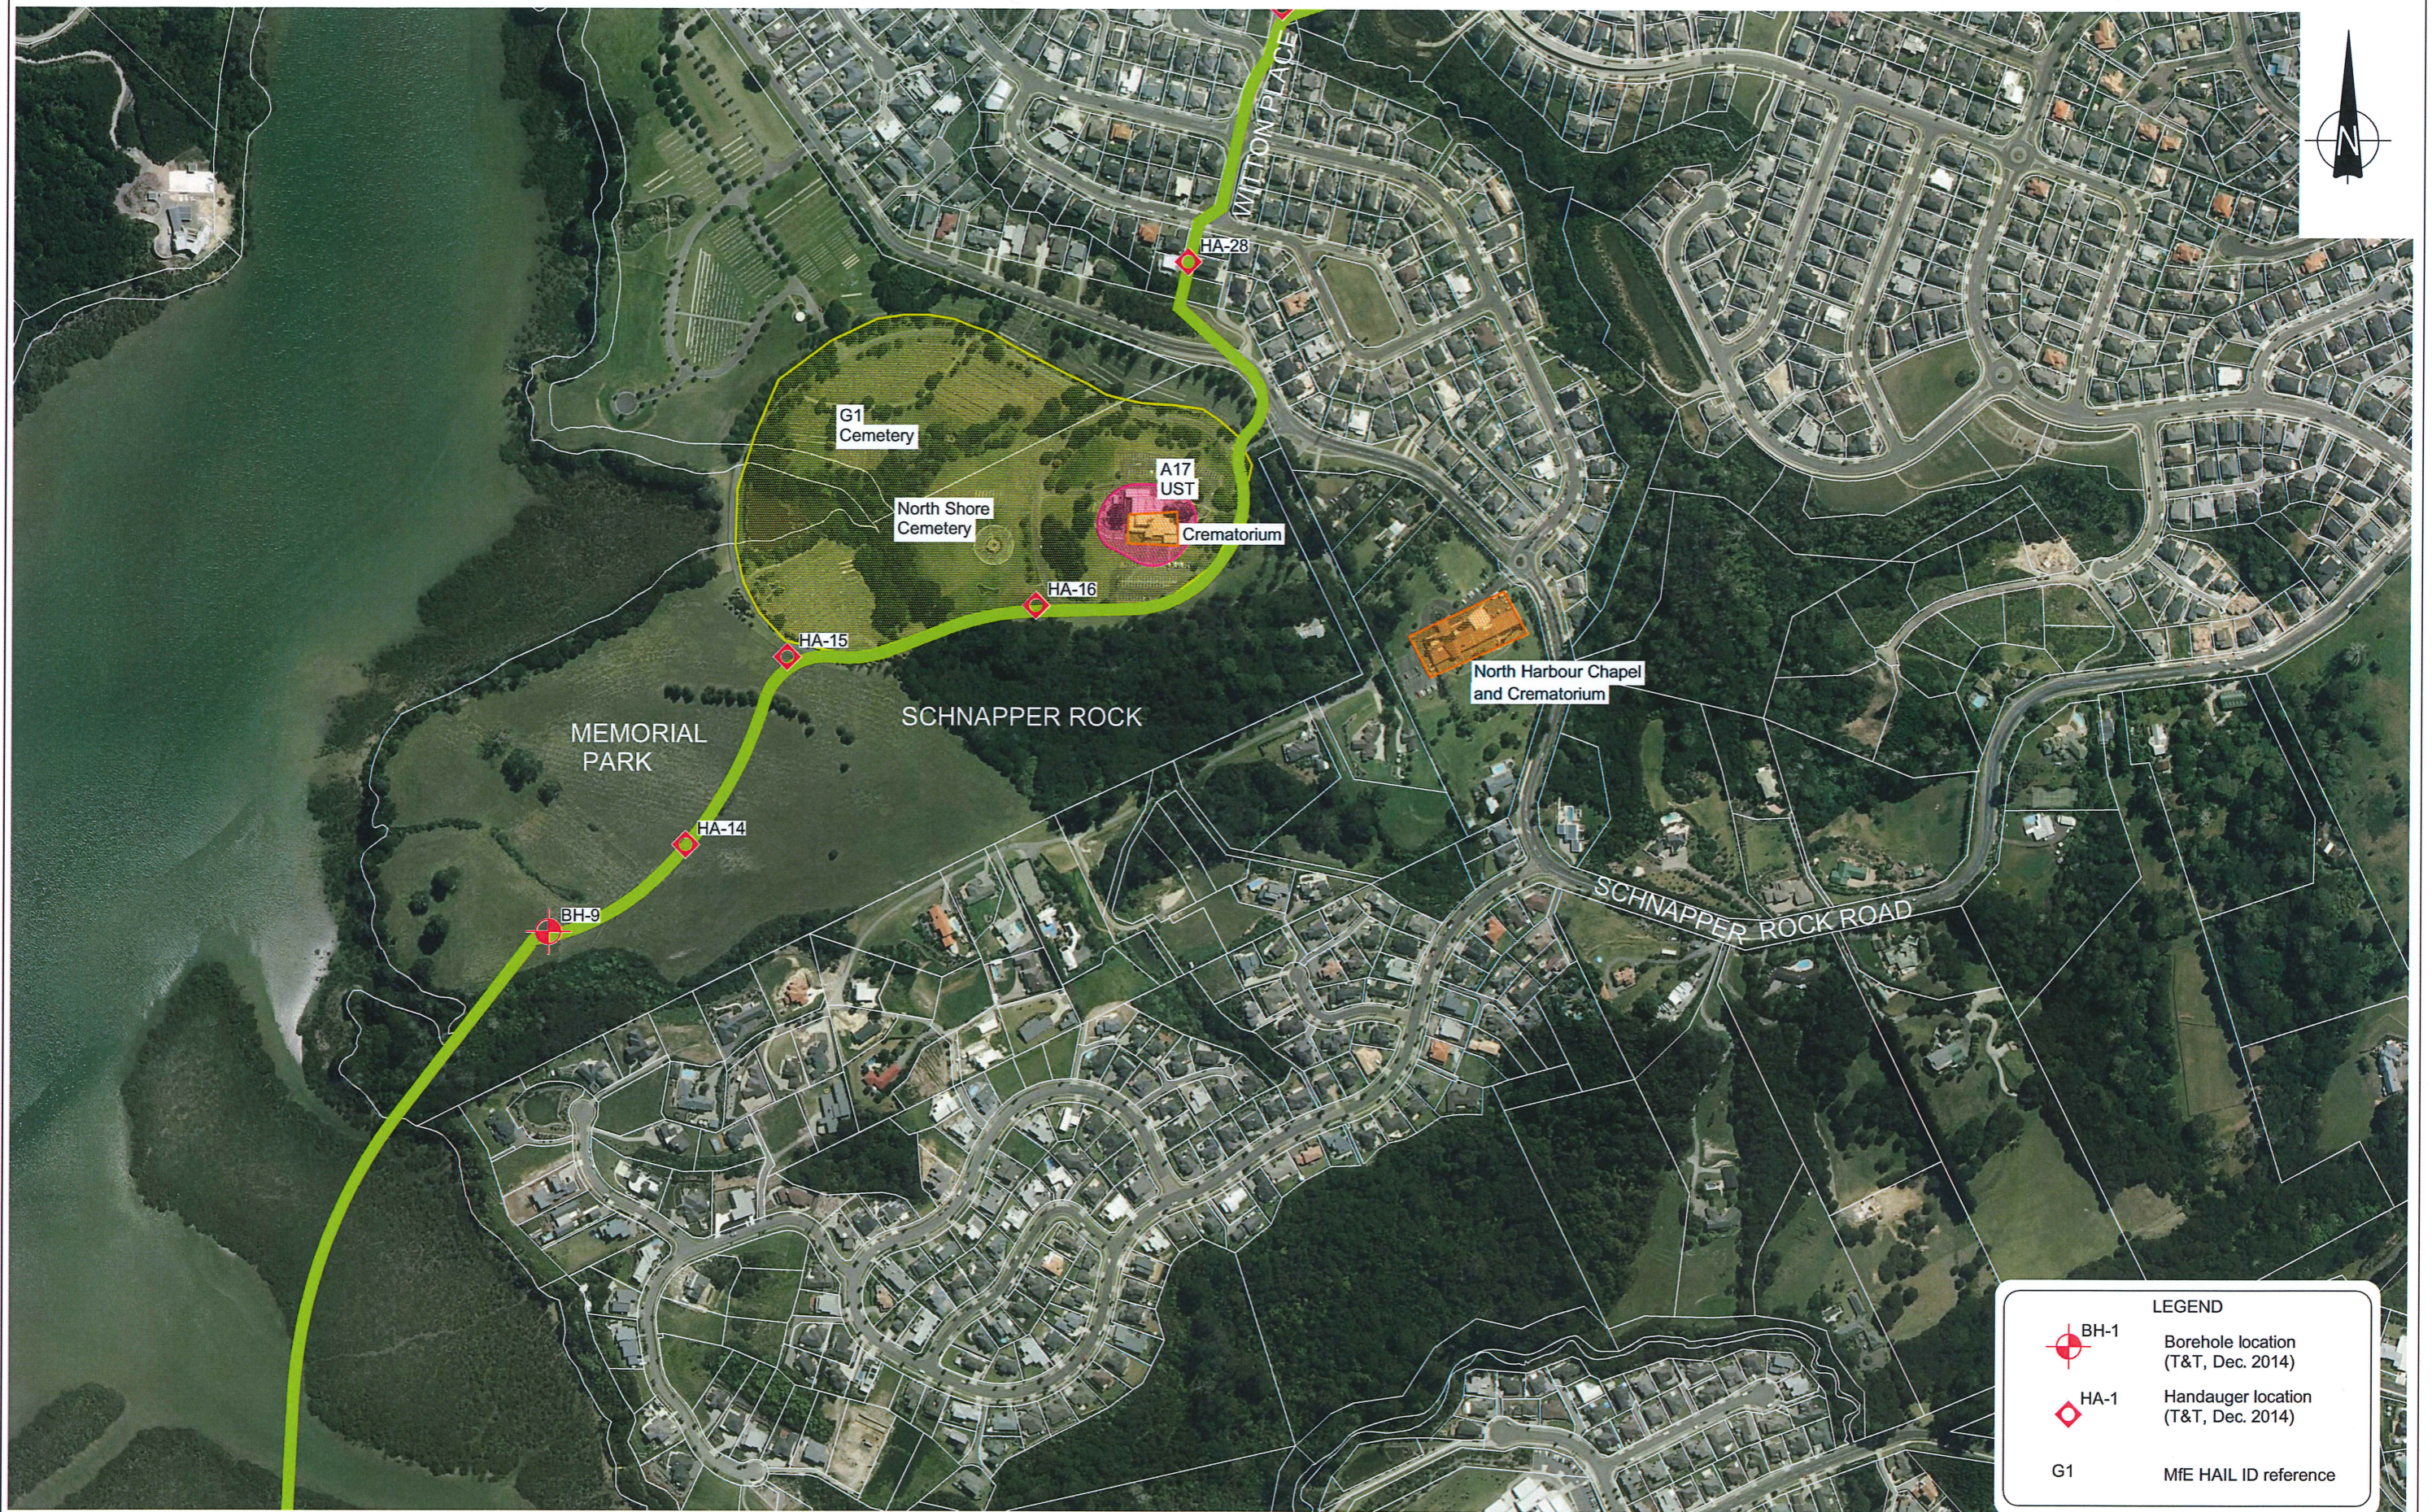
FIG. No. **Figure 6** REV. **1**

**NORTHERN INTERCEPTOR PHASE 1 ALIGNMENT PSI/DSI**  
Potential HAIL Activities – Schnapper Rock

at the proposed alignment through groundwater is negligible. Potential for contamination: negligible		
Bulk fuel storage associated with the crematorium in North Shore Memorial Park (refer Figure 6)	Hydrocarbons including TPH, VOC and PAH	If significant spills/leakage have occurred from the underground storage tank (UST) these have the potential to contaminate soil around the tank and groundwater below the tank depending on the permeability of underlying soils. The proposed alignment is up-gradient of the former UST which has also been indicated to have been removed. Potential for contamination: negligible	None (Activity H - Contaminant migration to the alignment is highly unlikely to have occurred)	None
Pollution incident at 15 Unity Drive North, Rosedale (refer Figure 7)	Unknown, but likely to be metals, VOCs and PAH associated with inks and dyes	The incident file indicates that a moderate volume of ink/dye was spilled and recorded within a pond at the site. It is possible that contamination of residual soils beneath the site has occurred due to the proximity of the incident directly adjacent to the alignment. Potential for contamination: low to moderate	Activity I – Intentional or accidental release of a hazardous substances	HA24
