Greenhithe Bridge Watermain Duplication and Causeway

Technical Report C - Groundwater

19 May 2015

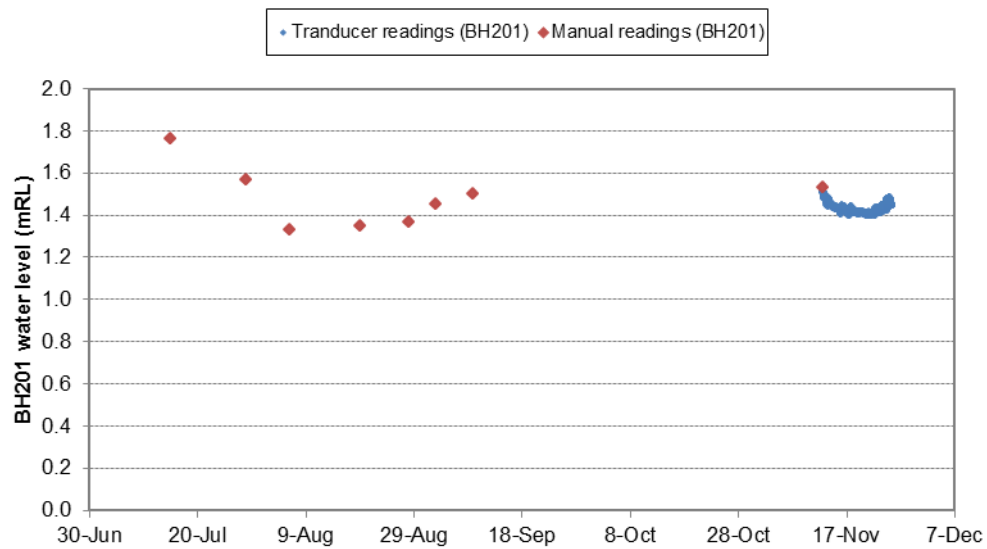
Figure 2 Recorded groundwater levels (mRL) at BH201

The transducers were installed in BH201, BH202, and BH204 on 12 November 2014 and removed on 25 November 2014. The water level readings (**Figure 2** to **Figure 4**) indicate maximum water levels of 1.85 mRL (2.6 to 3.4 mBGL) on the west end of the bridge where the NH1-GWBD connecting pipe is to be tunnelled under SH18 and 22.80 mRL (3.8 mBGL) on the east end of the bridge near the value chamber at the new watermain and NH1 pipe connection.

Monitoring also indicates groundwater levels at BH202 are relatively steady (maximum fluctuation of 0.06 m) whereas water levels at BH201 and BH204 show evidence of water level fluctuation of 0.45 m and 0.35 m, respectively. This was investigated further by assessing the transducer data collected in the piezometers.

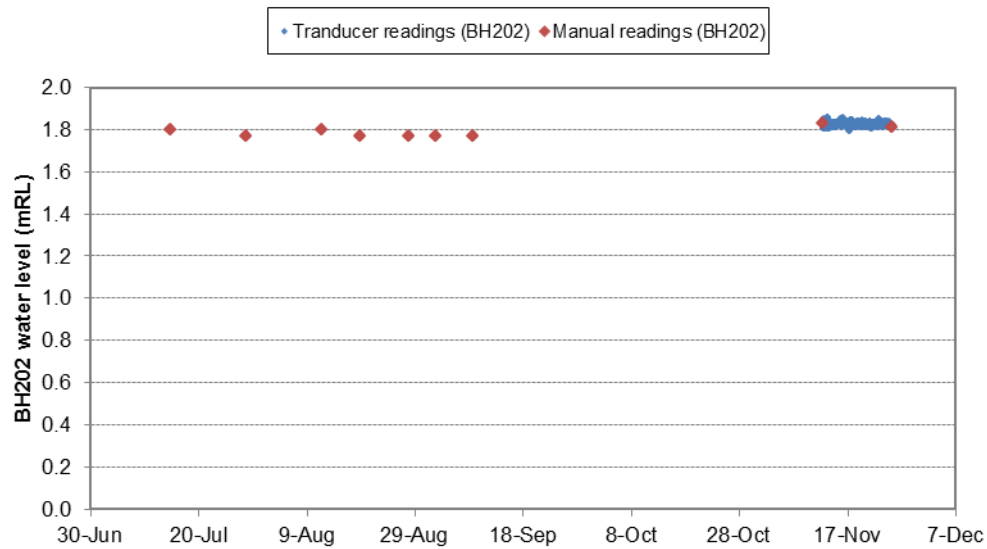
Figure 3 Recorded groundwater levels (mRL) at BH202

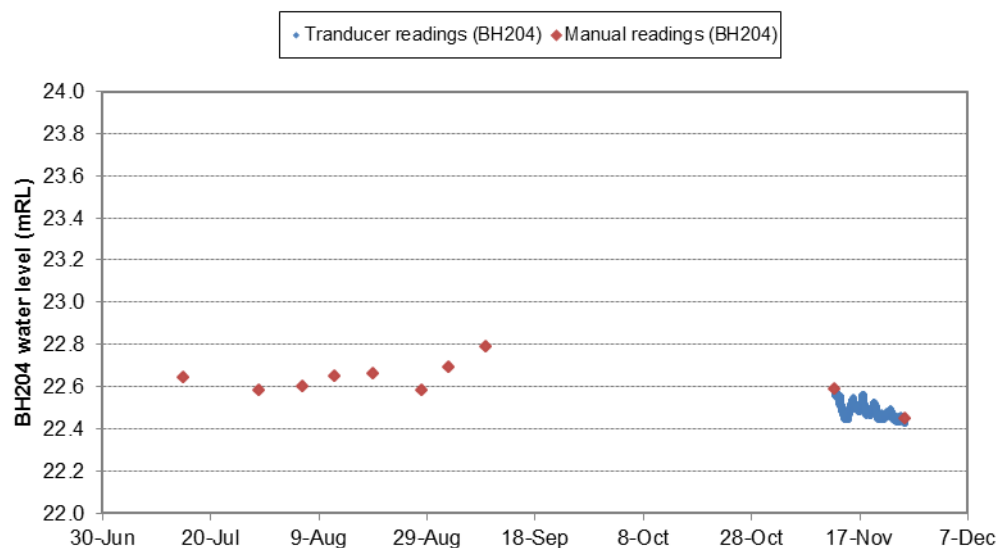
Figure 4 Recorded groundwater levels (mRL) at BH204

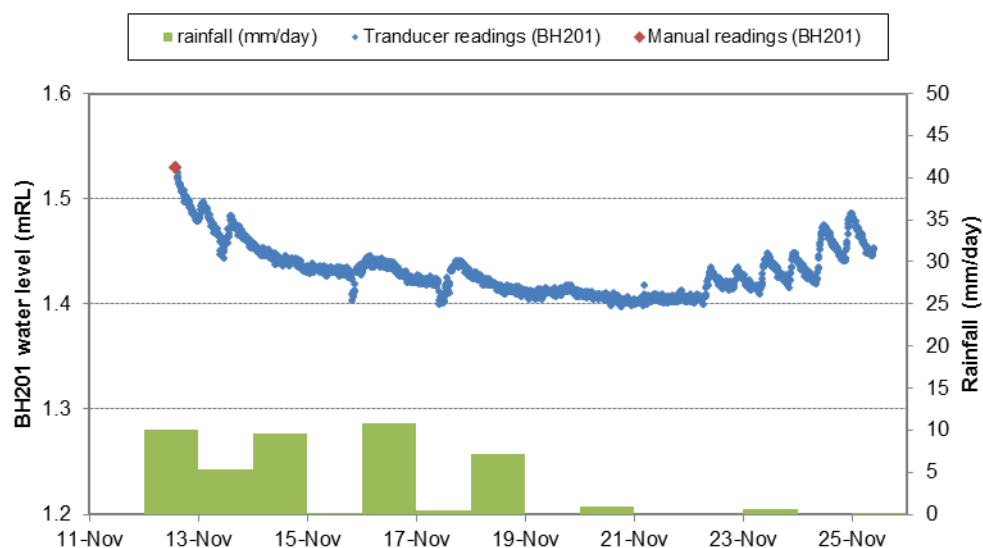
Figure 5 Continuous water level readings at BH201 between 12 and 25 November 2014

Figure 5 to Figure 7 compare the water level monitoring data with the local rainfall recorded at North Shore Albany Ews (Cliffo, 2014), located approximately 6 km north-west of the Greenhithe Bridge. BH201 water level fluctuations show some evidence of sensitivity to rainfall (17 November); however, the data is dominated by sharp intermittent increases in the later part of the record that may indicate anthropogenic influence as it cannot be directly related to rainfall. Water levels in BH202 and BH204 show evidence of tidal influence and rainfall; however, the response to rainfall in BH202 is limited due to the high level of development in the surrounding area (e.g. reduced infiltration).

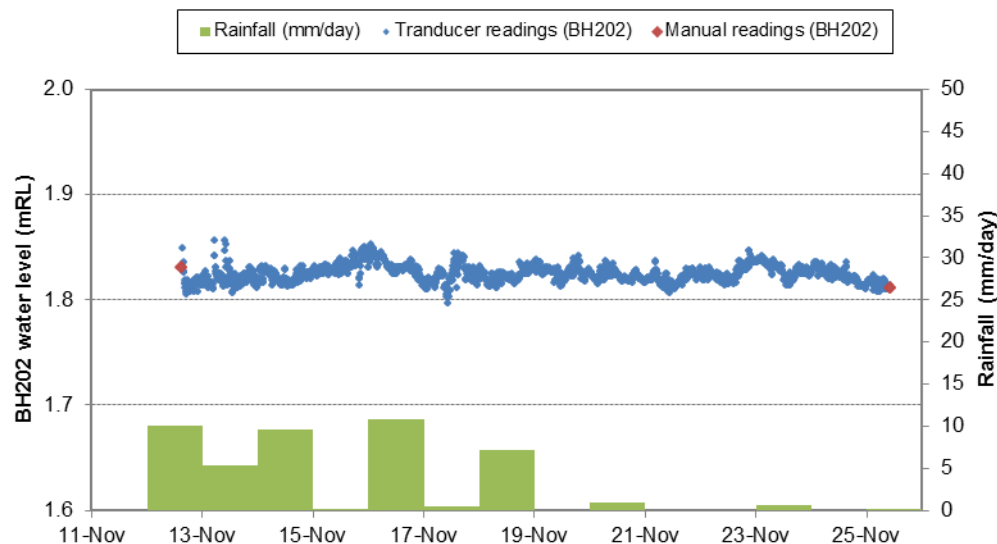
Figure 6 Continuous water level readings at BH202 between 12 and 25 November 2014

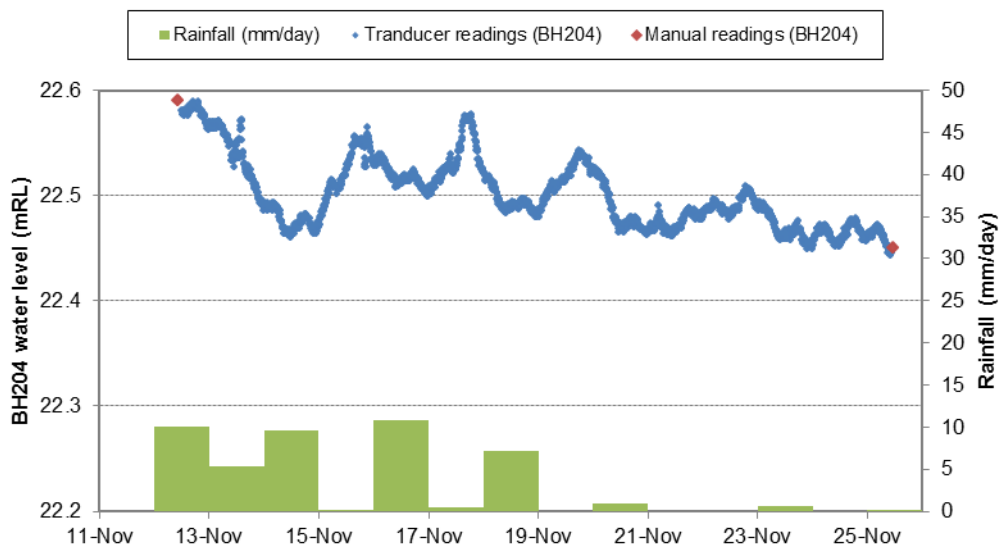
Figure 7 Continuous water level readings at BH204 between 12 and 25 November 2014

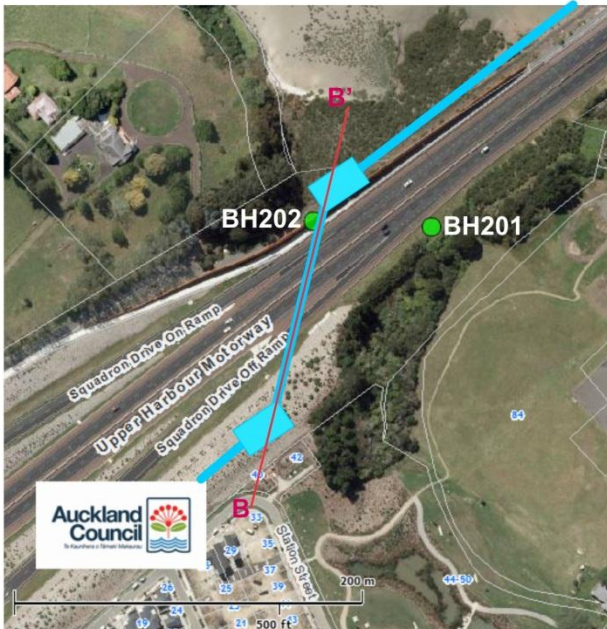
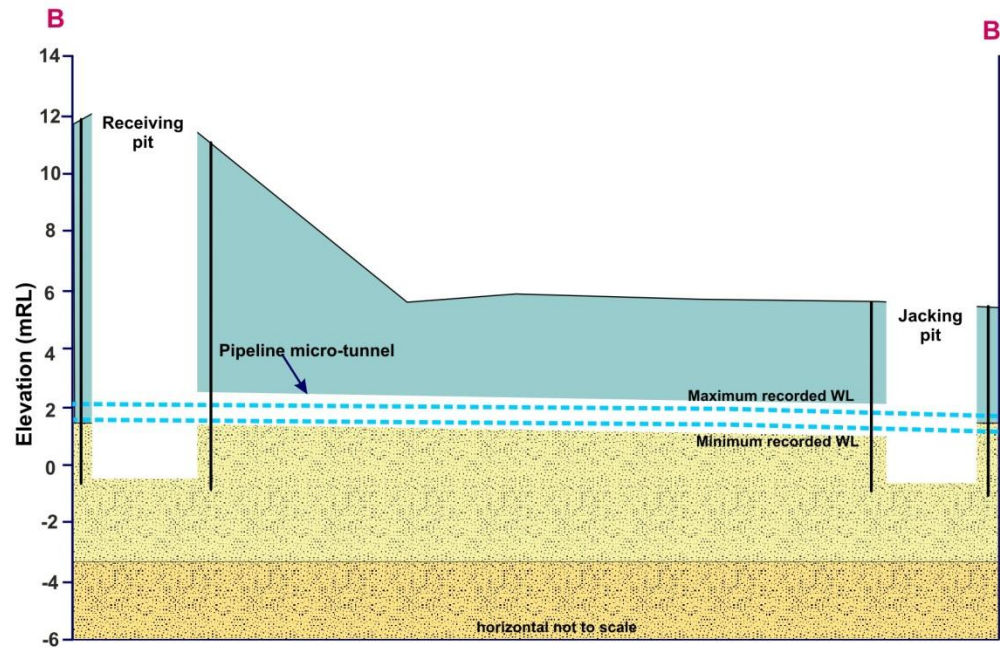
Plan view

Cross-sectional view

**FIGURE 9. SCHEMATIC DIAGRAM SHOWING
TEMPORARY WORKS AT MICRO-TUNNEL
SECTION RELATIVE TO WATER**

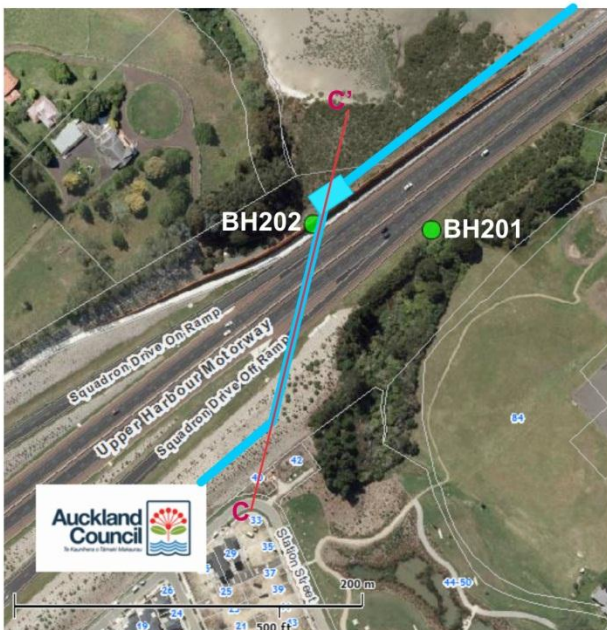
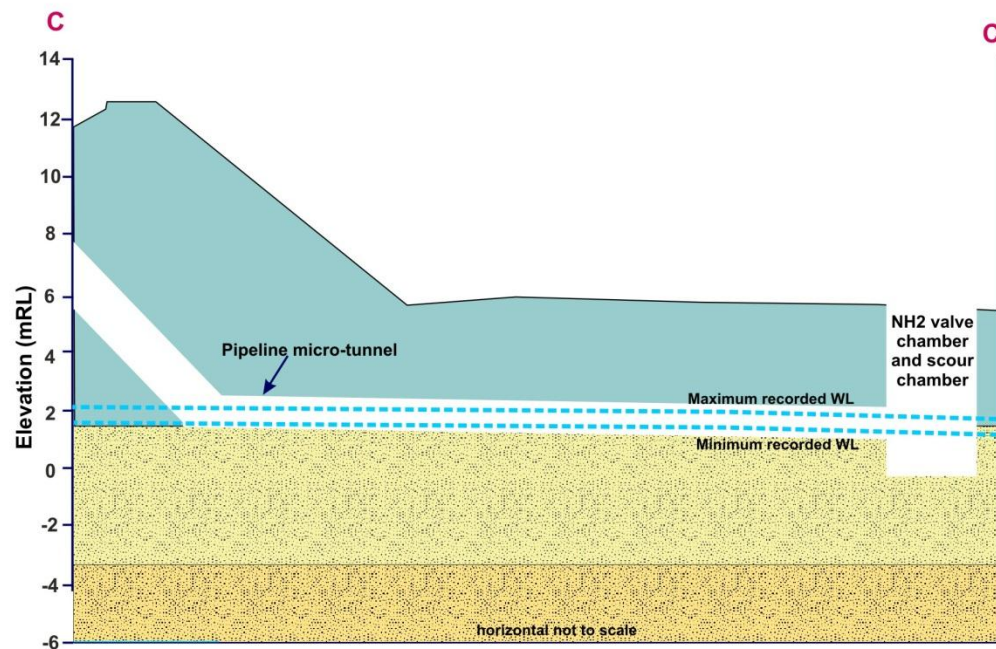
Plan view

Cross-sectional view

FIGURE 10. SCHEMATIC DIAGRAM SHOWING PERMANENT PIPELINE STRUCTURES RELATIVE TO WATER TABLE AT MICRO-TUNNEL SECTION

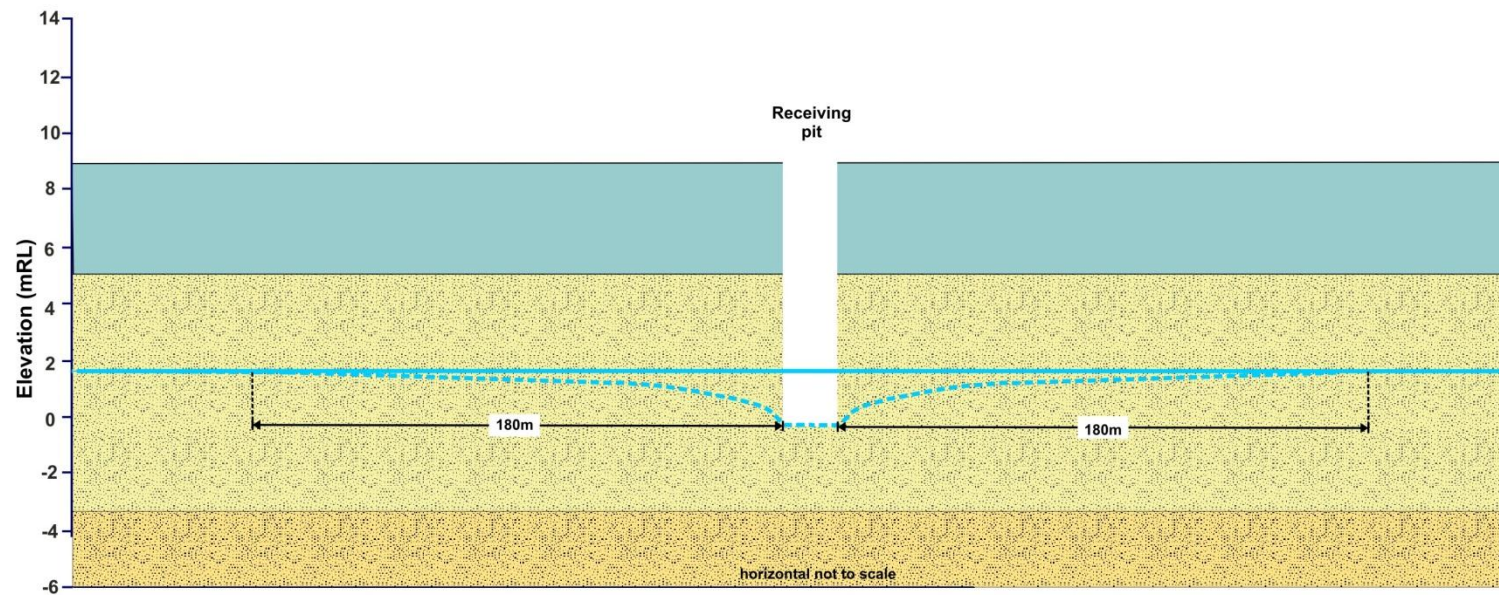
Figure 11: Schematic diagram showing drawdown at receiving pit

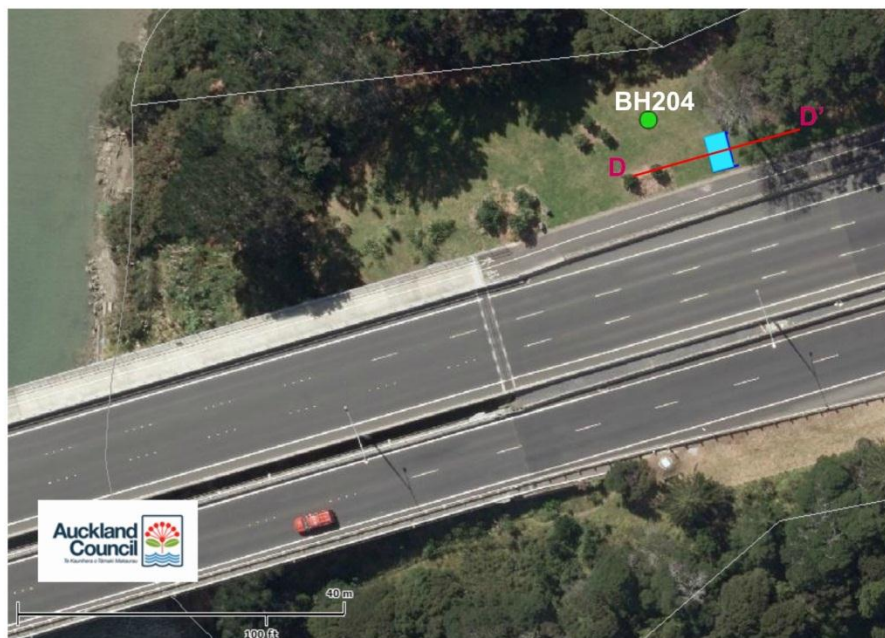
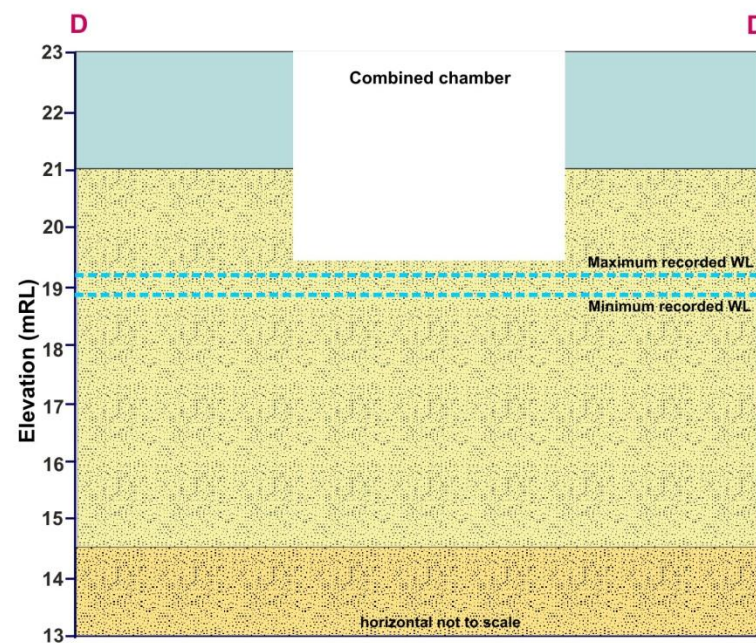
Figure 12: Schematic diagram showing east end combined chamber relative to water table

Plan view

Cross-sectional view

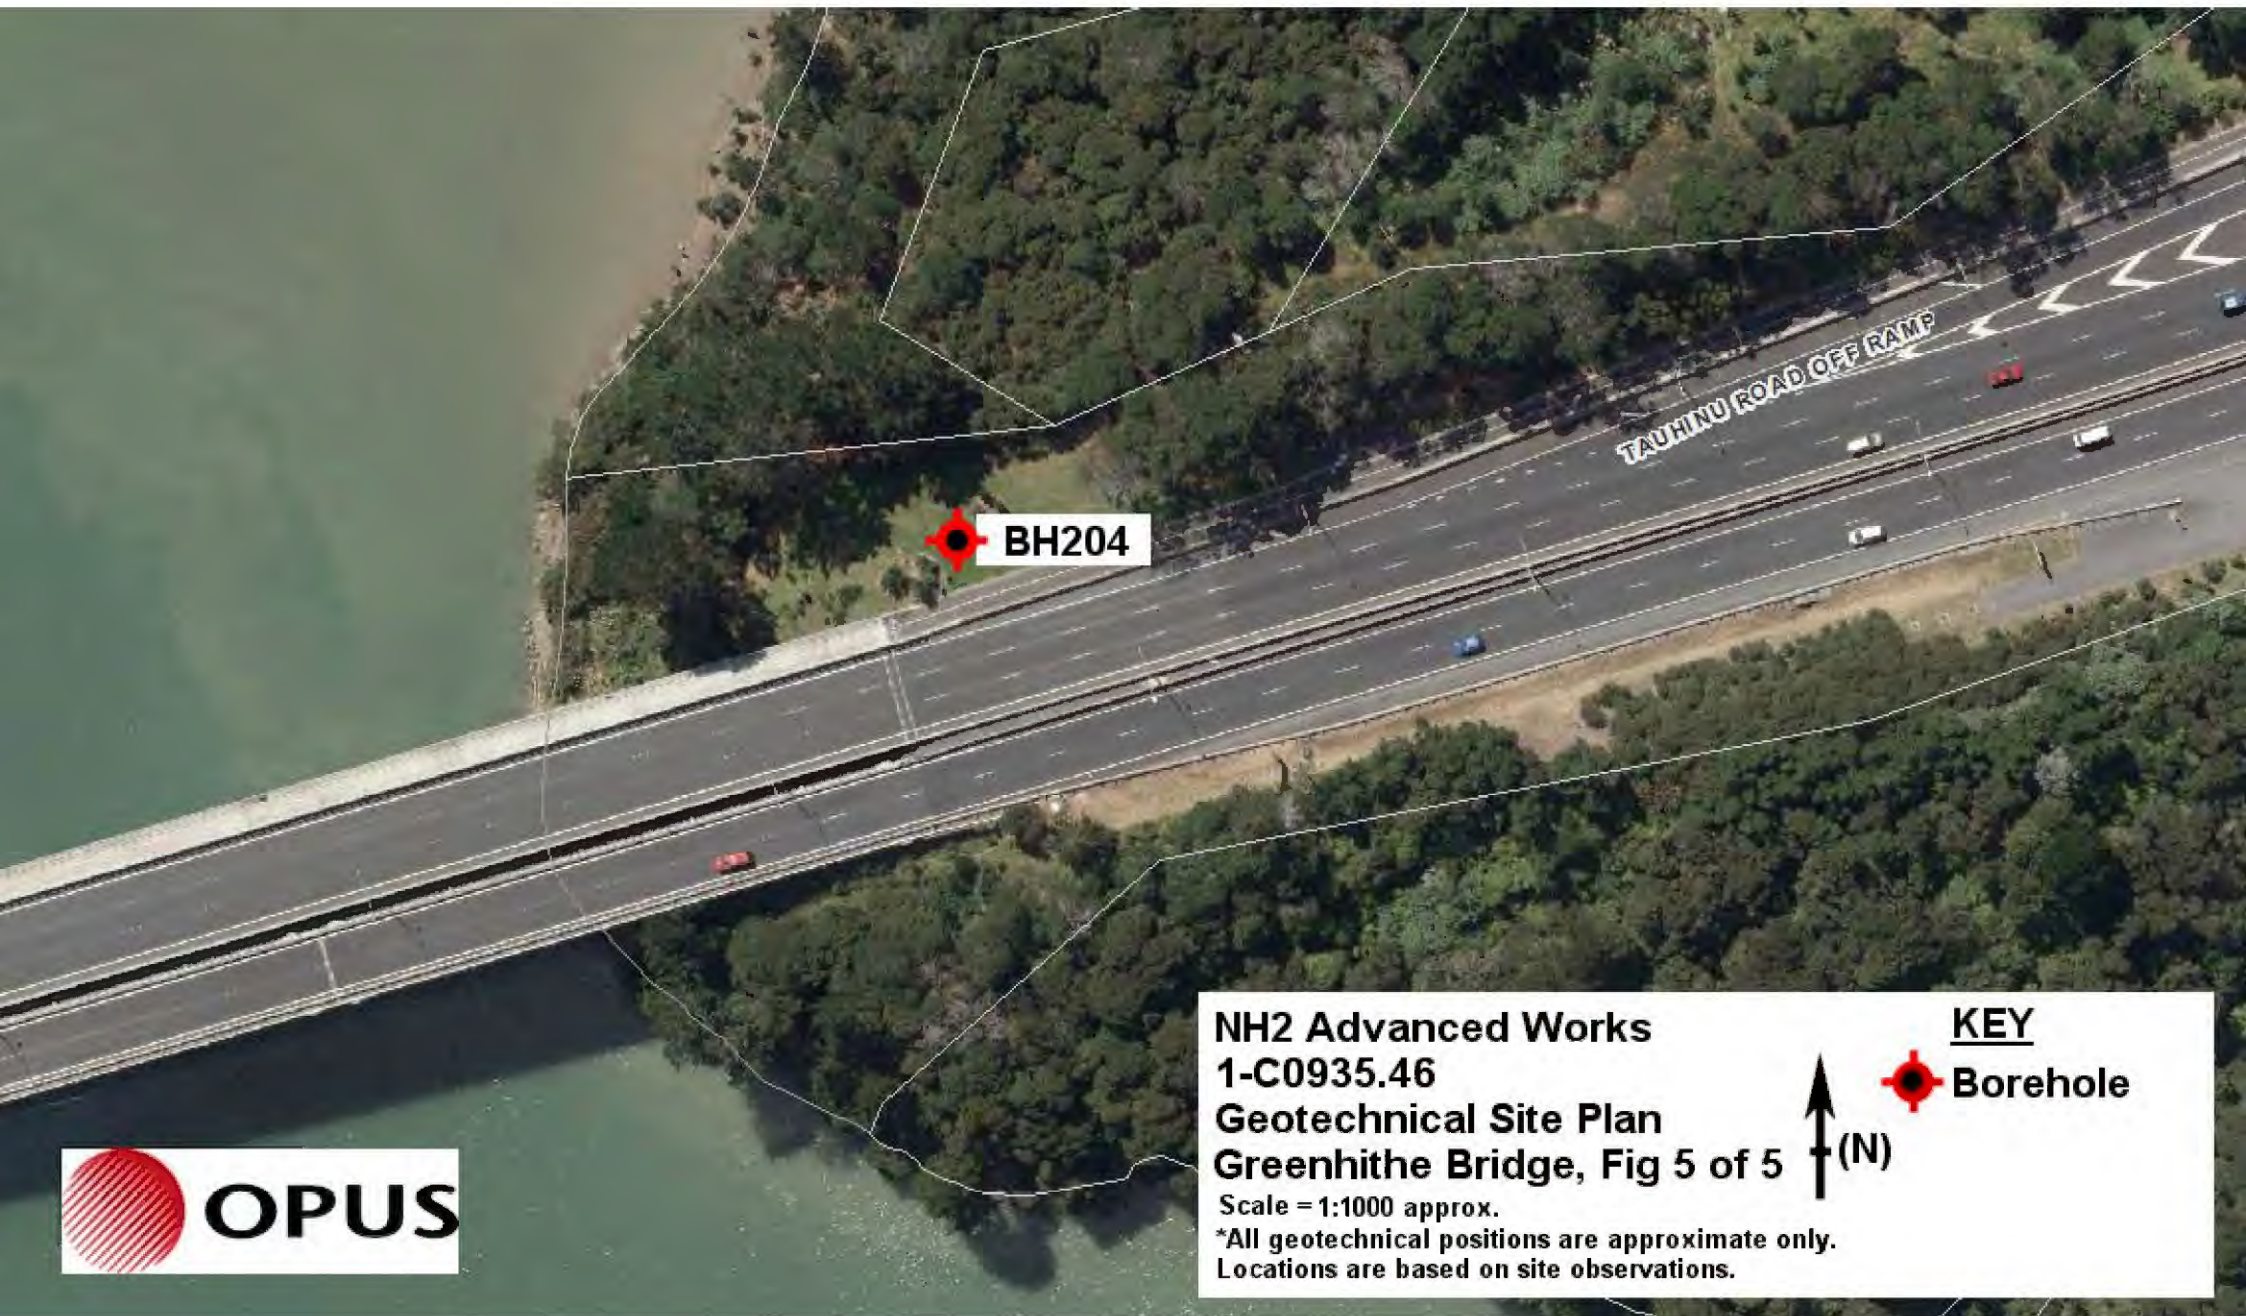
**NH2 Advanced Works
1-C0935.46
Geotechnical Site Plan
Greenhithe Bridge, Fig 5 of 5**

Scale = 1:1000 approx.

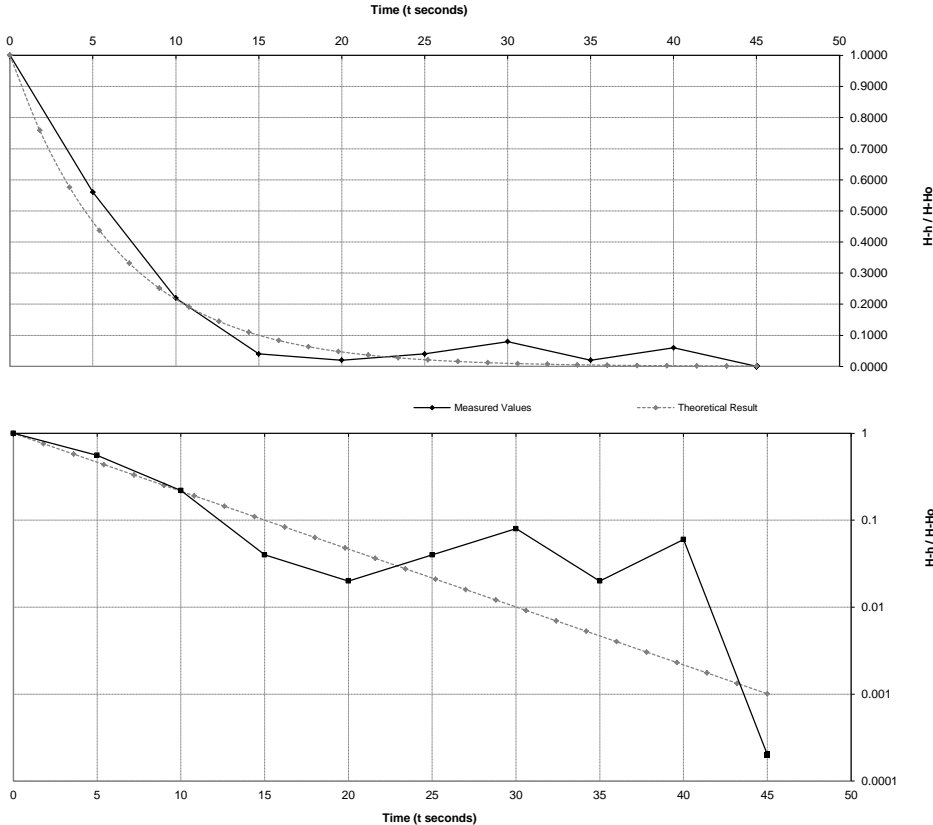
Hydraulic Conductivity
***K* = 3.15E-05 m/s**

Test Schematic

Bouwer-Rice (1976) Method:

$$K = \frac{r^2 \ln(R_e/R)}{2d} \frac{1}{t} \ln \left(\frac{H - H_0}{H - h} \right)$$

Graphs of Bouwer-Rice (1976) Piezometer Test (top graph has normal axes and bottom graph has a log H-h/H-Ho axis)

Rising head tests completed by Jacobs on two of the piezometers indicate that hydraulic conductivity values in the project area are consistent with geology found at the site and are within the expected range, e.g. 3.15×10^{-5} m/s (for fill in BH201) and 2.24×10^{-5} m/s (for weathered soils in BH204). A bore search enquiry from Auckland Council's bore database was undertaken and identified four deep groundwater take bores and two site investigation bores within 1.5 km of the proposed works.

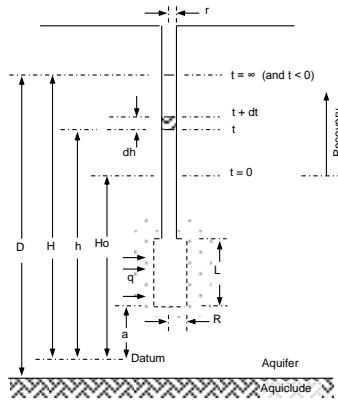
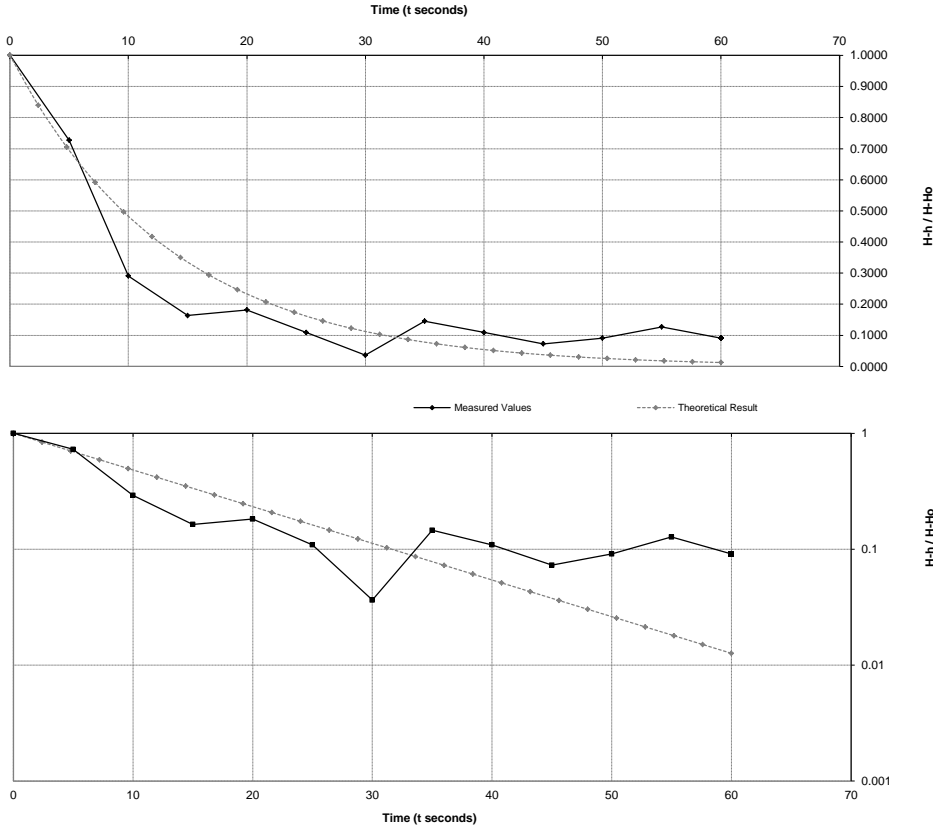
NHWM BH204

K = 8.41E-06 m/s

Test Schematic

Bouwer-Rice (1976) Method:

$$K = \frac{r^2 \ln(R_e/R)}{2d} \frac{1}{t} \ln \left(\frac{H-H_0}{H-h} \right)$$

Graphs of Bouwer-Rice (1976) Piezometer Test (top graph has normal axes and bottom graph has a log H-h/H-Ho axis)
