# **Arboricultural Assessment of Effects**

Trunk Sewer line construction in Herne Bay, resulting in alteration to street and reserve trees.

Prepared for	William Hung	Prepared by	Sean McBride
	Watercare		Director
	Victoria Street West	Date	9 June 2023
	Auckland 1142	Job ref #	2590

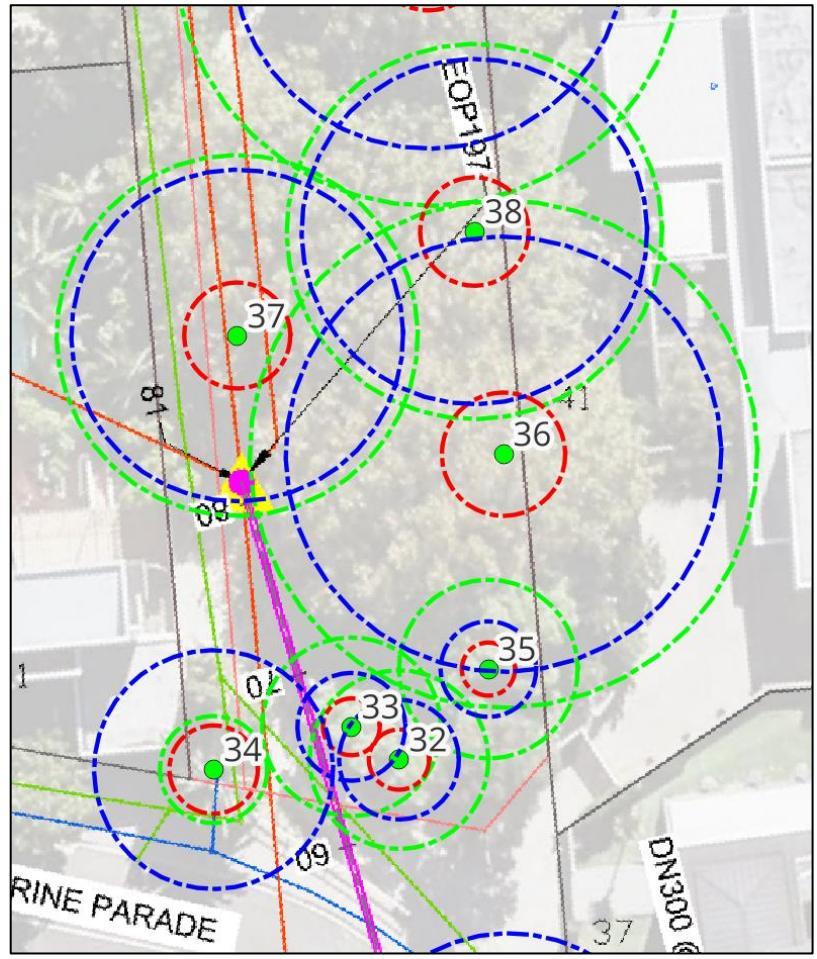
Figure 15 – Herne Bay Beach Reserve.

- 5.27 A 4 m deep manhole will need to be constructed within Herne Bay Road Reserve and trenchless methods will be used to install a 300mm pipe in a southerly direction towards Shaft 4. The excavation to form the manhole is on the periphery of several mature London plane trees PRZ and TPZ, and indiscriminate root loss to construct it will have minimal effects on the trees. Any drilling pits will need to be carefully located to ensure similar clearances are maintained from the trees, in particular tree 37 (Figure 15). Overall, the impact on trees can be managed to acceptable levels.

- 5.32 Tree 47 is more centrally located and can be retained to allow for access. It too has good vitality and has a fair form and branch structure. A western limb grows acutely from near the base and heads towards tree 46. The removal of this stem (Figure 15) will be required to allow for vehicle access.
